**Montanuniversität Leoben**

**Dissertation**

**Crevice Corrosion with Additional Heating and  
Cooling Cycles in Automotive Exhaust  
Systems**

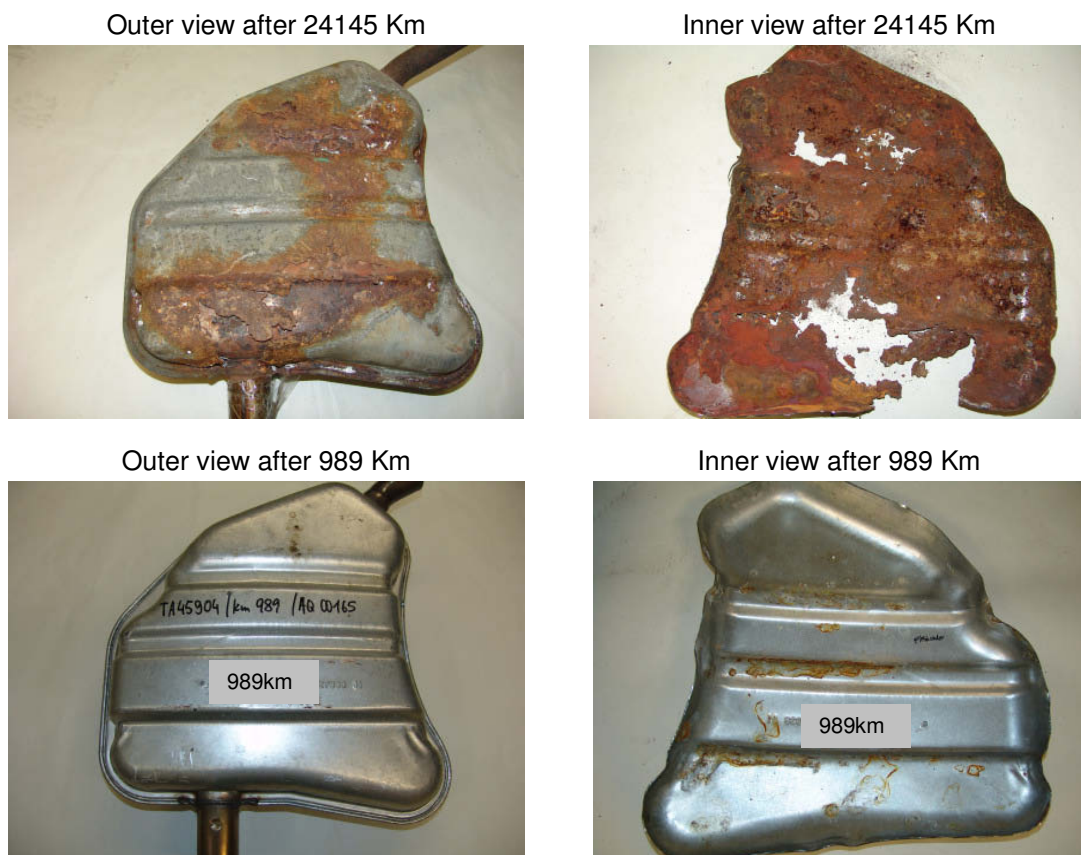
**Figure 1.1:** Field mufflers from material 1.4509 after different mileages

The life time of a muffler is shorter as compared to any other part of an exhaust system. Of all automotive exhaust failures, about 80% are caused by corrosion and oxidation while the majority of the remainder is caused by fatigue [20]. In figure 1 some examples from field are given. It can be seen that the parts showed corrosion attack even after a short period of time. This unique phenomenon of crevice corrosion was frequently observed during field investigation. This problem is more common in double sheet mufflers. Even after a very short mileage, lot of systems suffered from this type of corrosion between the sheets without showing any signs of corrosion on outside.

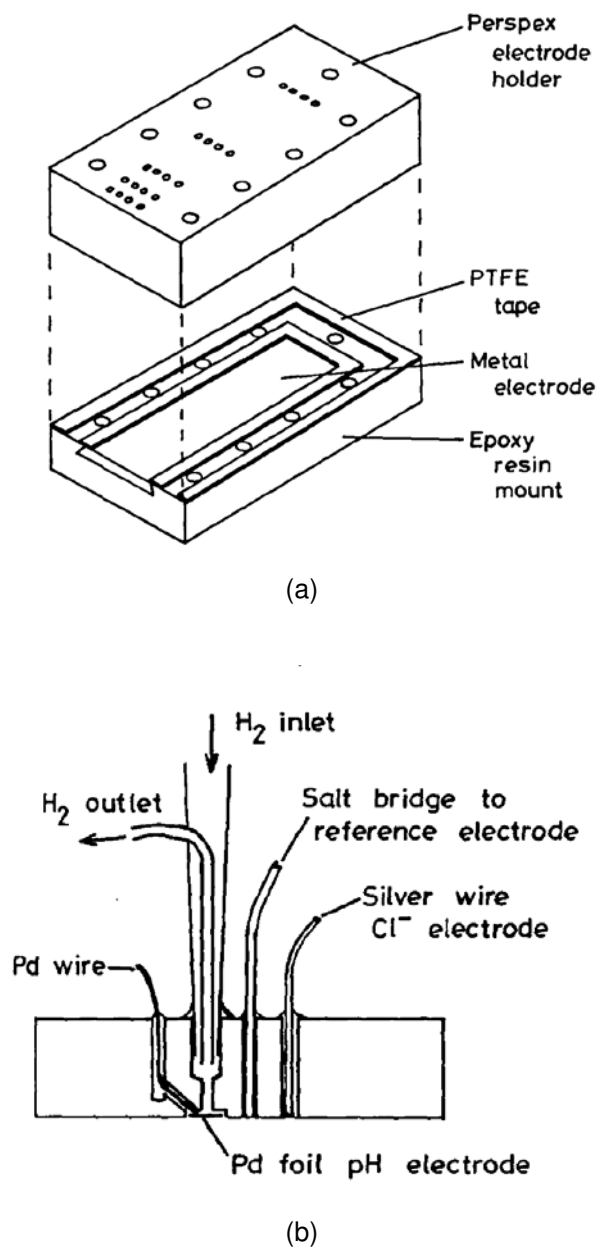
**Figure 2.1:** Schematic of artificial crevice in Alavi and Cottis's experiment [29]

Alavi and Cottis studied the potential, pH and chloride concentration variations in an engineered crevice of AISI 304 stainless steel and AA 7475 aluminum alloy, in 0.6 M bulk NaCl solutions. The crevice used in their experiment was built from a 304 SS plate with dimensions 80 mm long and 25 mm wide and encased in epoxy resin with a Perspex electrode holder as shown in figure 2.1.

The crevice gap was approximately 90  $\mu\text{m}$  and the temperature of the electrolyte was set at  $23 \pm 1^\circ\text{C}$ . pH values of 1-2 near the crevice mouth were measured for the 304 SS alloy and pH levels of 3-4 near the crevice mouth was measured for the AA 7475 aluminum alloy as well. Furthermore, a pH of near 8 was measured around the crevice tip for both stainless steel and aluminum alloys. Results from the experiments show that the external potential dropped slowly to positive (noble) values as time and distance from the crevice mouth increased for both metals. This indicates that both crevices were subject to anodic dissolution, due to reduction in the oxygen concentration of the crevice electrolyte compared with the oxygen concentration in the bulk solution. The potential drops between the external solution and the various parts of the crevice are plotted in figure 2.2 as a function of external potential.

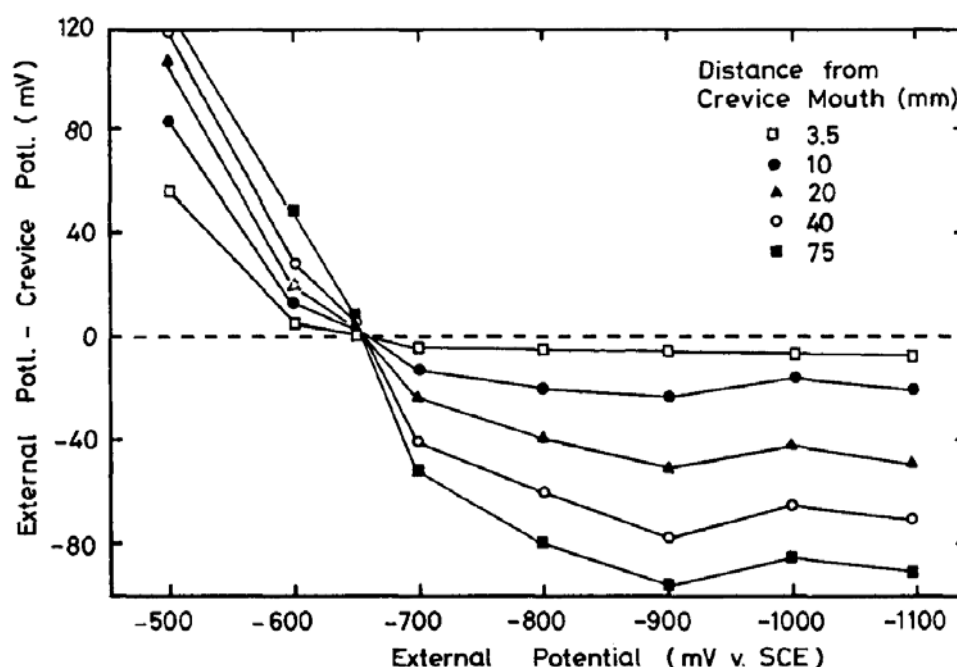
Figure 2.2: Potential Drop in Crevice v. External Potential [29]

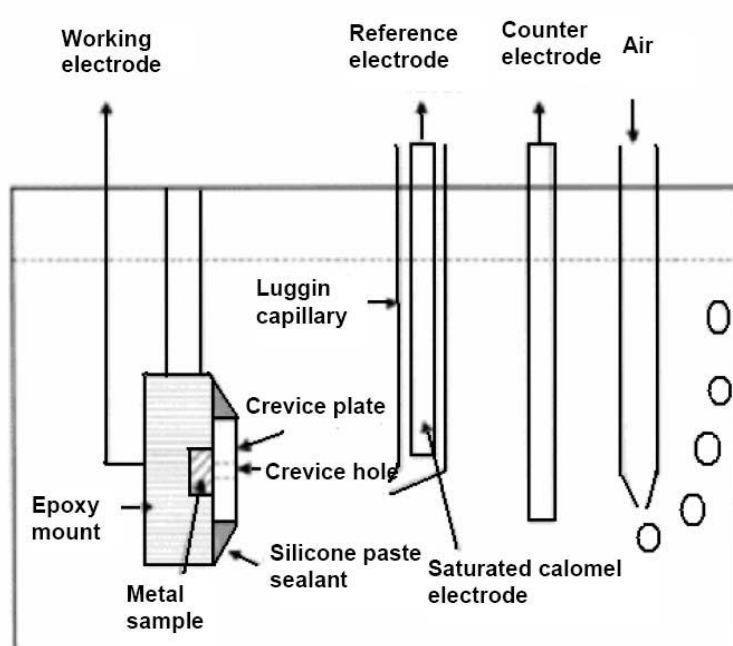
**Figure 2.3:** Schematic of the experimental crevice corrosion setup by Klassen et al. [30]

crevice assembly designed for their study was such that the crevice was oriented perpendicular to the specimen surface by placing a crevice cover with a hole over the specimen. The test specimens were made of nickel-aluminum-bronze material embedded in a cylindrical epoxy mount as one part of the crevice, and the other part of the crevice plate made from Perspex® material. A conducting wire was attached to the metal epoxy block connected the potentiostat to the metal sample. The electrolyte used for their experiment was 3.5 wt% NaCl solution. A crevice hole of 0.18 mm diameter was drilled into the crevice plates as shown in figure 2.3.

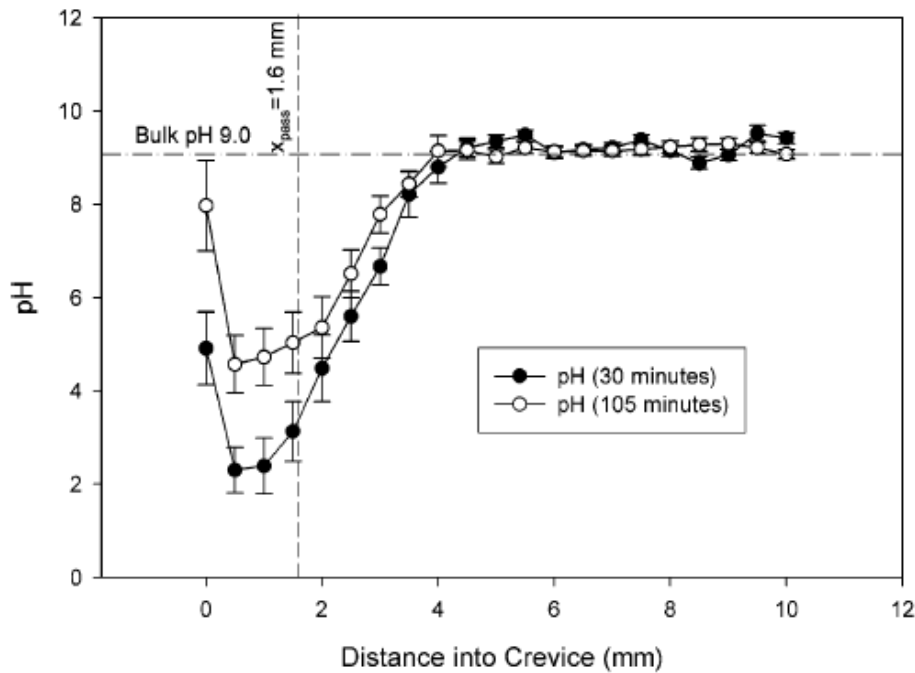
**Figure 2.5:** Profiles of pH for iron in 0.5 M  $\text{Na}_2\text{SO}_4$  (a) 0.7 mm). A large decrease in pH is observed near the active region of the crevice wall [31]

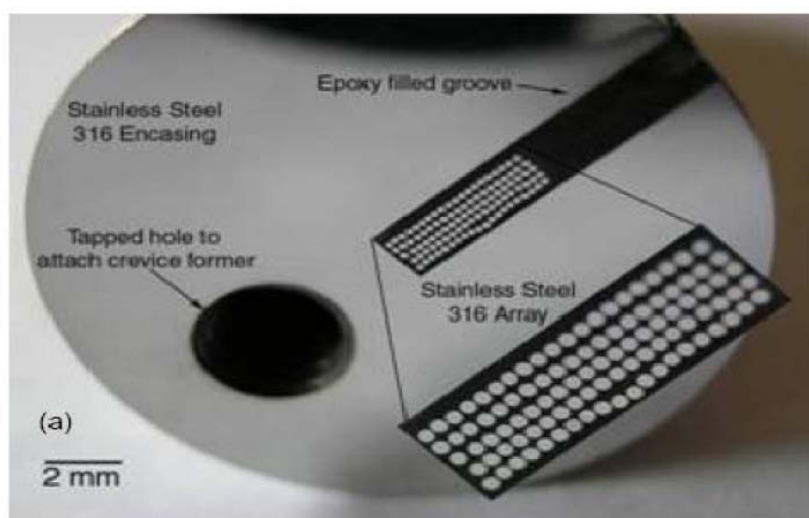
**Figure 2.8:** Close packed array of one hundred 250  $\mu\text{m}$  diameter wires of AISI 316 stainless steel mounted in a 5x20 arrangement in AISI 316 stainless steel rod [33]

The arrays of wires were coated with a poly-imide film to ensure electrical insulation. The crevice was designed to cover 12 columns of 5 wires leaving remaining 8 columns open to bulk solution. The crevice array was immersed in the heated solution for 2 days at the open circuit potential to allow passive film stabilization and solution wicking into the whole crevice. Crevice corrosion was found to be readily initiated close to crevice mouth at  $X_{\text{crit}} = 0$  for 316 stainless steel.  $X_{\text{crit}}$  is the distance from the crevice mouth to the location where the potential reaches a critical passive potential value,  $E_{\text{flade}}$ , on the crevice wall.  $E_{\text{flade}}$  is defined as the lowest potential in the passive region below which marks a steep fall from the passive region to the active region.

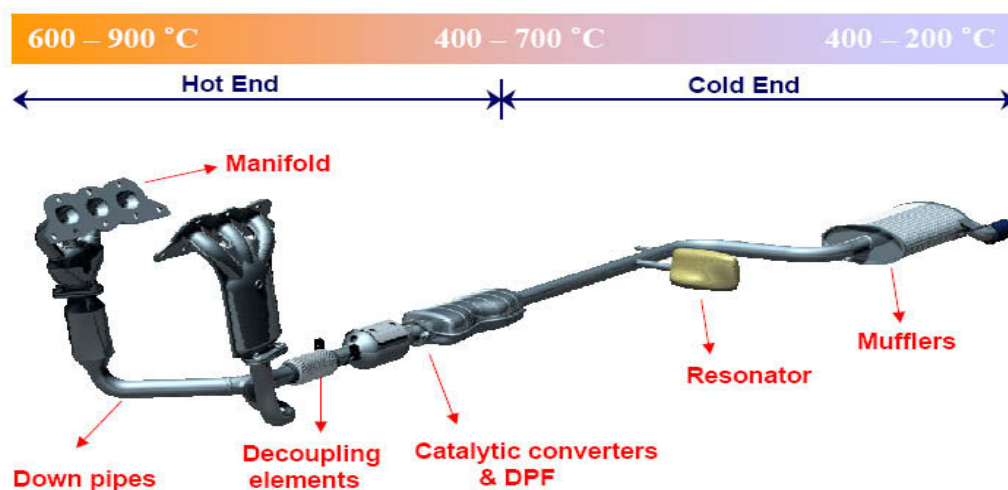
Figure 2.9: Schematic of a complete exhaust system

Exhaust system of an automobile is a complex assembly and often ignored part of various components, performing important tasks in harsh conditions. It performs four distinct jobs: controlling noise, directing fumes away from the people travelling in the car, improving the performance of the car's engine, and last but not least is improving fuel consumption. The exhaust system can be divided into two parts, namely the hot (or front) end and cold (or rear end) [1]. The hot end includes the manifold, downpipe and catalytic converter. The cold end includes the resonator, intermediate pipe, muffler and tail pipe. Figure 2.1 shows this configuration and the associated temperature scale for each component.

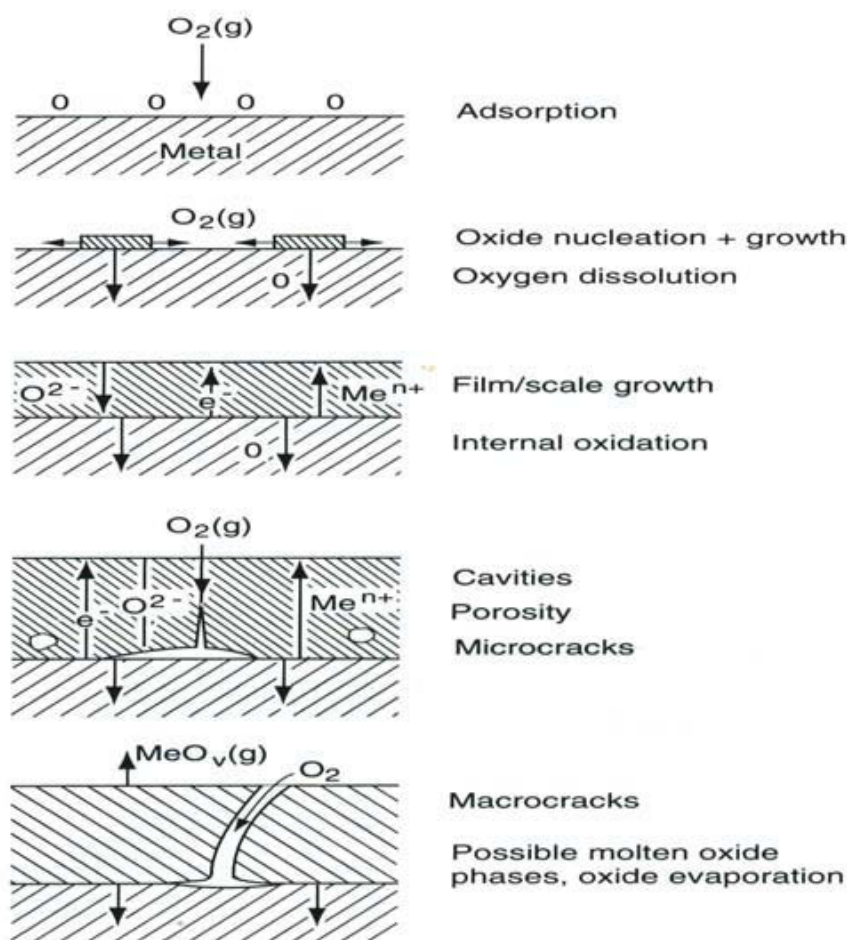
**Figure 2.13:** Film and scale formation during high-temperature metal oxidation [75]

materials with oxygen form a chromium oxide ( $\text{Cr}_2\text{O}_3$ , chromia) film. This oxide film may be protective and persist for a finite time after which scale breakaway occurs and thereafter a scaling rate develops. Consequently, oxides formed at higher temperatures loose their adherence to the substrate alloy when cooled to lower temperatures and become non-protective when reheated [74-76]. Oxides have coefficients of thermal expansion that differ from those of the metals from which they have formed. Therefore, stresses develop when the temperature changes, particularly during running and stopping of the vehicle [77-79]. The oxide film converts into a nonprotective scale with various defects including cavities, microcracks and porosity as shown in figure 2.13.

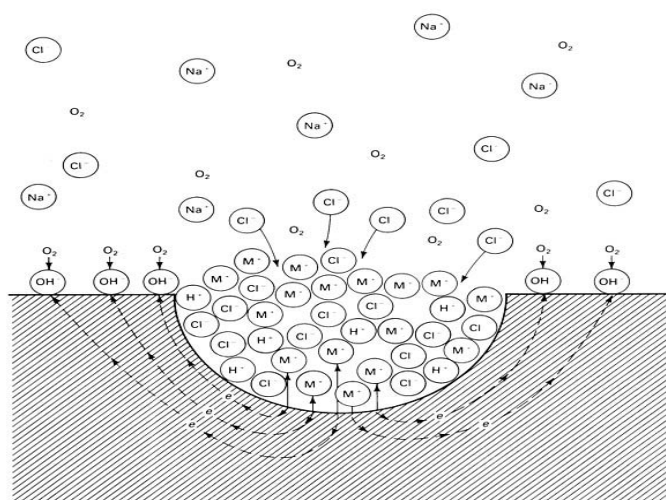
**Figure 2.15:** Autocatalytic processes occurring in corrosion pit. The metal, M, is being pitted by an aerated NaCl solution. Rapid dissolution occurs within the pit, while oxygen reduction takes place on the adjacent surfaces [102]

It is stated that pits begin by the breakdown of passivity at favoured nuclei on the metal surface [102]. The breakdown is followed by the formation of an electrolytic cell. The anode of this cell is a minute area of active metal, and the cathode is a considerable area of passive metal. The large potential difference characteristic of this passive-active cell accounts for considerable flow of current with rapid corrosion at the small anode. The corrosion-resistant passive metal surrounding the anode and the activating property of the corrosion products within the pit account for the tendency of corrosion to penetrate the metal rather than spread along the surface. Once pits are initiated, they may continue to grow by a self-sustaining, or autocatalytic, process; that is, the corrosion processes within a pit produce conditions that are both stimulating and necessary for the continuing activity of the pit. This process is illustrated schematically in figure 2.15.

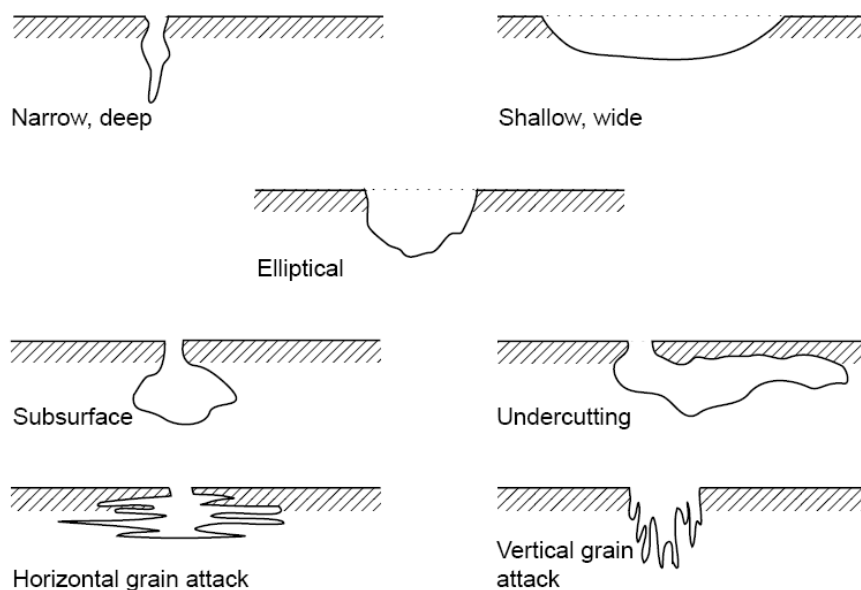
**Figure 2.17:** Typical variations in the cross-sectional shape of pits [106, 107]

Pitting corrosion, may assume different shapes, as illustrated in figure 2.17. Pitting corrosion can produce pits with their mouth open (uncovered) or covered with a semi-permeable membrane of corrosion products. Pits can be either hemispherical or cup-shaped. In some cases they are flat-walled, revealing the crystal structure of the metal, or they may have a completely irregular shape [103, 106,107].

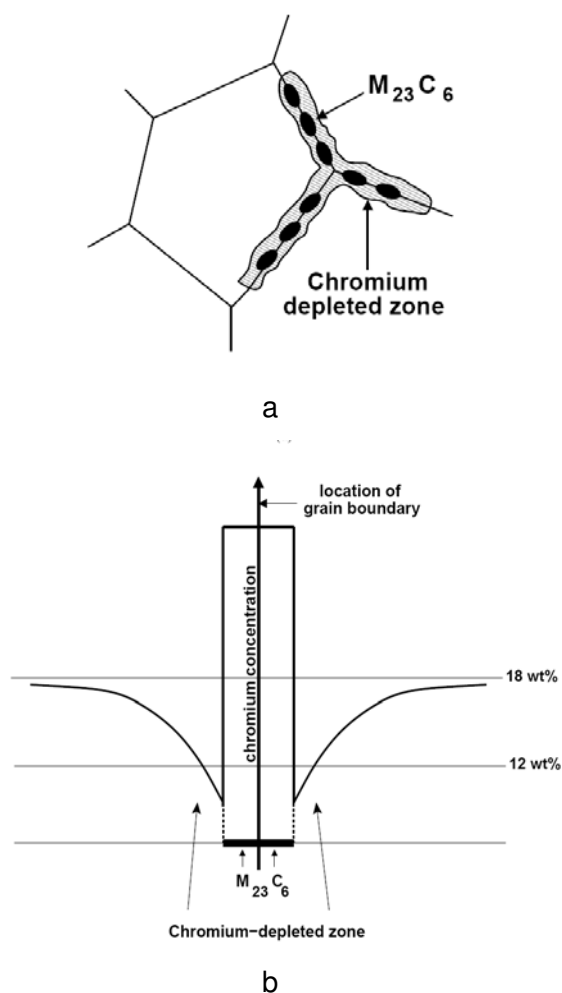
**Figure 2.20:** Schematic diagrams (a, b) showing chromium depleted zone at a grain boundary [126]

When stainless steels are heated to approximately the temperature range 450 to 850°C, they become sensitized or susceptible to IG corrosion [114, 115]. Sensitization is associated with the precipitation of chromium rich carbides such as  $M_{23}C_6$  or  $M_7C_3$  along grain boundaries during the detrimental heat treatments [118, 119]. The M represents metal atoms, mainly chromium. During carbide precipitation, interstitial carbon can diffuse rapidly to the grain boundaries. Unlike carbon, chromium diffuses much more slowly, resulting in the chromium-depleted zone near the grain boundaries. A schematic diagram showing the chromium carbides and the resulting chromium depleted zone is shown in figure 2.20. Corrosion then proceeds along the grain boundary network at a much higher rate than in the matrix.

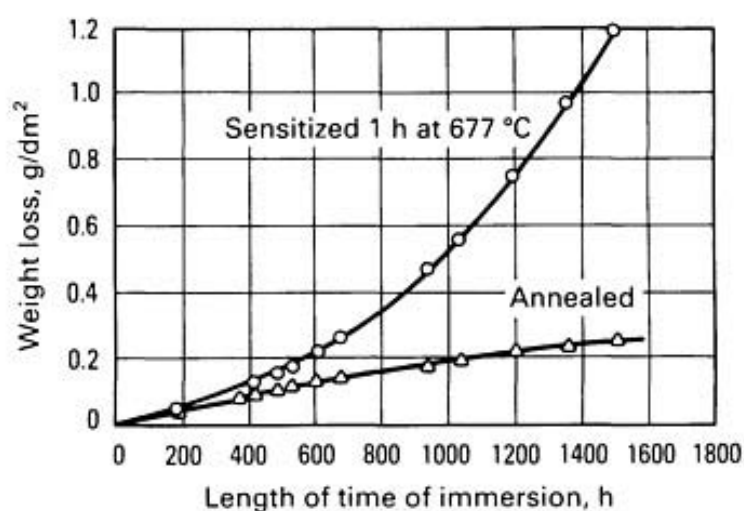
**Figure 2.21:** Corrosion of type 304 steel in inhibited boiling 10% H<sub>2</sub>SO<sub>4</sub> [127]

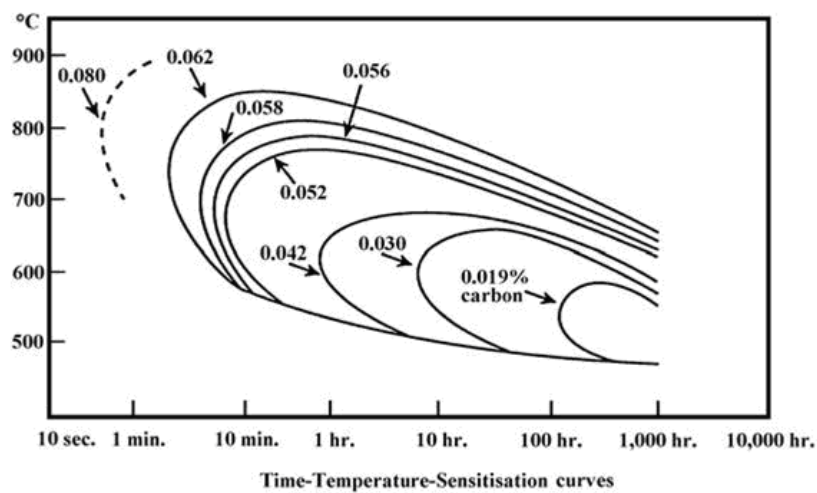
**Figure 2.22:** Time-Temperature-Sensitization curves for type 1.4301 stainless steel [128]

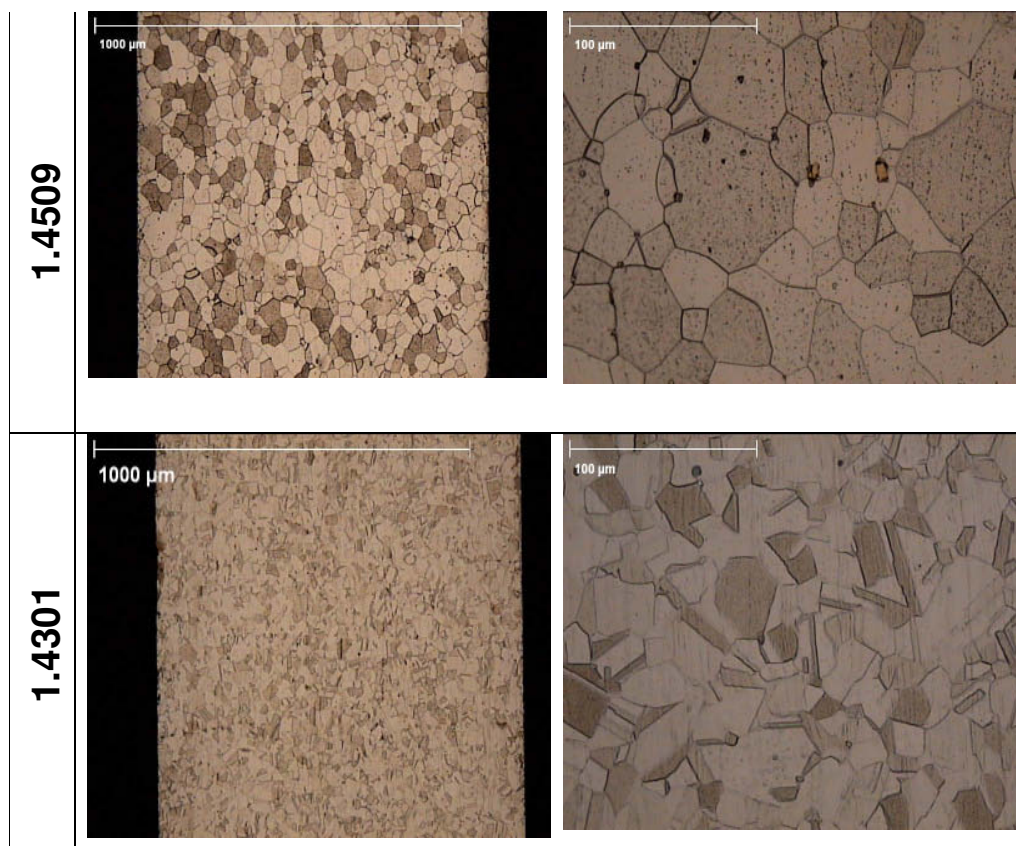
**Figure 3.1:** Microstructure as received condition 1.4509 and 1.4301

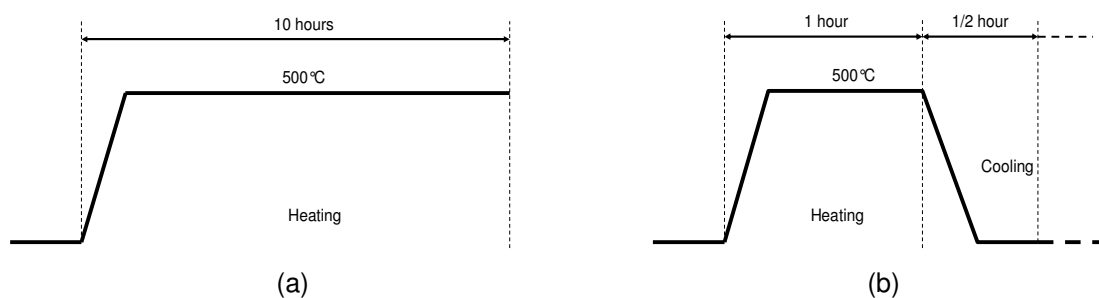
**Figure 3.2:** Graphical representation of two different heat treatments (a) Continuous heating, (b) Heating with additional cooling intervals

Stainless steel type	Heating temp. [°C]	One step heating [h]	Heating with additional cooling intervals [h]
1.4509	500	10	10
1.4301	500	10	10

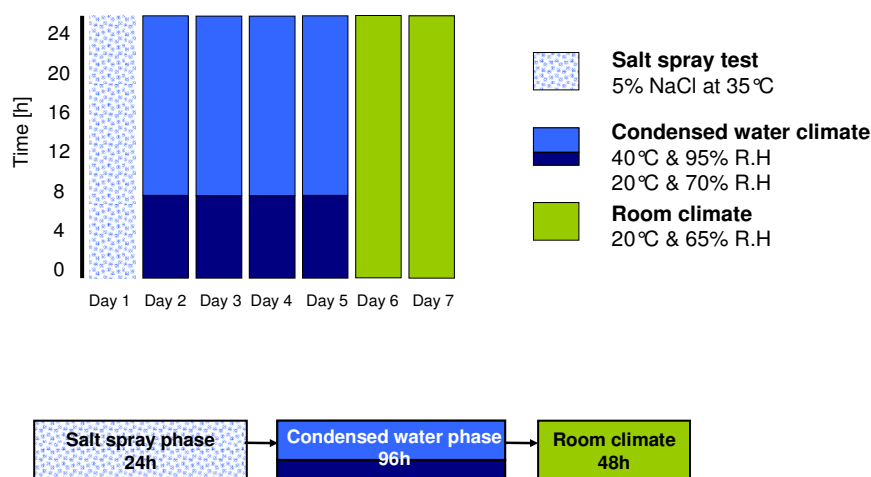
**Figure 3.3:** Layout of a standard VDA 621-415 Test

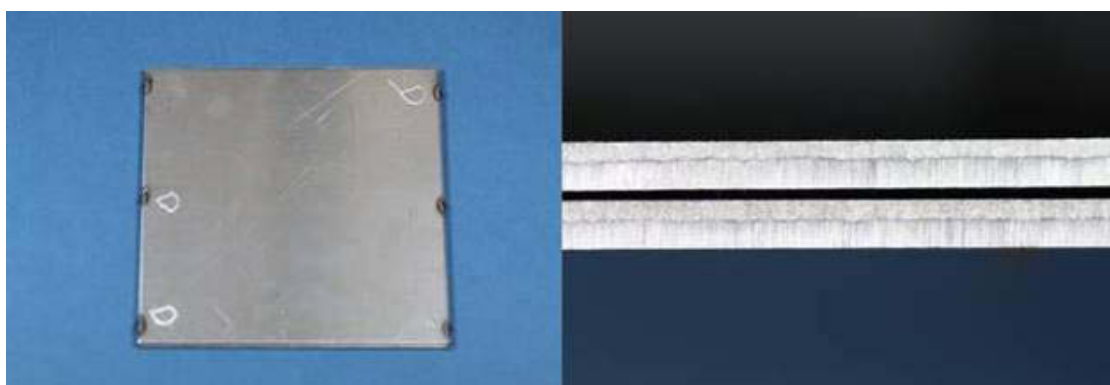
**Figure 3.7:** Specimen assembly with well defined crevice

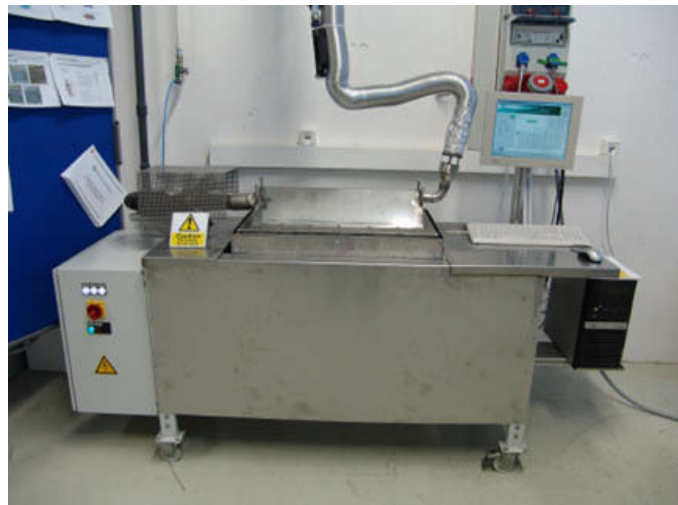
**Figure 3.12:** Overview of a constructed dip and dry testing equipment

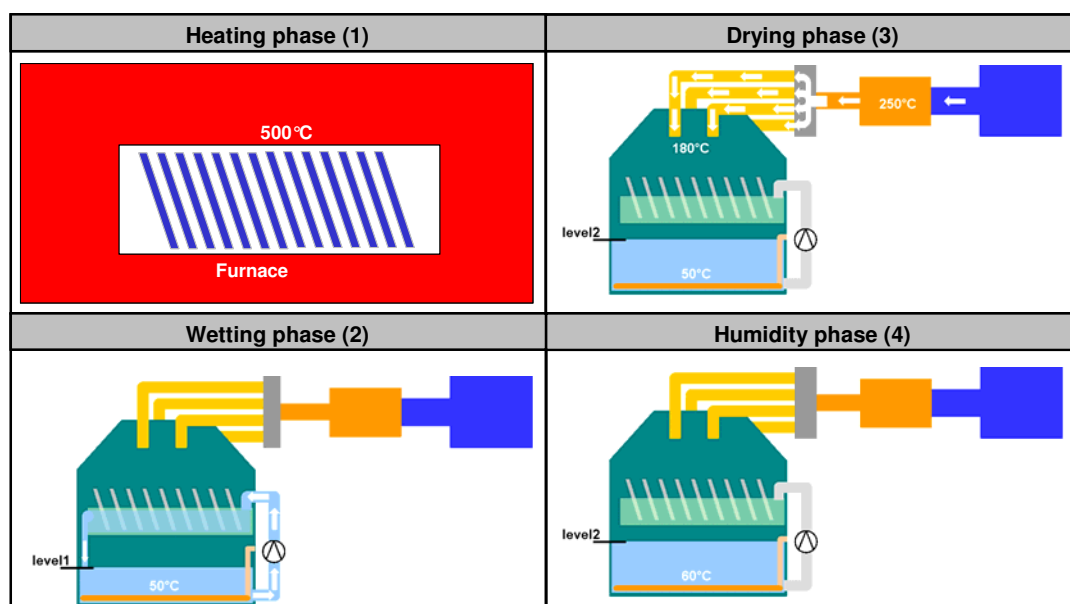
**Figure 3.14:** Schematic view of testing phases: (1) Heating phase, (2) Wet phase (3) Dry phase and (4) Humid phase

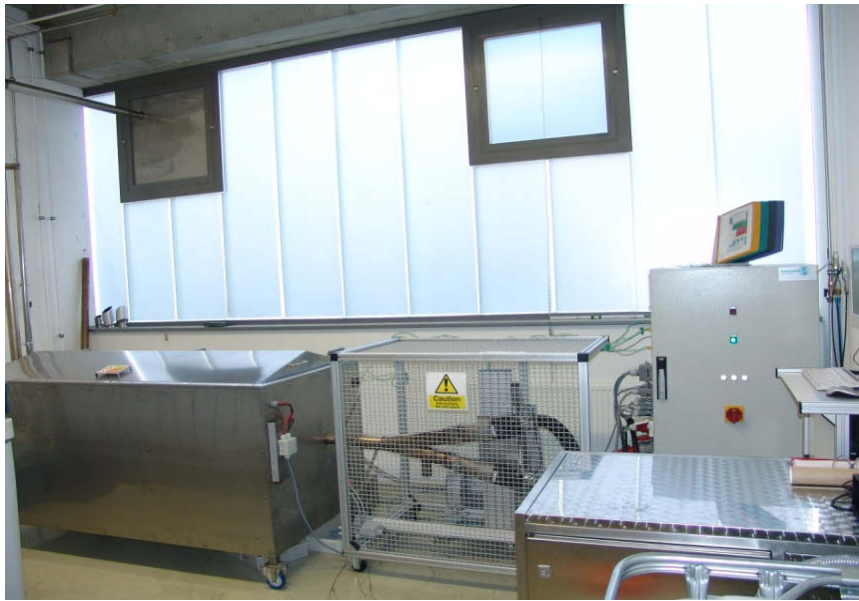
**Figure 3.16:** Overview of a constructed corrosion rig

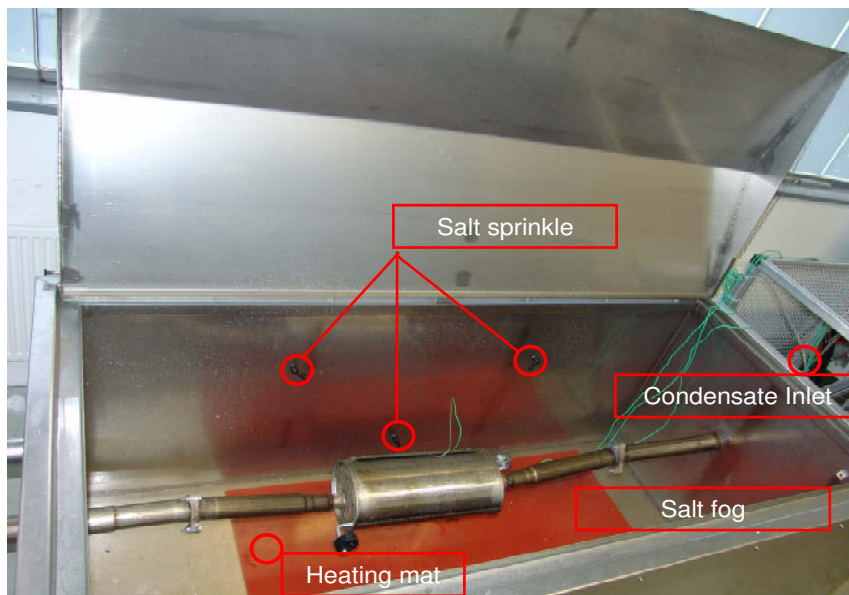
**Figure 3.17:** Inner view of corrosion rig with muffle inside

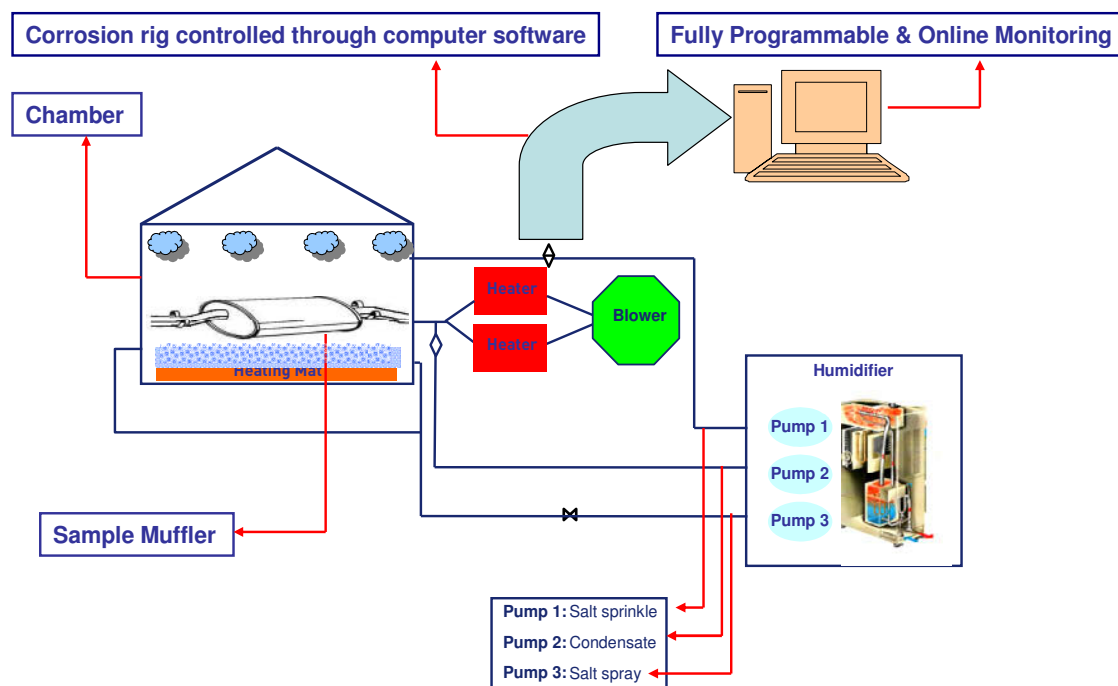
**Figure 3.18:** Schematic layout of test setup for components

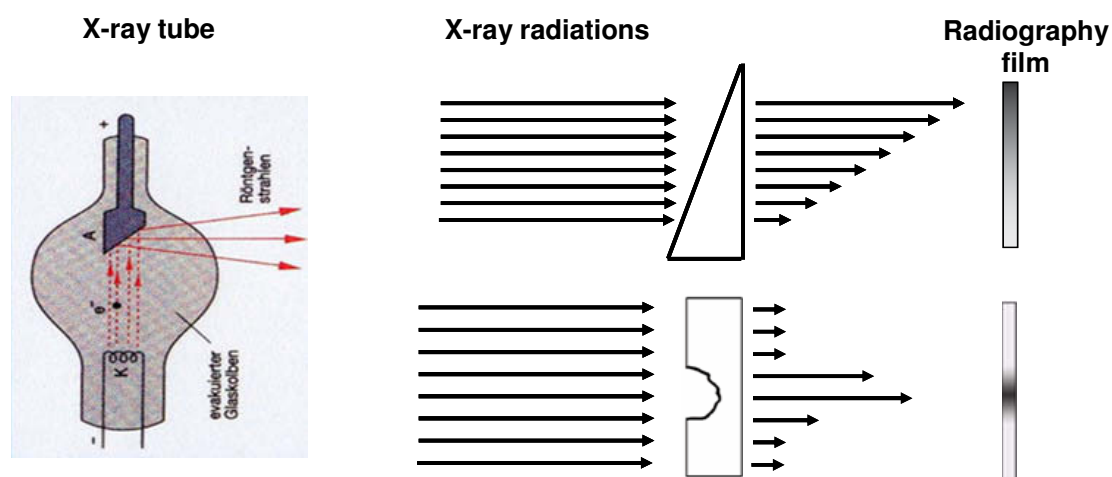
**Figure 3.20:** Radiographic schematic of calibration sample and corroded sample [140]

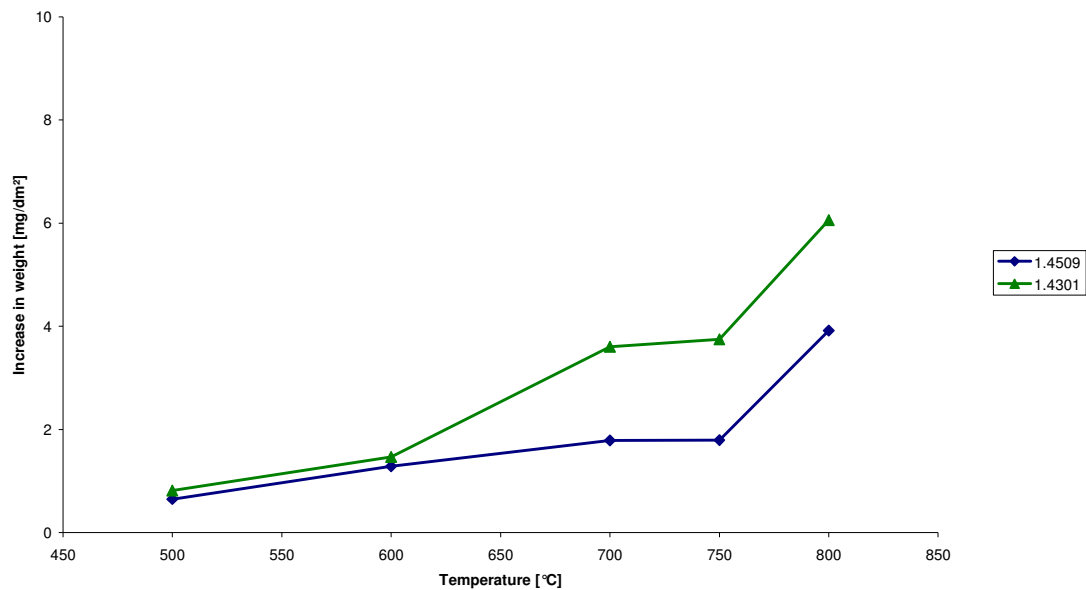
**Figure 4.1:** Weight gain of materials 1.4509 and 1.4301 as function of temperature,  $t=10$ h, air cooled, as rolled surface

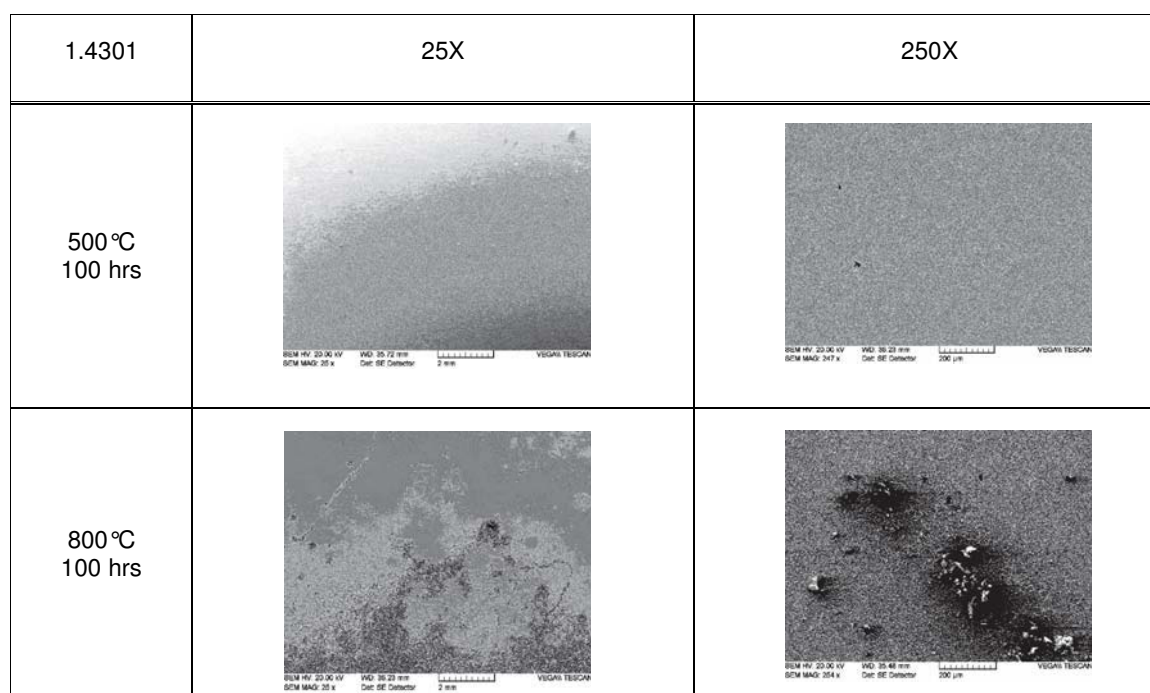
**Figure 4.4:** Surface oxides on 1.4301 after treatment of 500°C and 800°C after 100 hours showing ruptured films

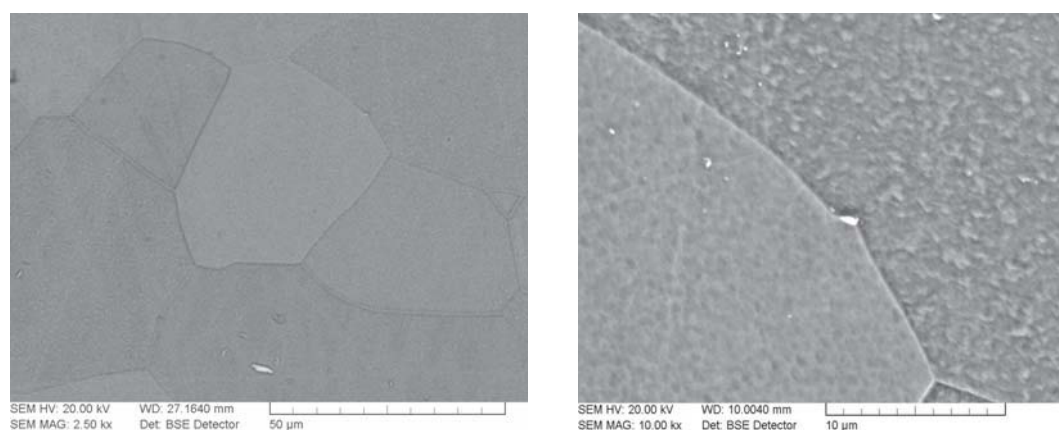
**Figure 4.6:** SEM micrograph 1.4509 treated 100h at 500 °C

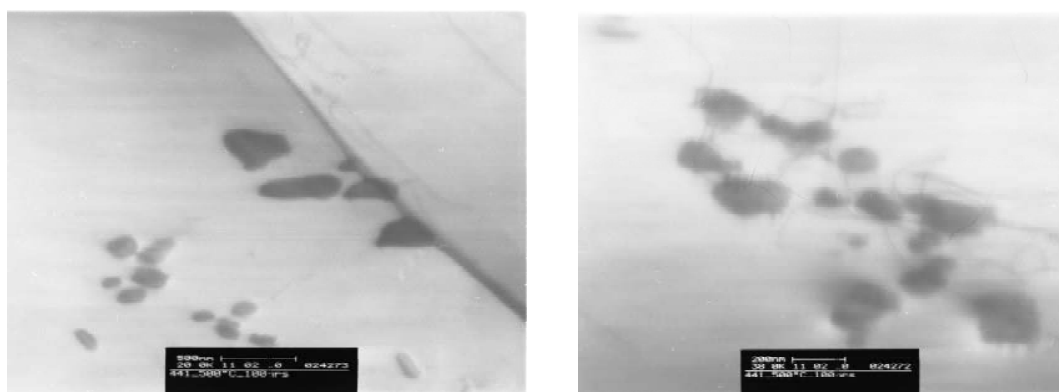
**Figure 4.7:** TEM micrograph 1.4509 treated 100h at 500 °C

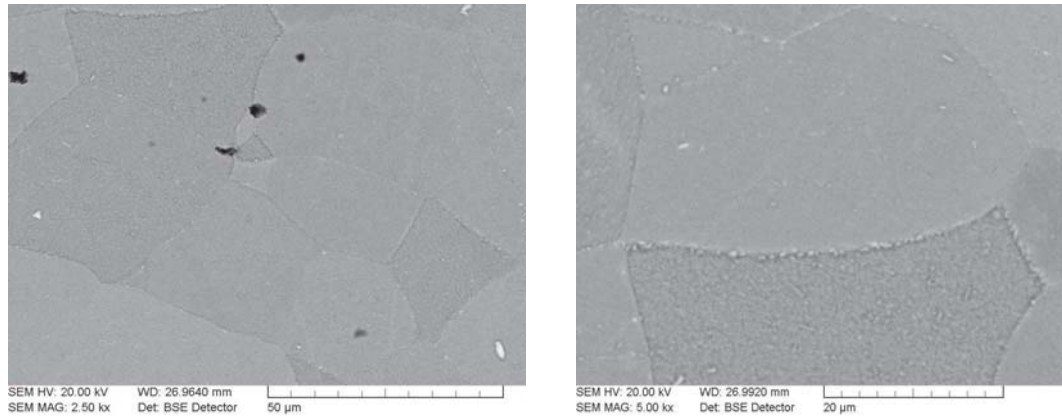
**Figure 4.8:** SEM micrograph 1.4509 treated 100h at 800 °C, showing precipitations along grain boundaries

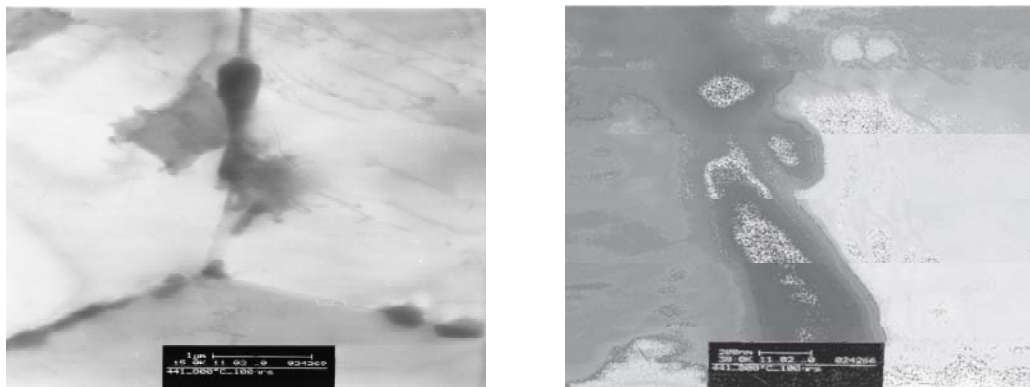
**Figure 4.11:** TEM micrograph 1.4509 treated 100h at 800°C

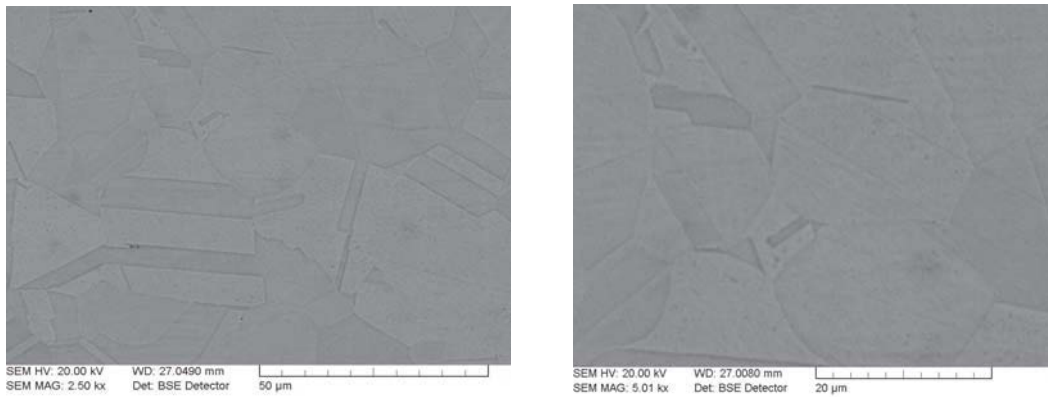
**Figure 4.14:** SEM micrograph 1.4301 treated 100h at 500°C

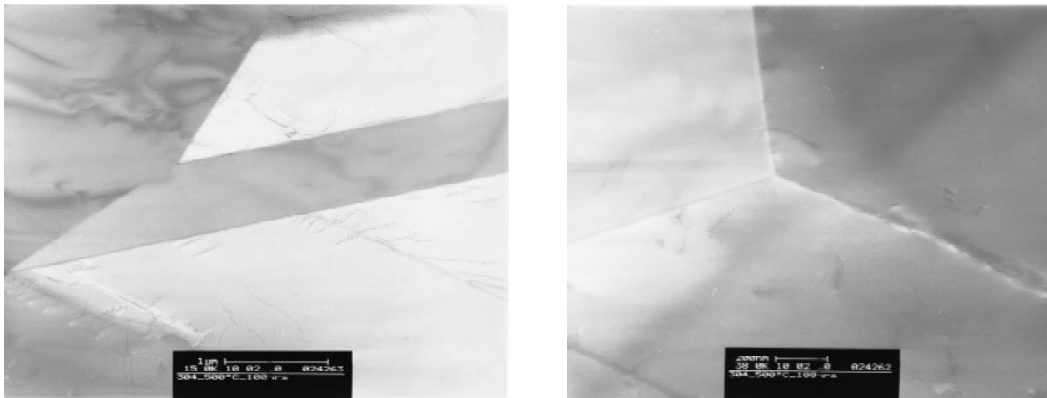
**Figure 4.15:** TEM micrograph 1.4301 treated 100h at 500°C

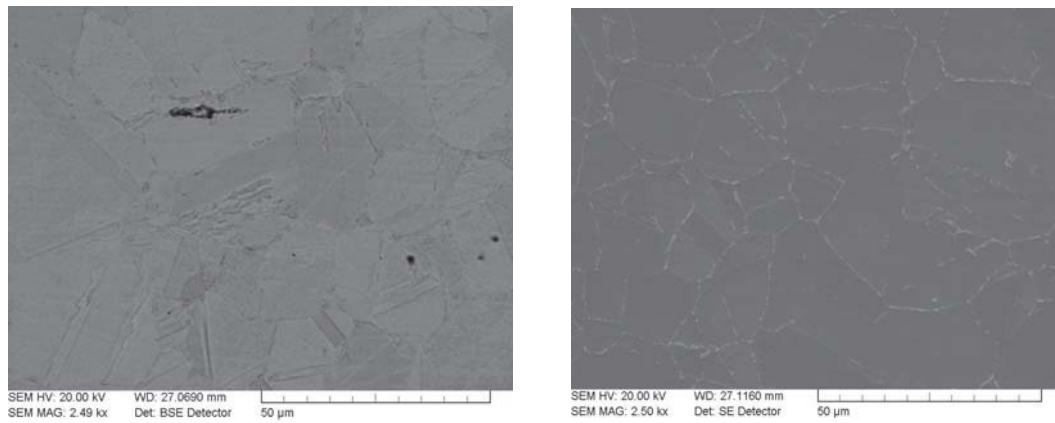
**Figure 4.16:** SEM micrograph 1.4301 treated 100h at 800°C

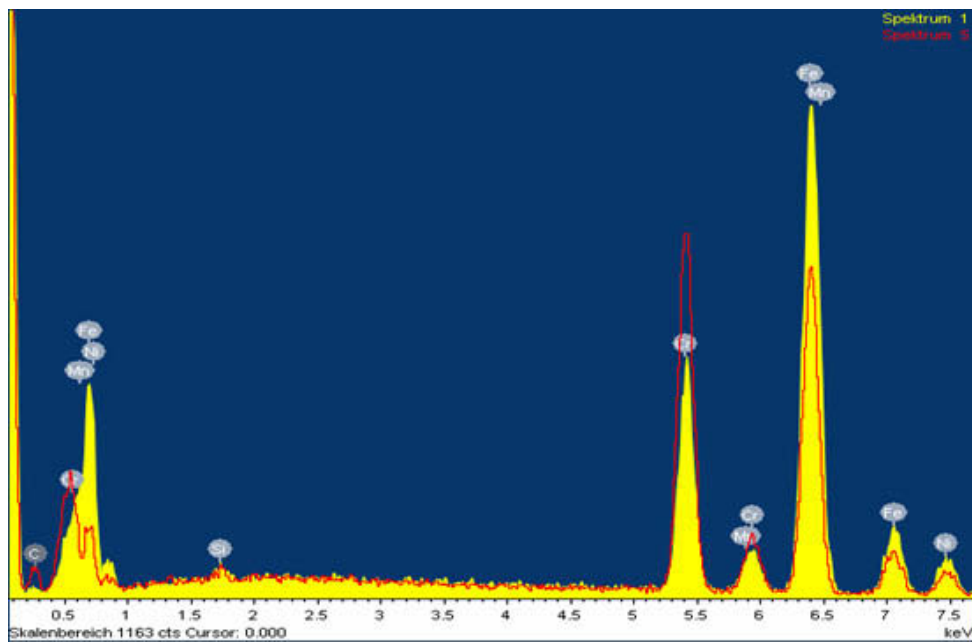
**Figure 4.18:** SEM/EDS analysis 1.4301 treated 100h at 800°C

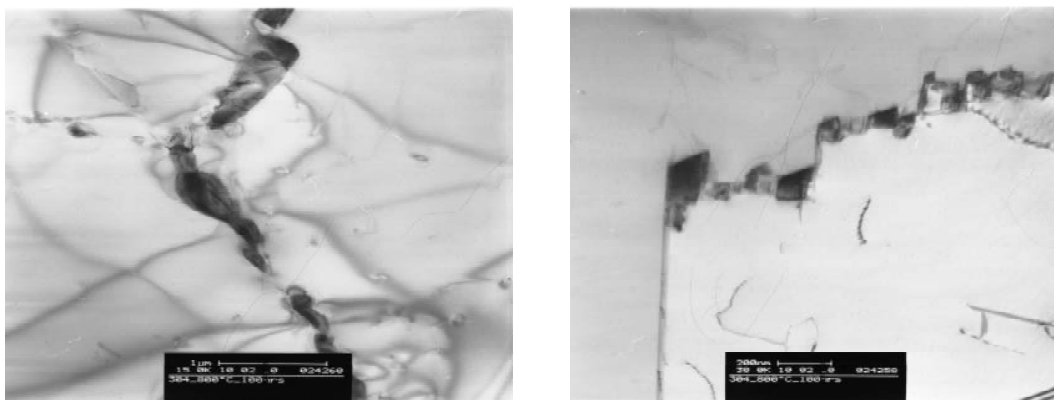
**Figure 4.19:** TEM micrograph 1.4301 treated 100h at 800°C, showing precipitations along grain boundaries

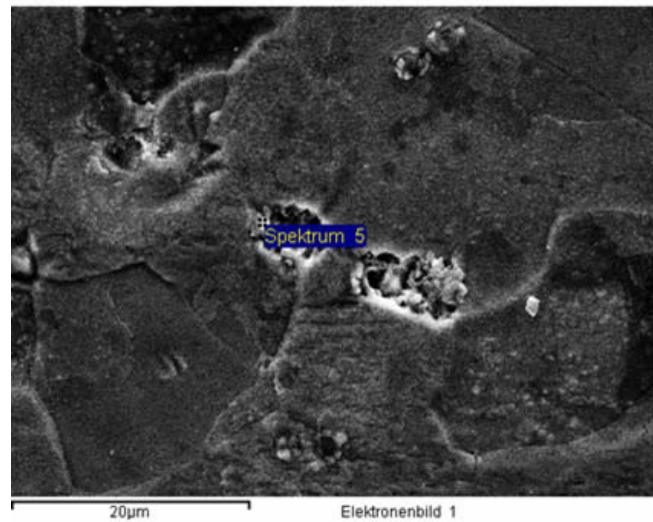
**Figure 4.24:** Microstructure of 1.4509 (500°C for 10 h with cooling cycles) after ferroxy test

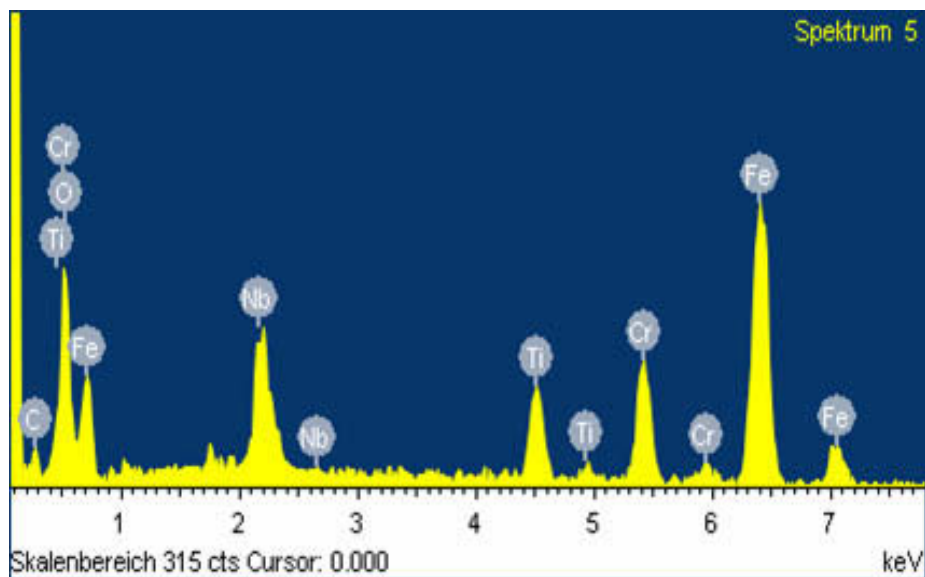
**Figure 4.25:** Elemental analysis from the opening in the surface

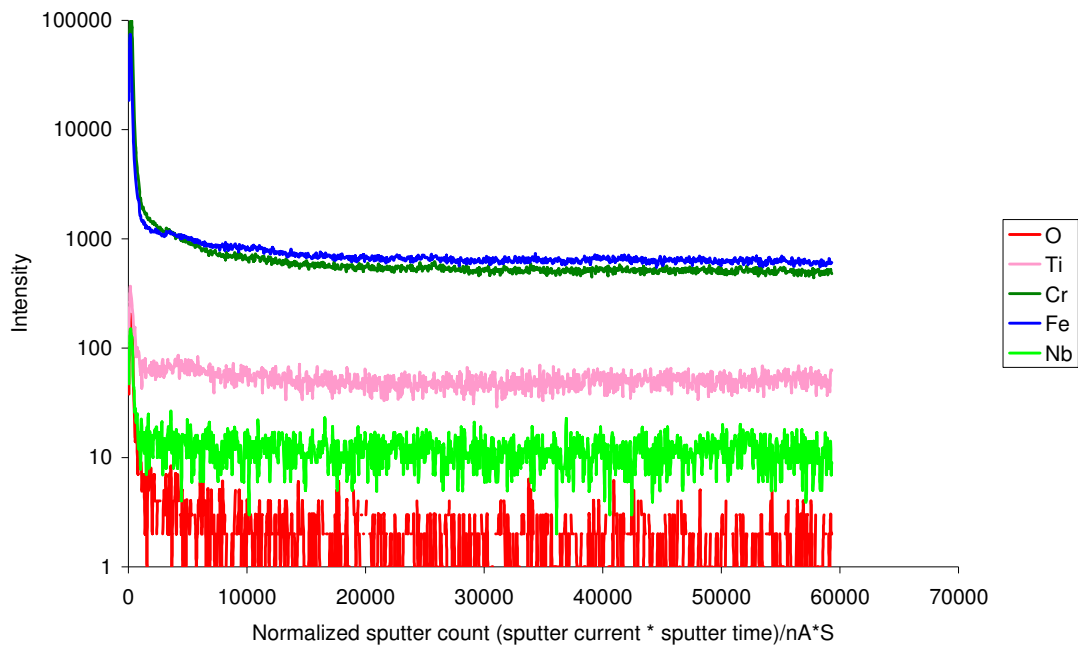
**Figure 4.26:** Depth profile analysis of 1.4509 as received condition
