**Montanuniversität Leoben**

**Dissertation**

**Crevice Corrosion with Additional Heating and  
Cooling Cycles in Automotive Exhaust  
Systems**

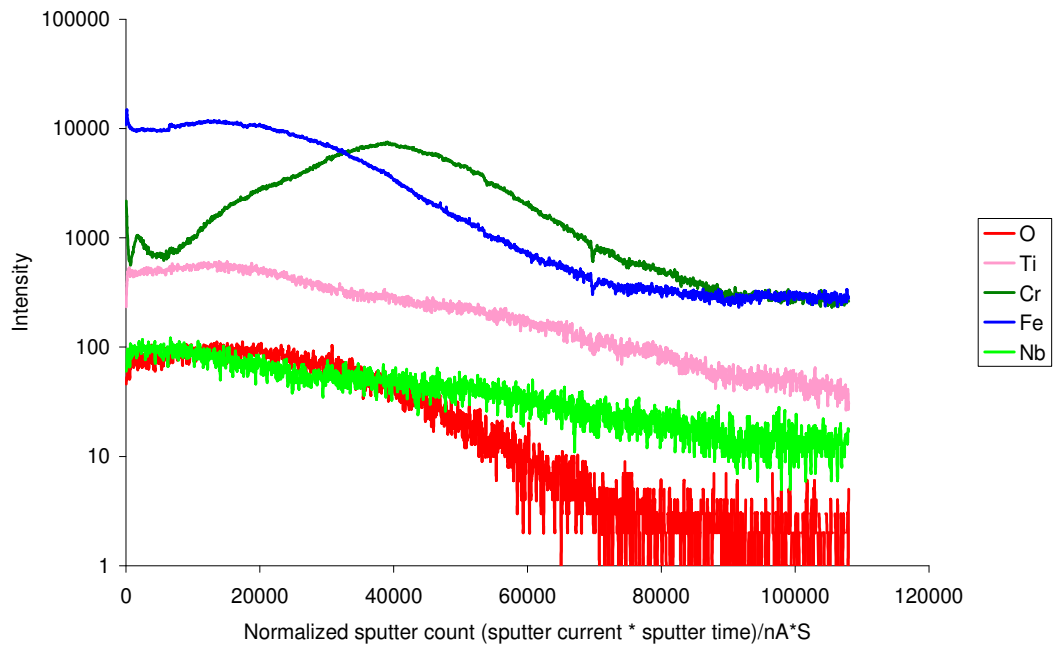
**Figure 4.27:** Depth profile analysis of 1.4509 heat treated samples at 500°C for 10 hours

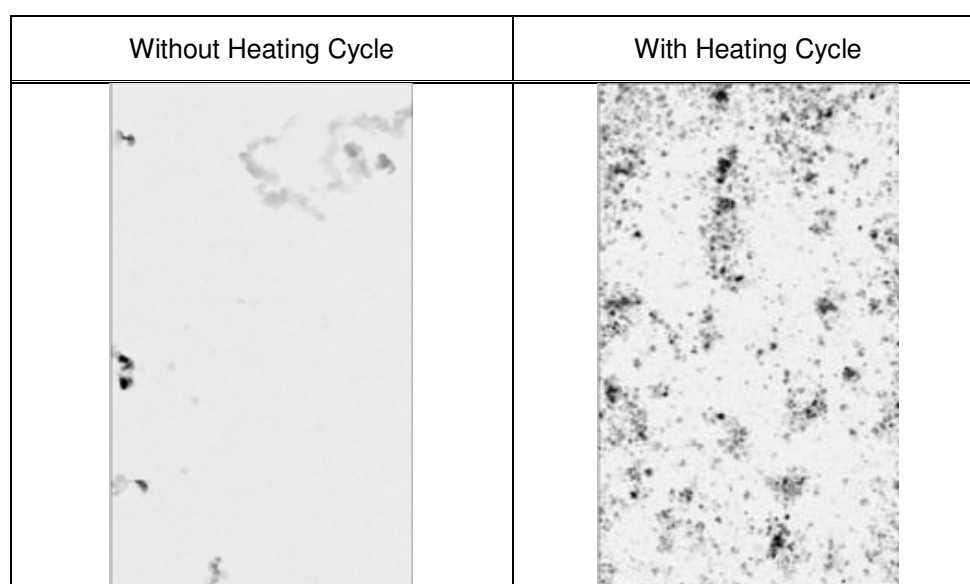
**Figure 4.28:** Radiographic images of crevice samples after 6 weeks

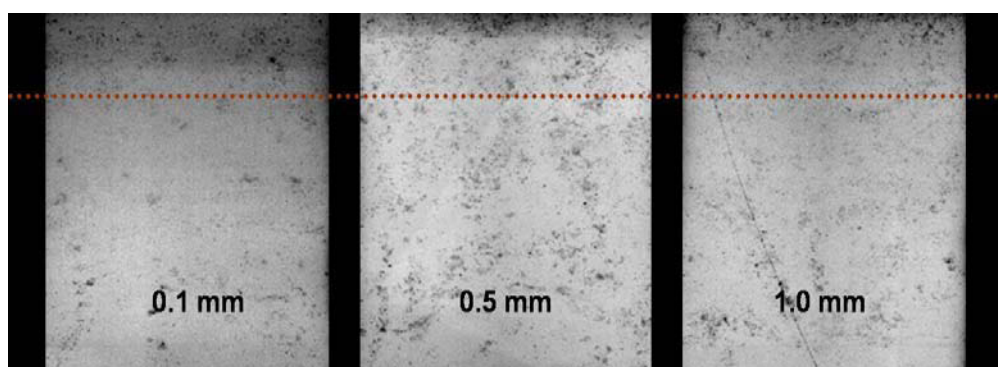
**Figure 4.31:** Radiographic images of crevice samples after 10 weeks Method D, area above dotted red line presenting crevice opening (crevice mouth)

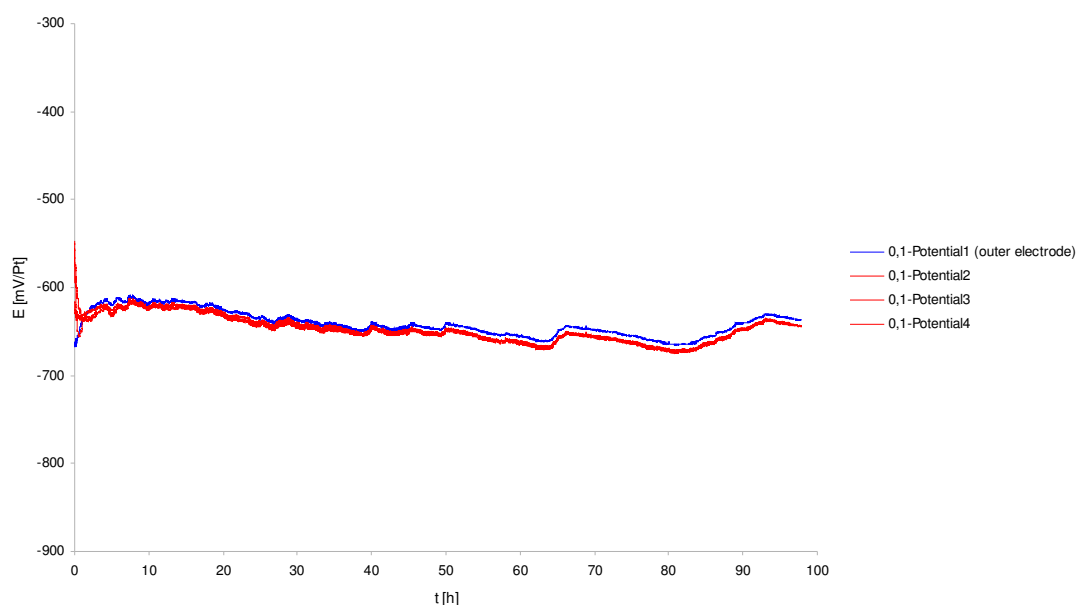
**Figure 4.34:** Potential time curve measured in 6%  $\text{FeCl}_3$  – 0.1 mm crevice

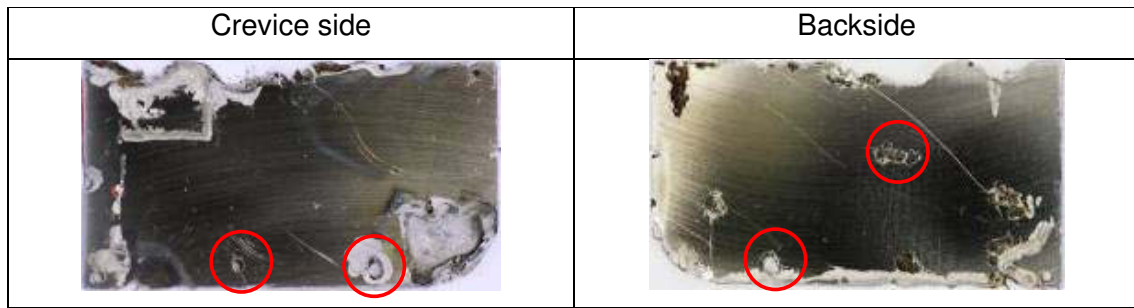
**Figure 4.35:** 1.4509 specimen surfaces after measurement in 6%  $\text{FeCl}_3$  – 0.1 mm crevice

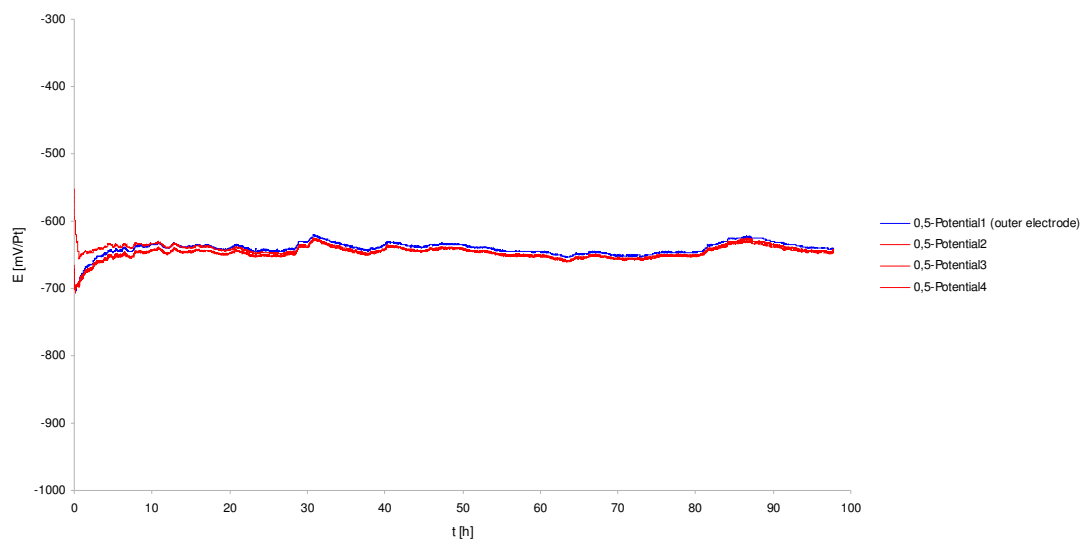
**Figure 4.36:** Potential time curve measured in 6%  $\text{FeCl}_3$  – 0.5 mm crevice

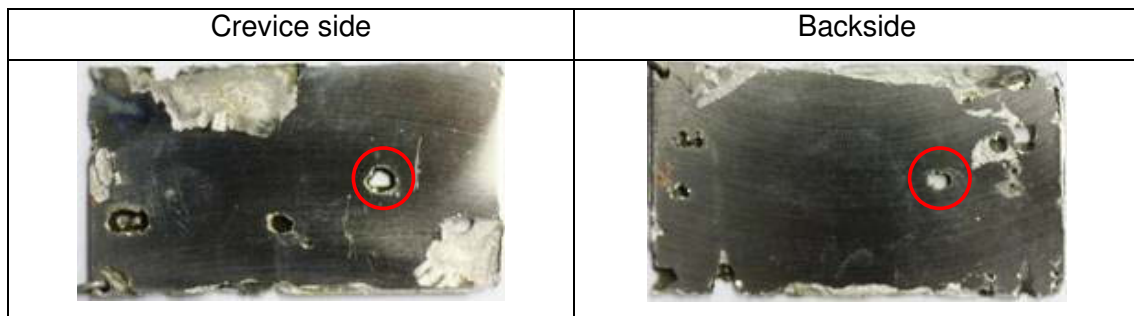
**Figure 4.37:** 1.4509 specimen surfaces after measurement in 6% FeCl<sub>3</sub> – 0.5 mm crevice

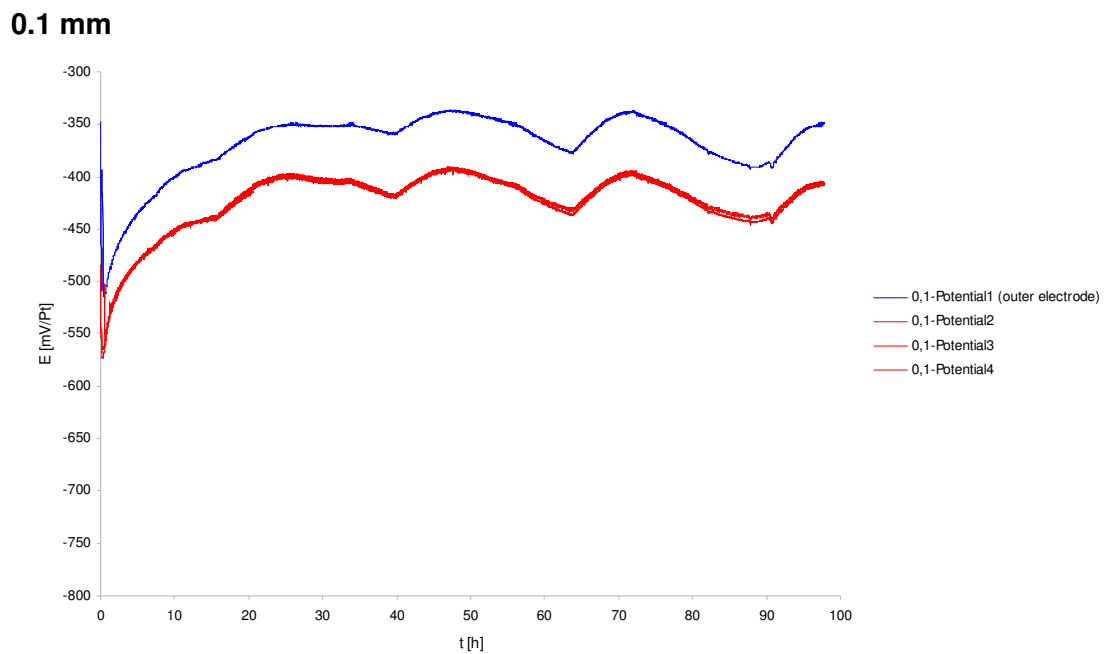
**Figure 4.38:** Potential time curve measured in 10 ppm Cl<sup>-</sup> – 0.1 mm crevice

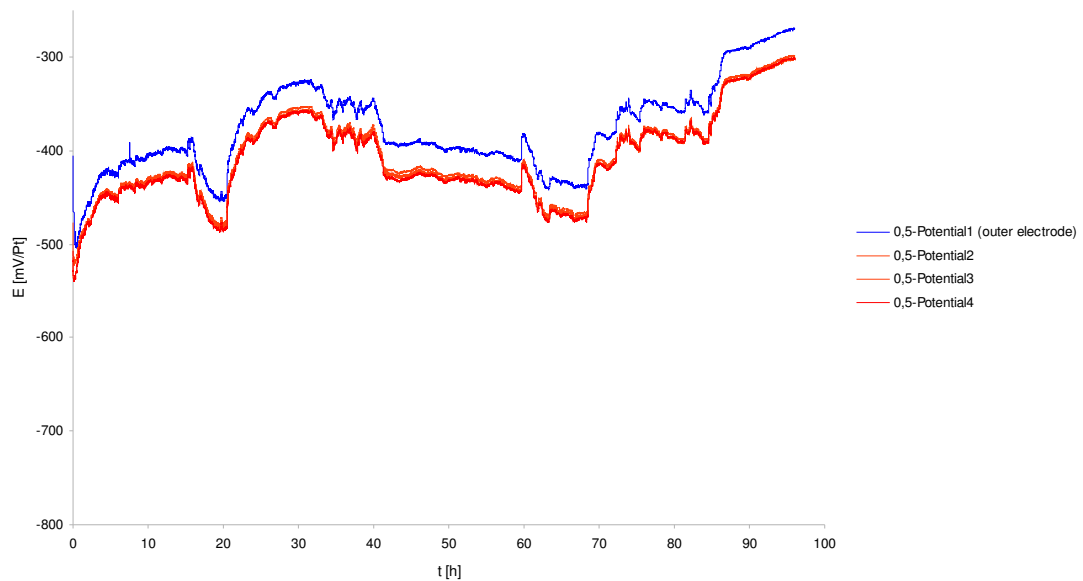
**Figure 4.39:** Potential time curve measured in 10 ppm Cl<sup>-</sup> – 0.5 mm crevice

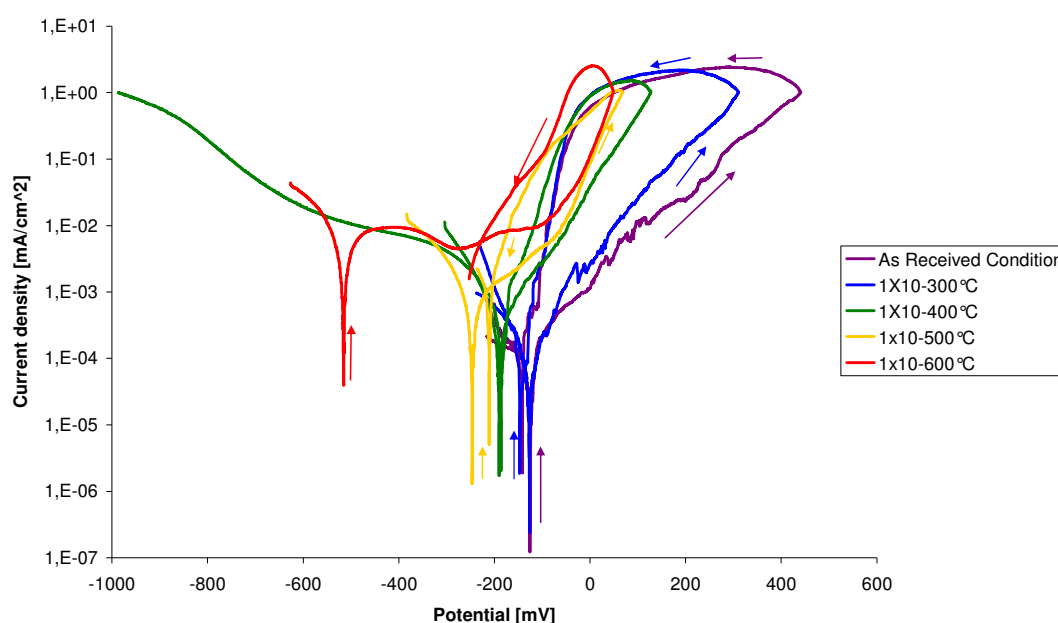
**Figure 4.40:** Potentiodynamic curves of differently sensitized 1.4509 in synthetic condensate with aeration at RT

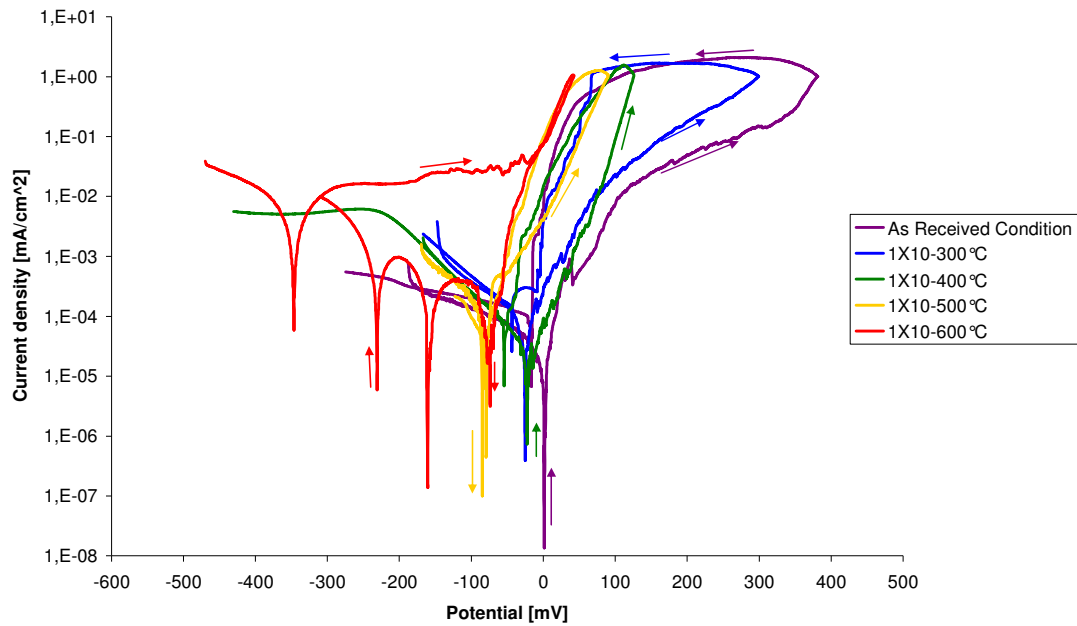
**Figure 4.41:** Potentiodynamic curves of differently sensitized 1.4301 in synthetic condensate with aeration at RT

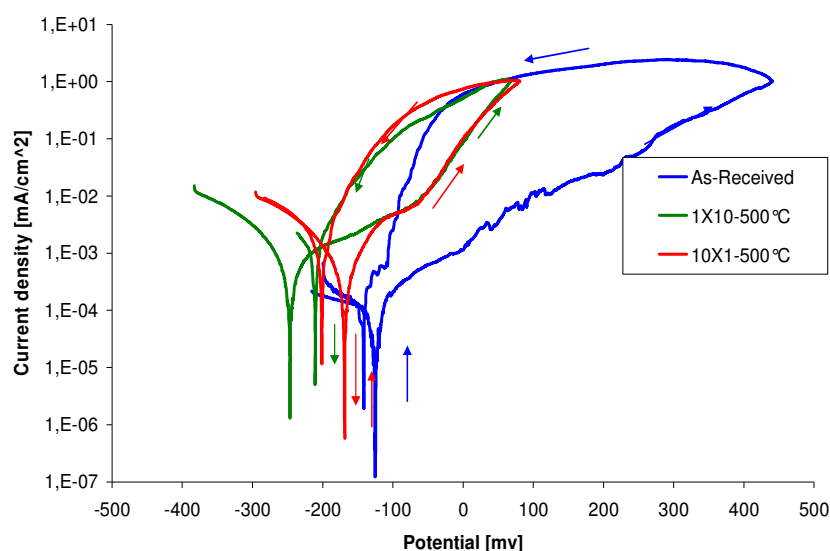
**Figure 4.43:** Potentiodynamic curves of continually heated (1X10) and periodically heated (10X1) 1.4509 at 500°C, testing in synthetic condensate with aeration at RT

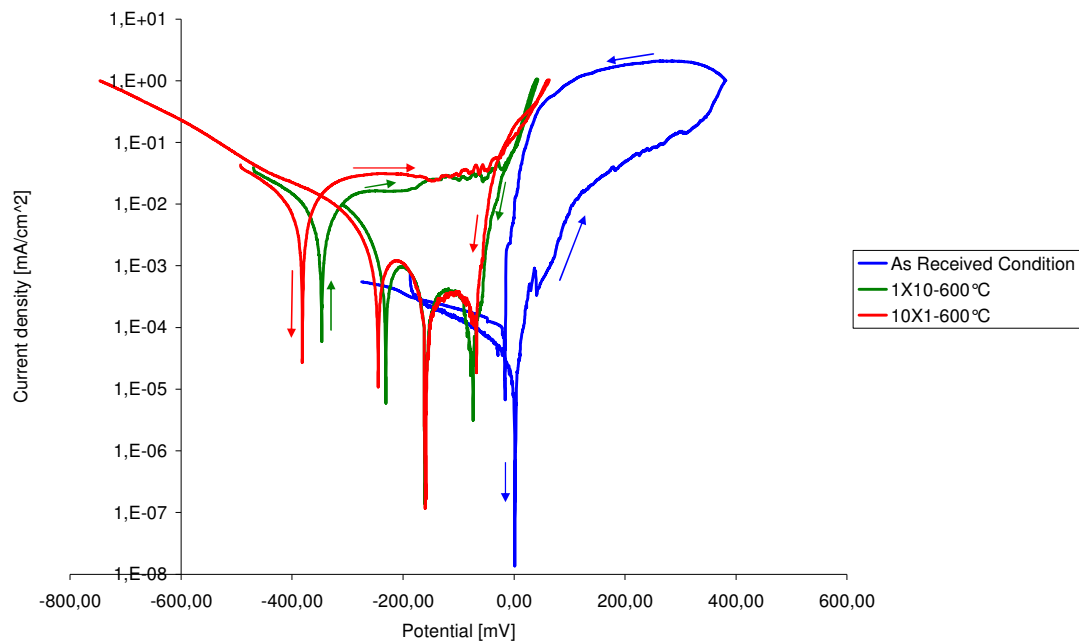
**Figure 4.46:** Potentiodynamic curves of continually heated (1X10) and periodically heated (10X1) 1.4301 at 600°C, testing in synthetic condensate with aeration at RT

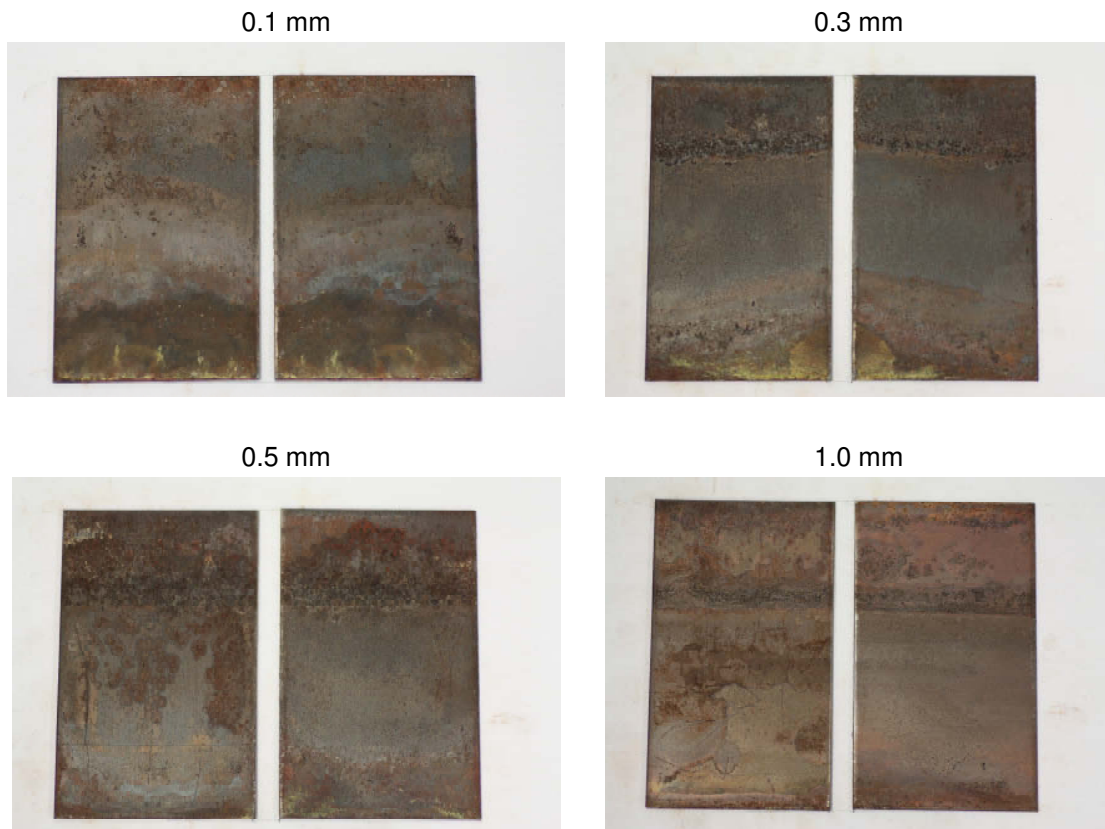
**Figure 4.47:** Overview of crevice samples grade 1.4509 after dip and dry test

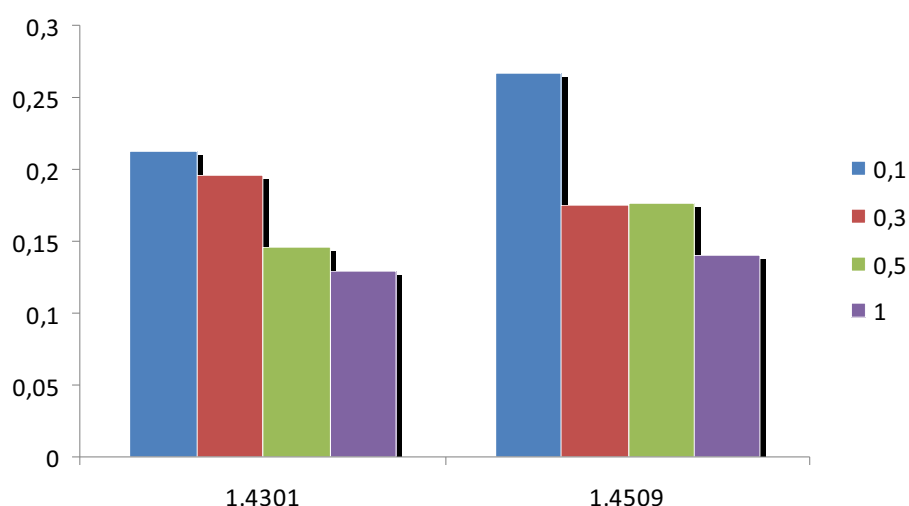
**Figure 4.48:** Average pit depth measurements  $\mu\text{m}$  in 0.1, 0.3, 0.5 and 1.0 mm after 3 cycles

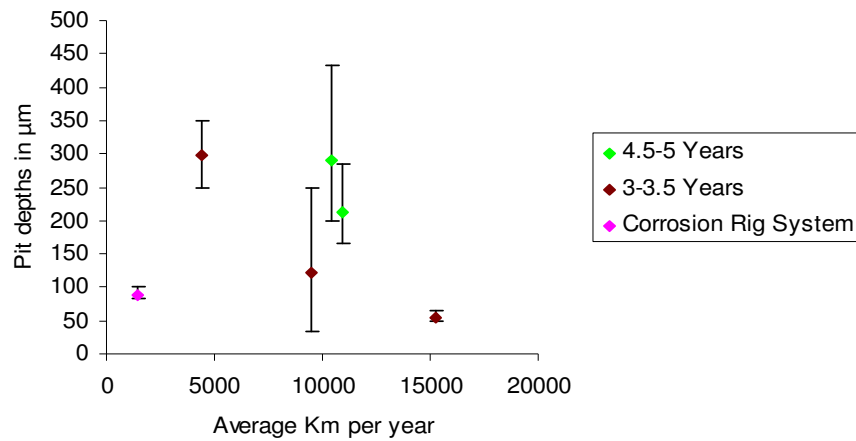
**Figure 4.50:** Pit depth results of end plate on inlet, representing external corrosion

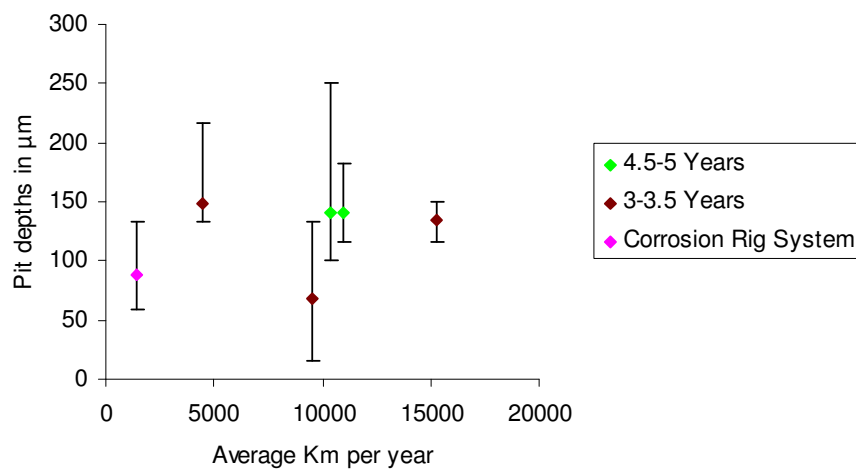
**Figure 4.51:** Pit depth results of end plate on outlet, representing external corrosion

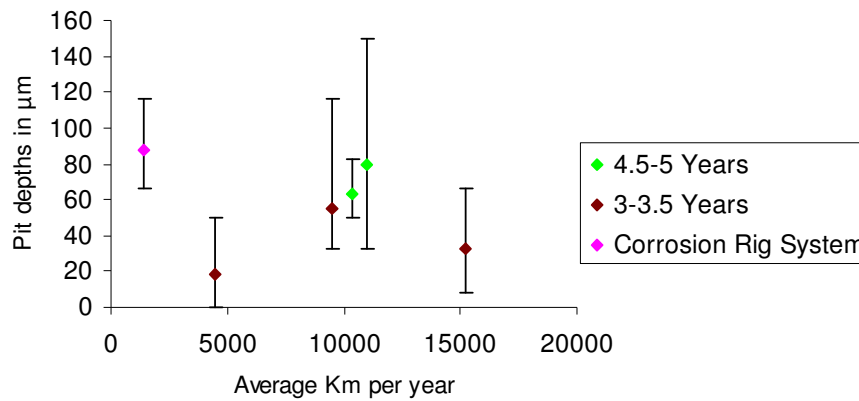
**Figure 4.52:** Pit depth results of inner baffle near to inlet, representing internal corrosion

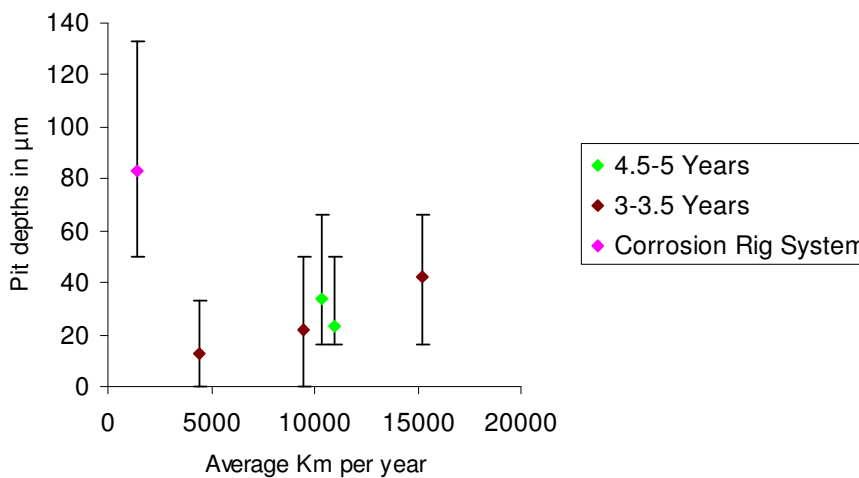
**Figure 4.53:** Pit depth results of inner baffle near to outlet, representing internal corrosion

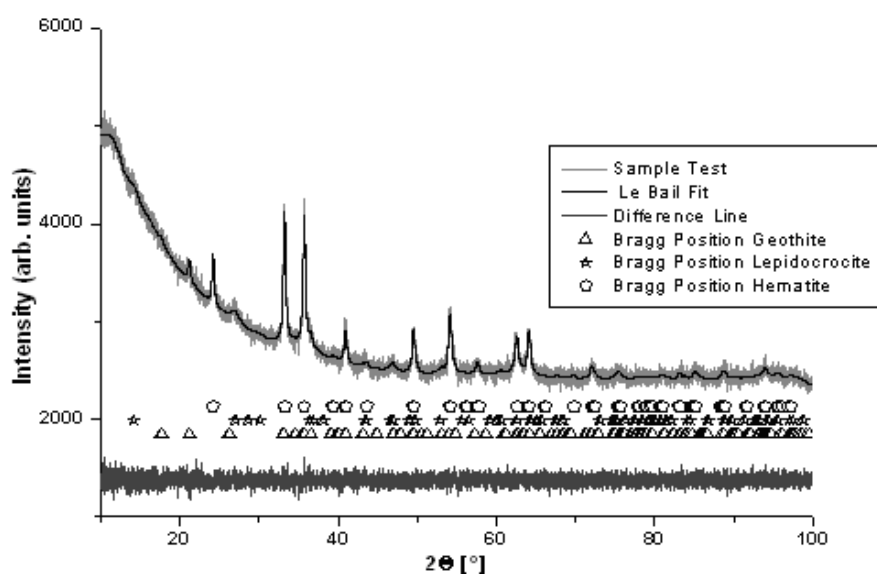
Figure 4.54: XRD spectra of a sample from test

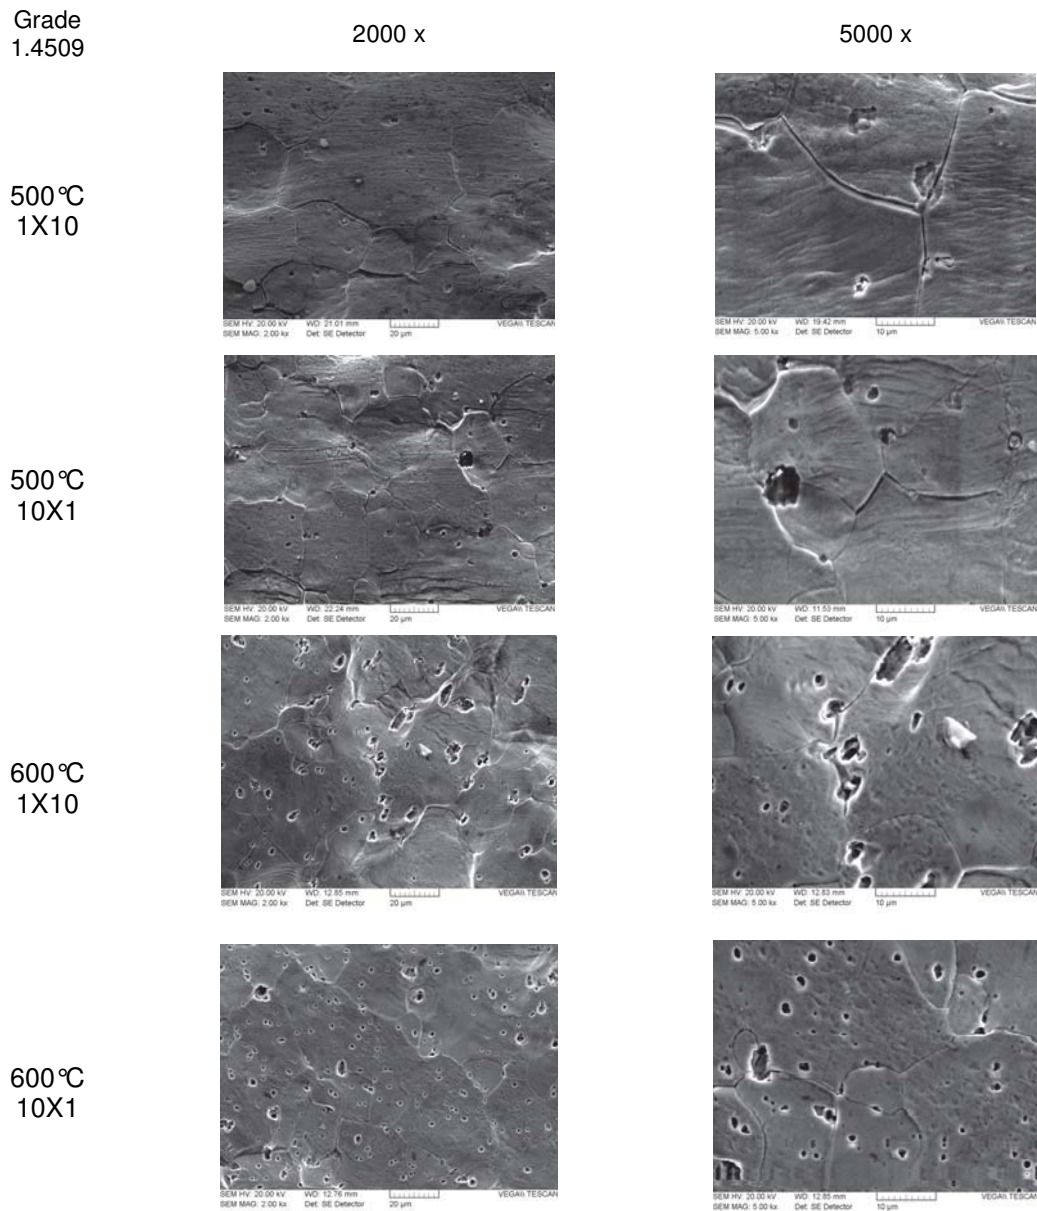
**Figure 4.60:** Microstructural characterization after Strauss test, grade 1.4509 after various heat treatments

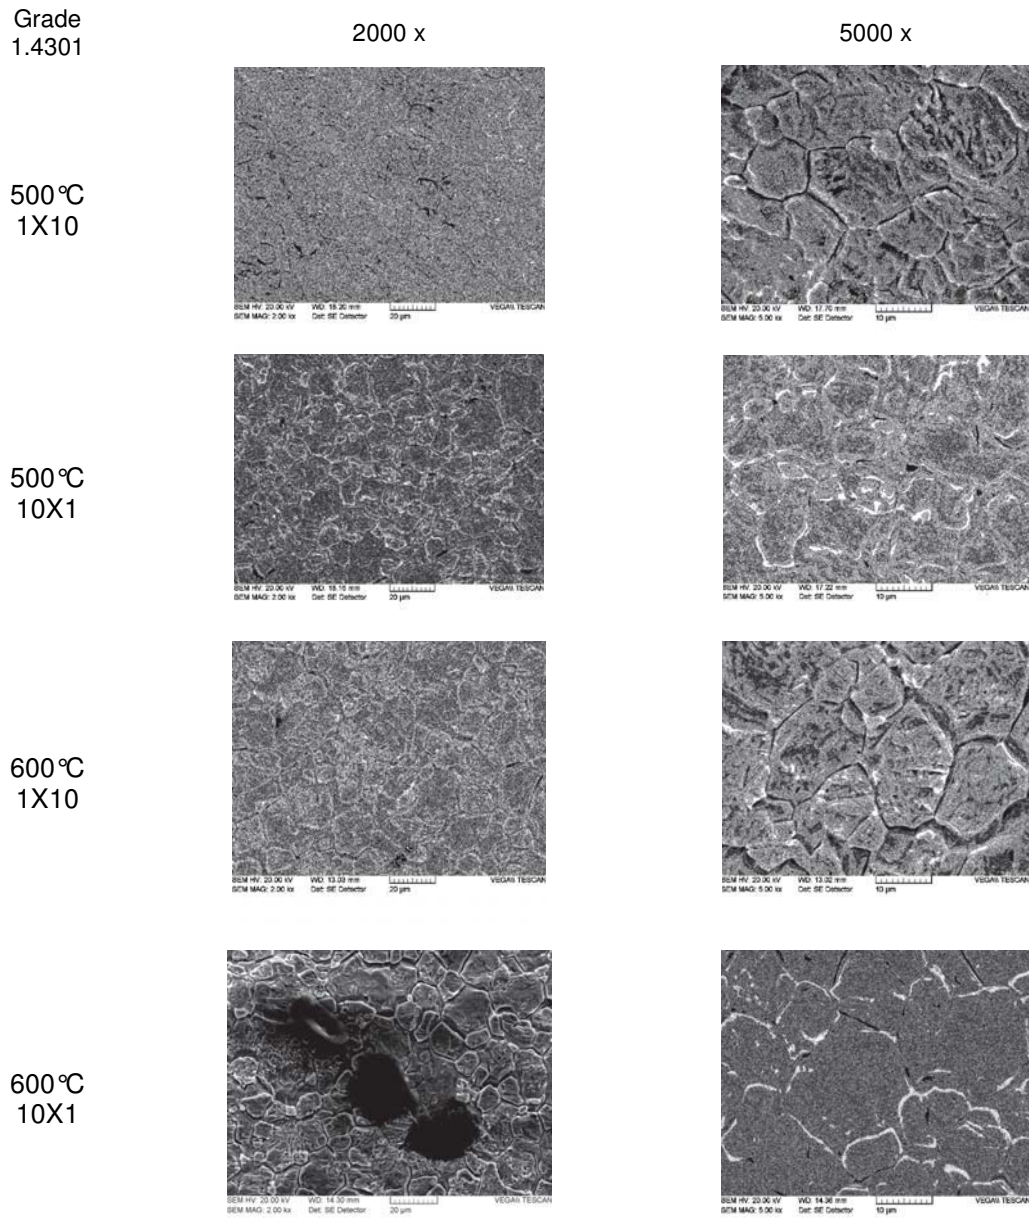
**Figure 4.61:** Microstructural characterization after Strauss test, grade 1.4301 after various heat treatments

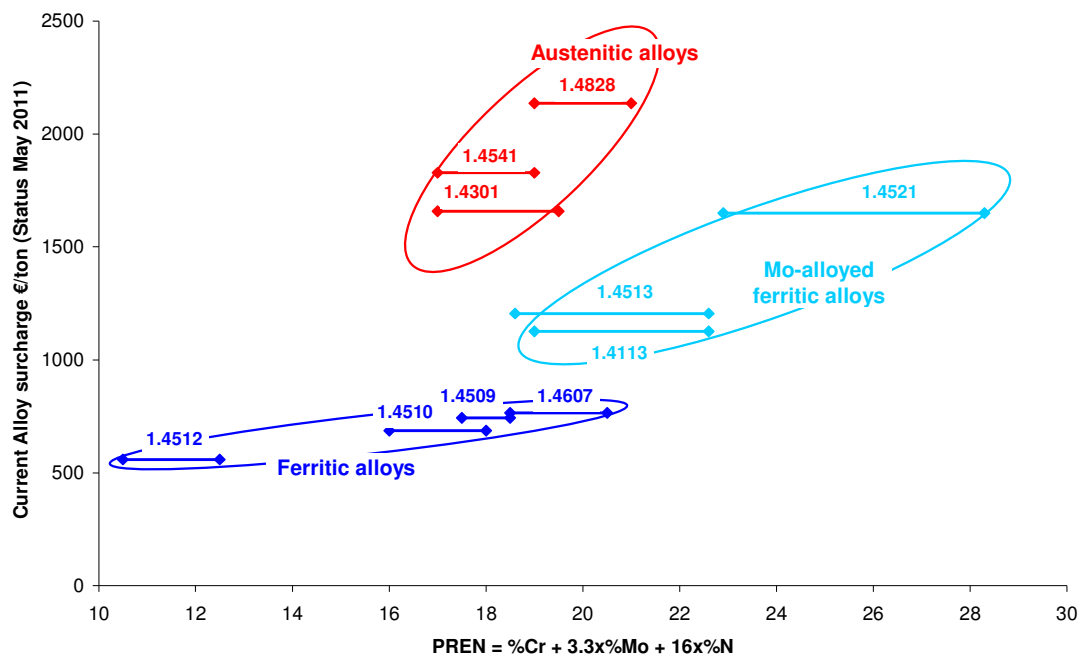
**Figure 5.1:** Alloy surcharge and PREN for some alloys used in automotive exhaust components

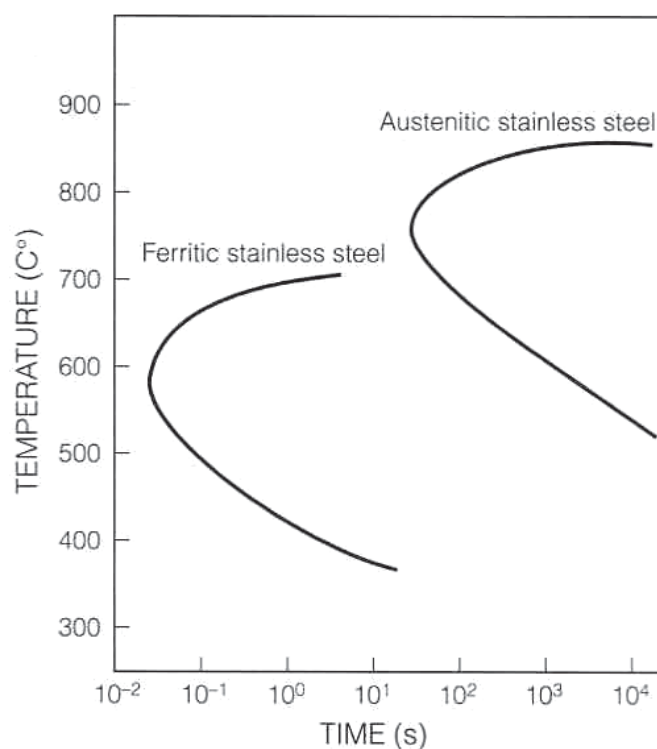
**Figure 5.2:** Differences in the location of time-temperature-sensitization curves of austenitic and ferritic steels of equivalent chromium content [156]
