Montanuniversität Leoben

Master's Thesis

Drill Stem Failure Analysis During
Fishbone Wells Construction in the East
Messoyakha Field

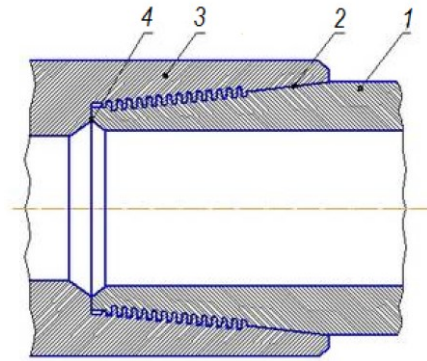
Figure 1: Example of tool joint with conical shouldered connection.

1 – pipe body, 2 – conical stabilizing shoulder, 3 – tool joint box, 4 – inside thrust face

However, the main cause of accidents in toll-jointed pipes was the same fatigue damage along fine pitch thread. It was possible to get rid of these problems by creating pipes with conical shouldered connection (Figure 1).

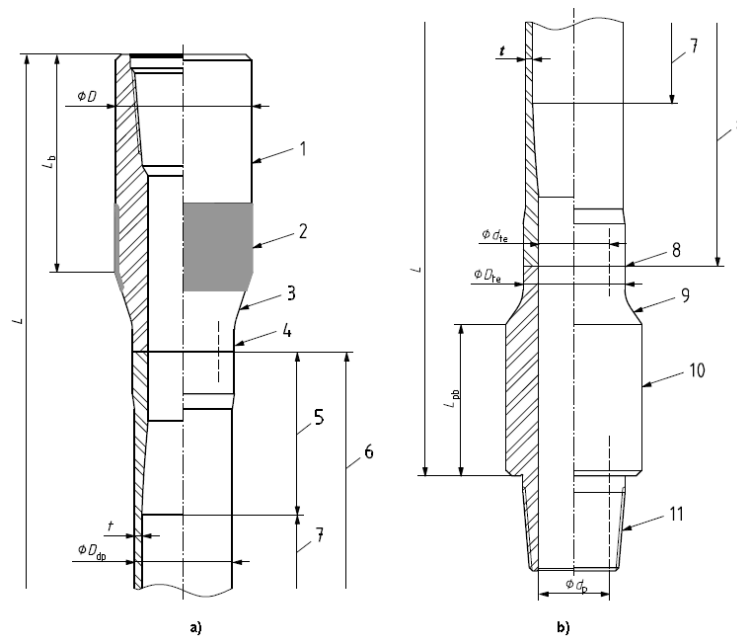
Figure 2: Drill pipe. 1 – tool-joint box; 2 - wear-resistant coating (optional); 3 - shoulder for the elevator; 4 - weld of the coupling; 5 - planted end; 6 - pipe body; 7 - pipe body; 8 - pin weld; 9 - pin socket; 10 – tool-joint pin; 11 - rotary shouldered connection.

- ØD_{dp} – outer diameter of the pipe body;
- ØD – outer diameter of the coupling;
- Ød – internal diameter of the nipple;
- ØD_{te} – the outer diameter in the weld zone;
- Ød_{ie} – the inner diameter in the weld zone;
- L_b – the outer length of the coupling;
- t – the wall thickness.

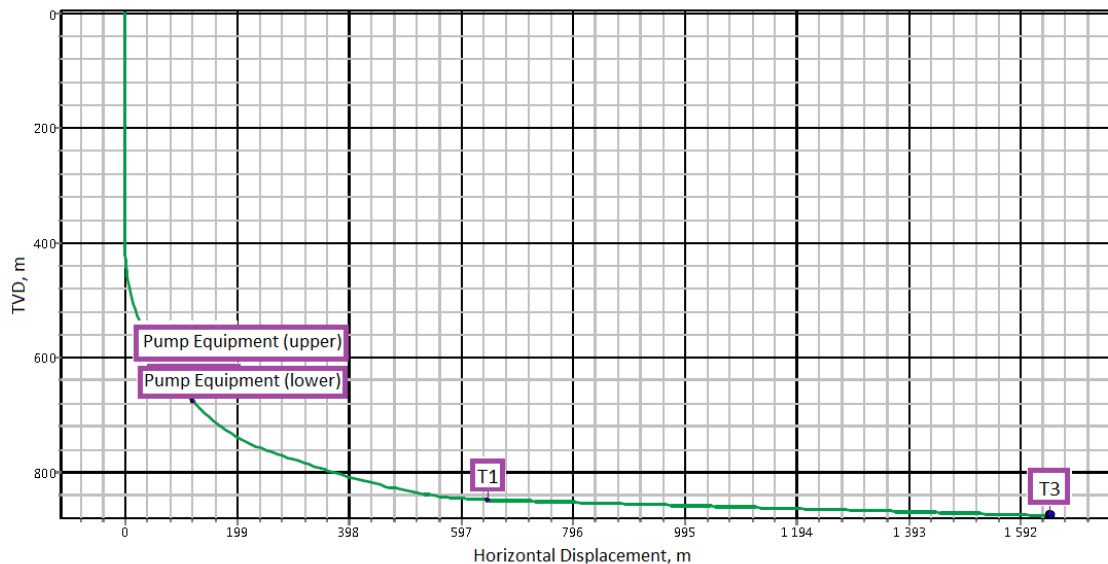
Figure 4: Well profile

- Maximum inclination angle, deg – 88,56;
- The maximum DLS, deg/10m (deg/100ft) - 2,0 (6,2);
- Top of pay, m - 825;
- Designed deviation of borehole on the top of pay, m - 580;
- Permissible deviation of an actual top of pay entry point from the designed one (target area), m - 50 (Projects Department of Gazprom Neft 2014).

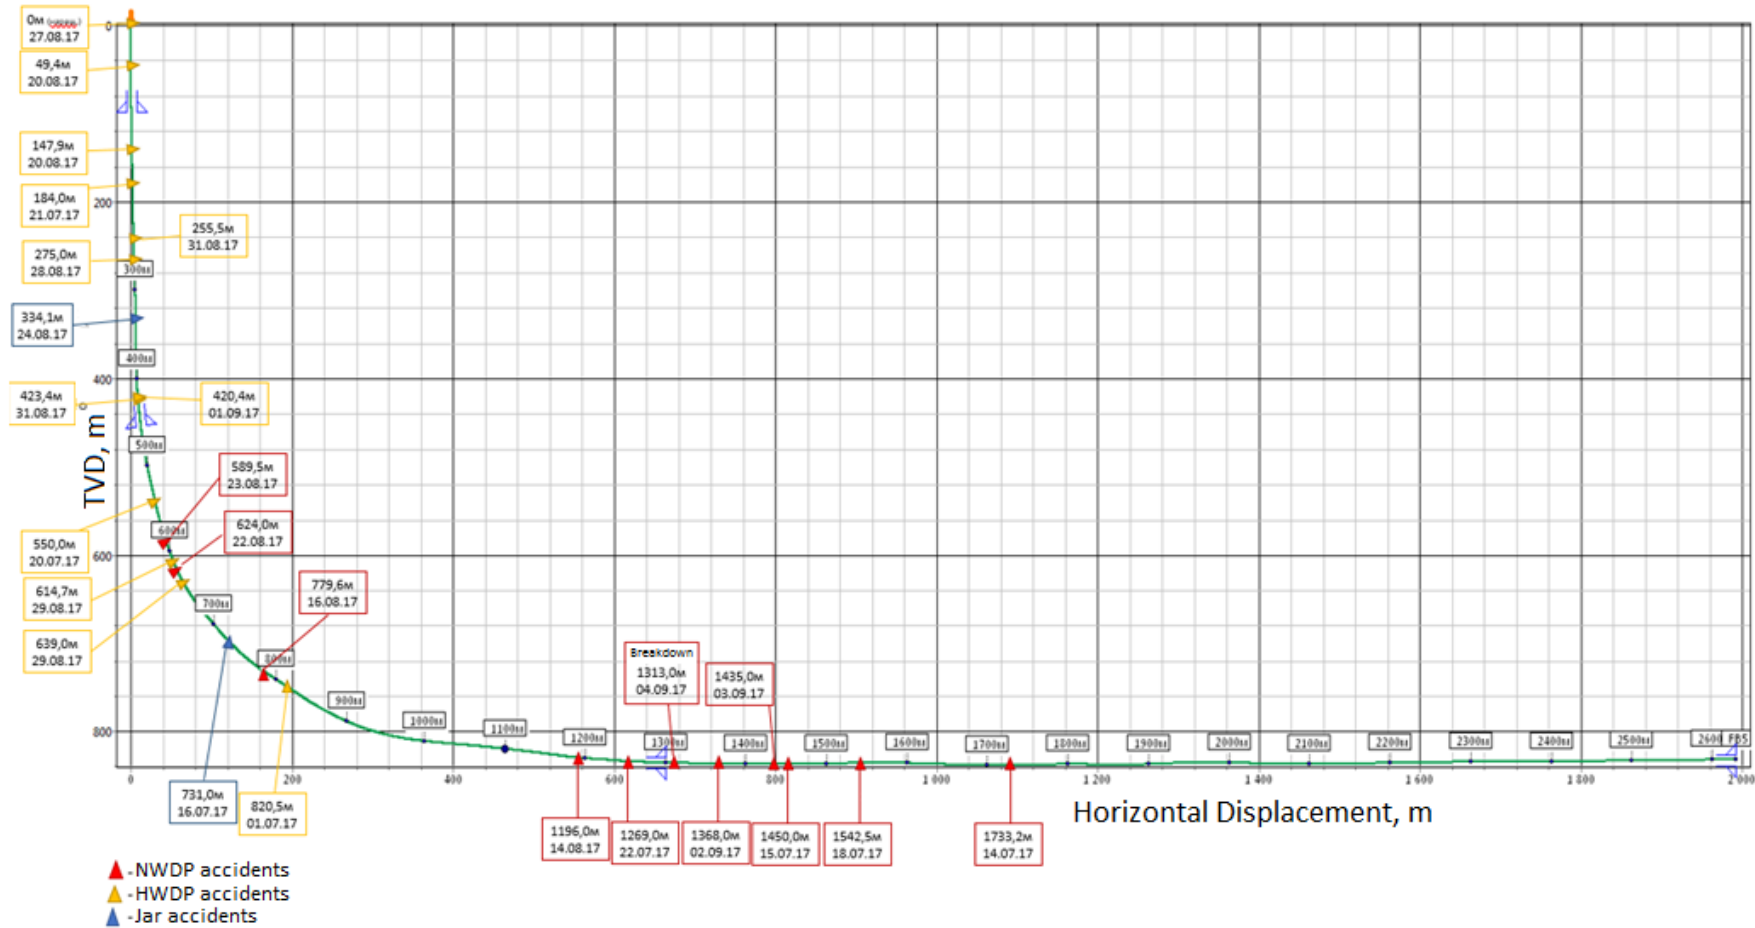
Figure 6: Schematics of washout and breakdown accidents on one of the well pads

Table 8: Summary of washout and breakdown accidents on one of the well pads

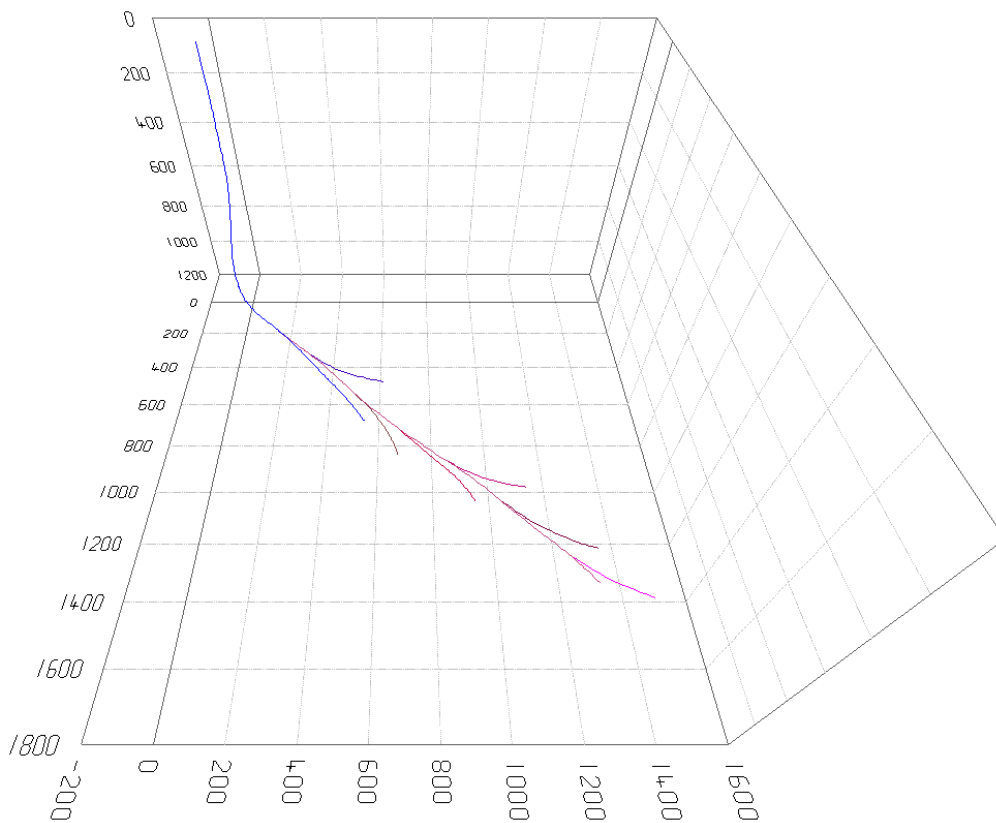
Figure 7: 3-D profile of the Well #1

This object at the date of the accident was a multilateral well with two pilot holes, seven lateral fishbone holes and a main (mother) horizontal hole. Figure 7 shows the 3-D profile of this well.

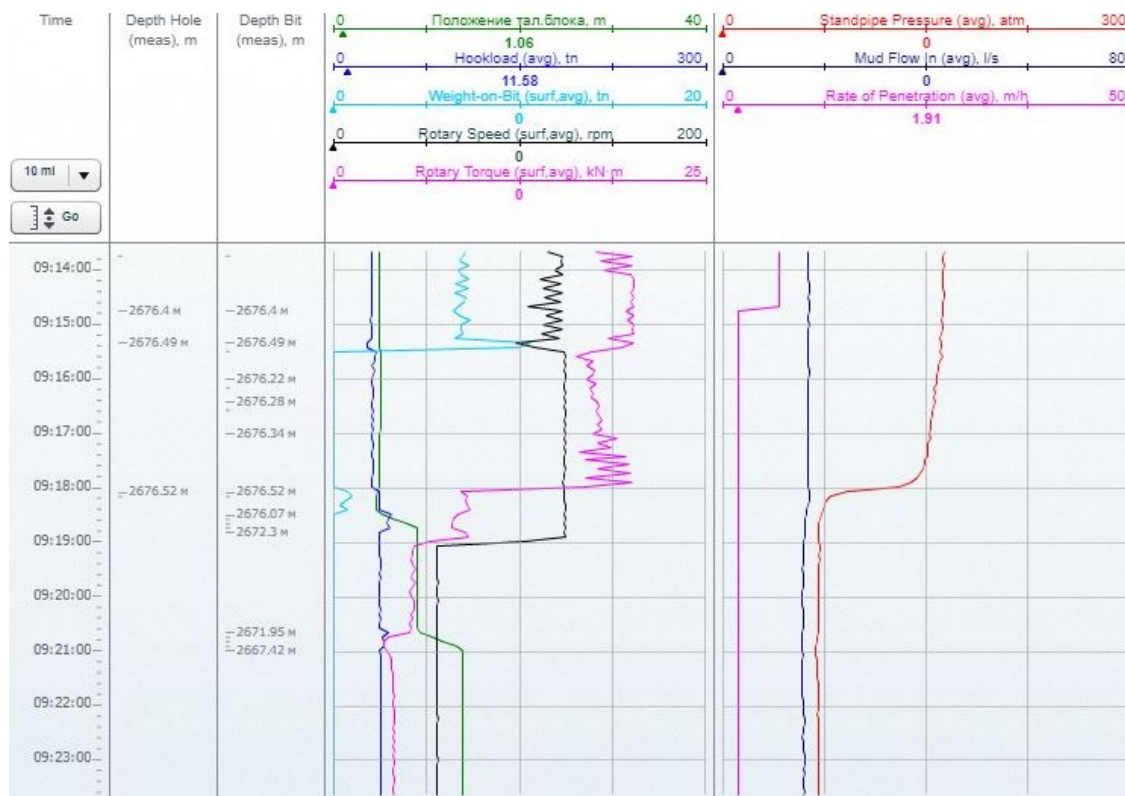
Figure 8: Mudlogging sensors readings at the moment of accident

Listed observations were confirmed after analyzing records of the mudlogging data (Figure 8).

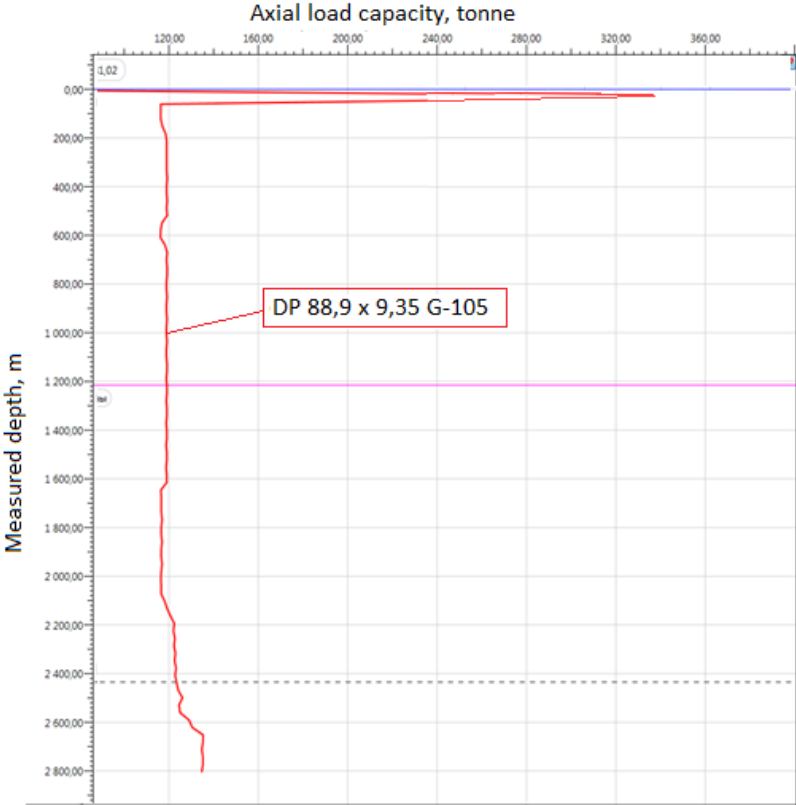
Figure 10: Limiting tensile loads along the drill stem in Well #1 while main wellbore drilling

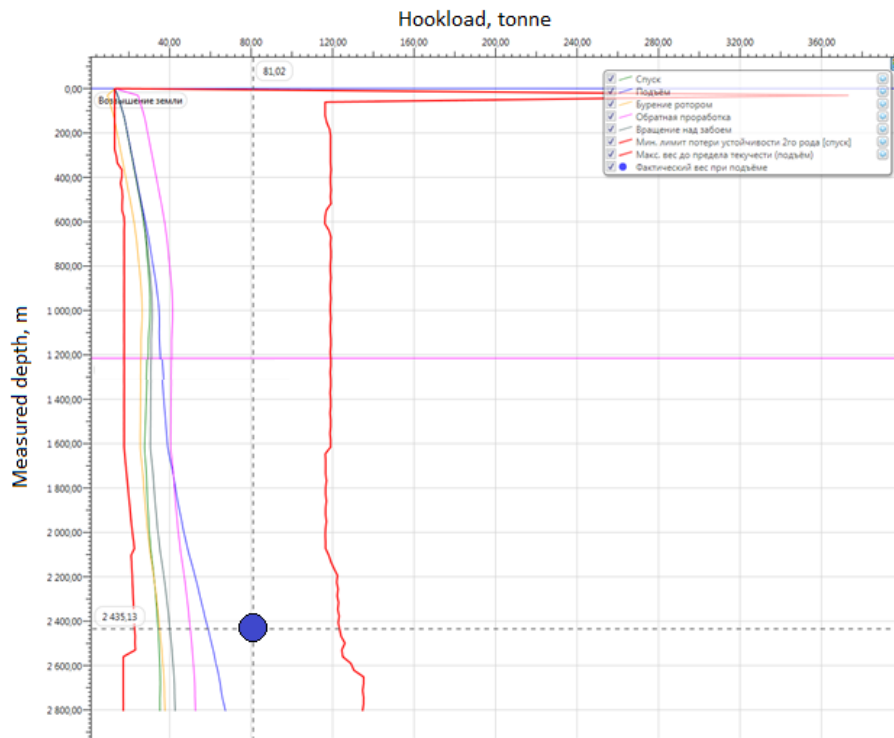
An example of actual values and maximal allowable values comparison is shown in Figure 11. The blue dot indicates an actual maximal value of tensile load.

Figure 11: Tensile load distribution during different operations

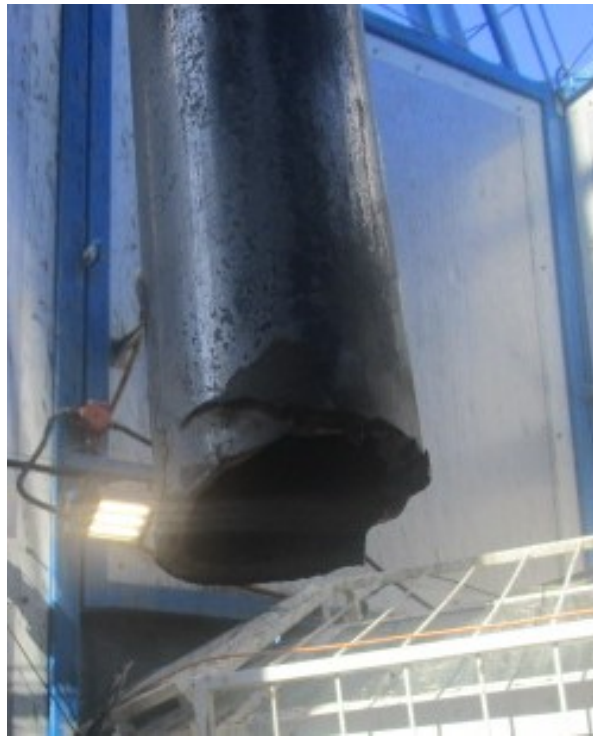
The excess of torsional stress in drill pipes can cause accidents while drilling in rotary mode. A failure due to torque limits exceedance is usually easy to recognize: it passes at an angle of 45 ° to the pipe axis. In our case, the fracture zone is inclined to the plane of the pipe cross-section at an angle of approximately 30° (Figure 12).

Figure 12: The photo of broken drill pipe (NWDP 88,9 x 9,35 G-105)

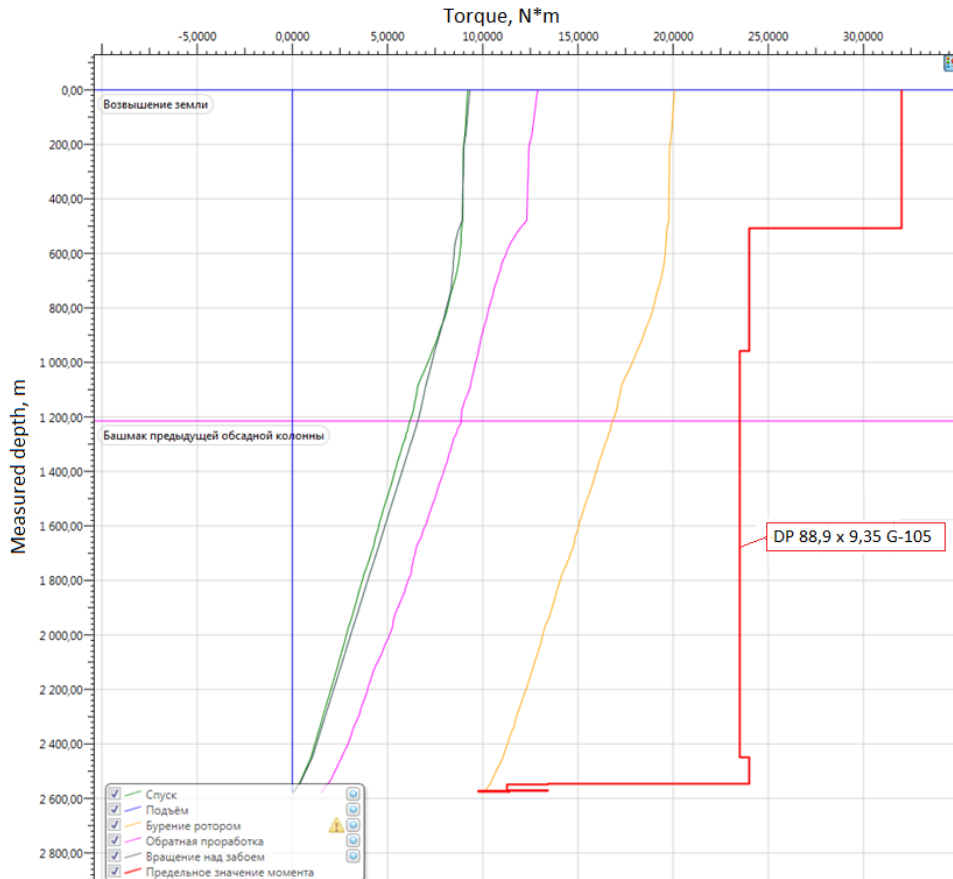
For the broken drill pipe, the allowable make-up torque is 23,75 kN*m (Table 9). An example of such comparison is shown in Figure 13, where the torque distribution is reflected while main horizontal borehole construction. The actual maximal value obtained from the mudlogging station readings – 20,3 kN*m was taken as the maximum rotary table torque. Summary for all branches is presented in Table 12.

Figure 13: The torque distribution along the string in the main hole of Well #1

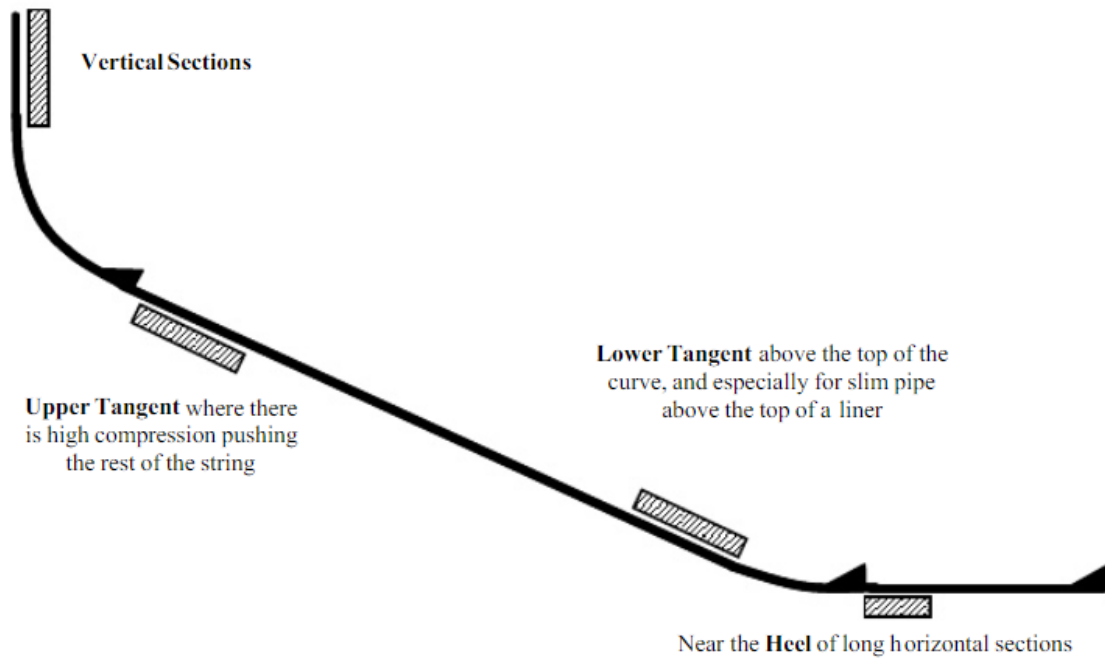
Figure 15: Sections where buckling is most likely to occur

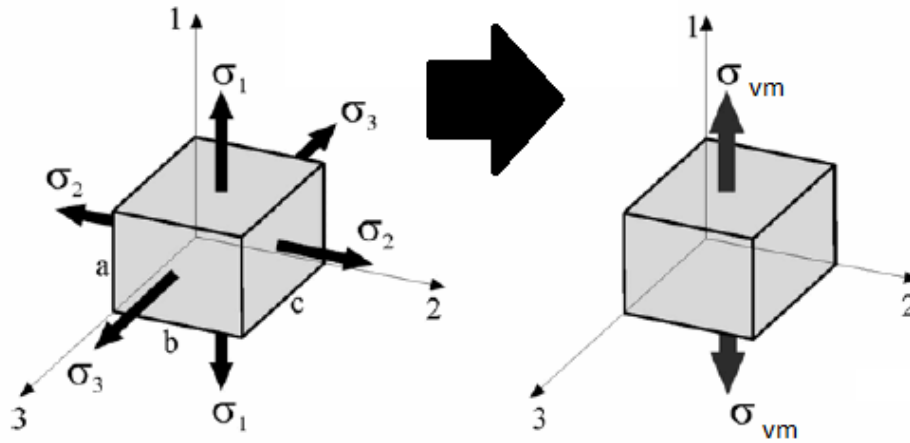
These stresses depend on pressures in the pipe and annulus; axial compressive or tensile forces; borehole geometry and pipe geometry. The equivalent stress is such a stress, under the action of which the material in a simple tension-compression condition would be in the equally dangerous state with the combined tri-axial stress state under consideration (Figure 17).

Figure 17: Tri-axial stress state transition into the equivalent stress

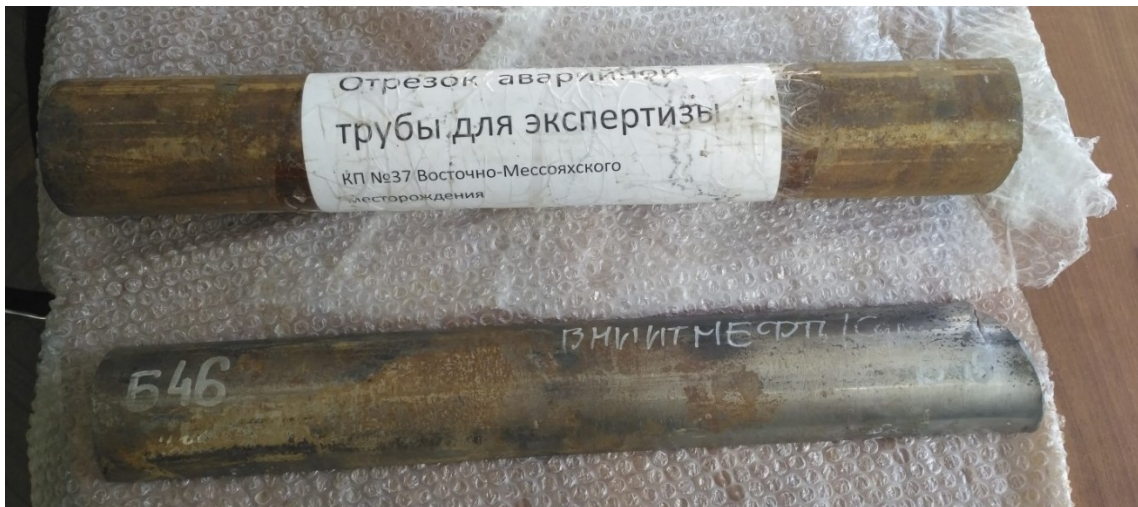
Figure 18: Two pieces of broken pipe delivered for the expertise

Inspection of the damaged drill pipe showed no visible deformations along the pipe body. There were no deep cuts or corrosion damage in the fracture zone that could cause destruction. The fracture zone on the semi-cylindrical fragment #2 is inclined with respect to the cross-sectional plane of the pipe at an angle of approximately 30°. On the section of the pipe adjacent to the plane of fracture, there is a through crack.

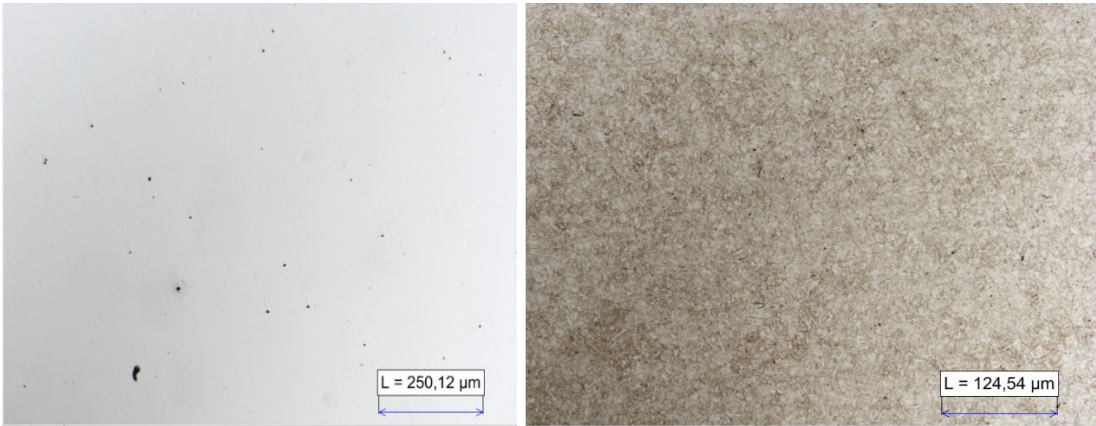
Metal is characterized by the presence of predominantly oxide non-metallic inclusions. Impurity rating – D 1.5. The structure of the metal wall - tempered martensite. No differences were found between the structure in the central part of the wall of the drill pipe and the near-surface layers (Elagina O., Buriakin A. and Volkov A. 2018).

Figure 19: Longitudinal cross-section of the pipe

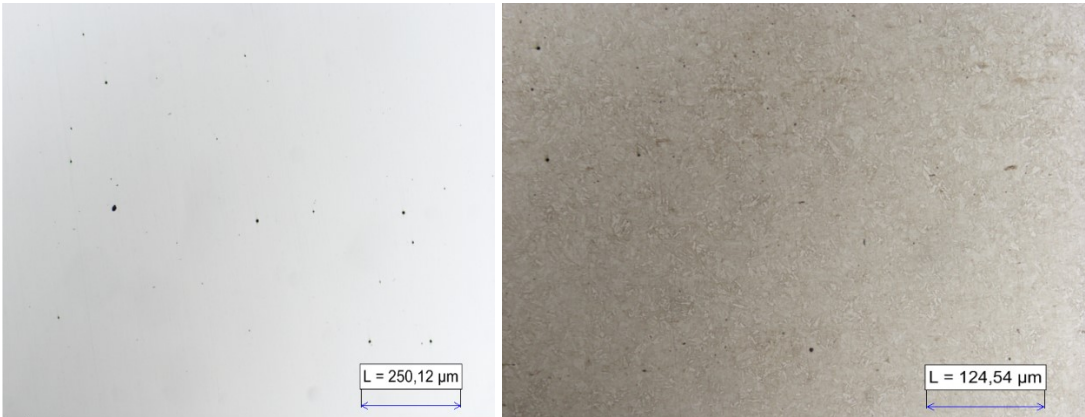
Figure 20: Lateral cross-section of the pipe

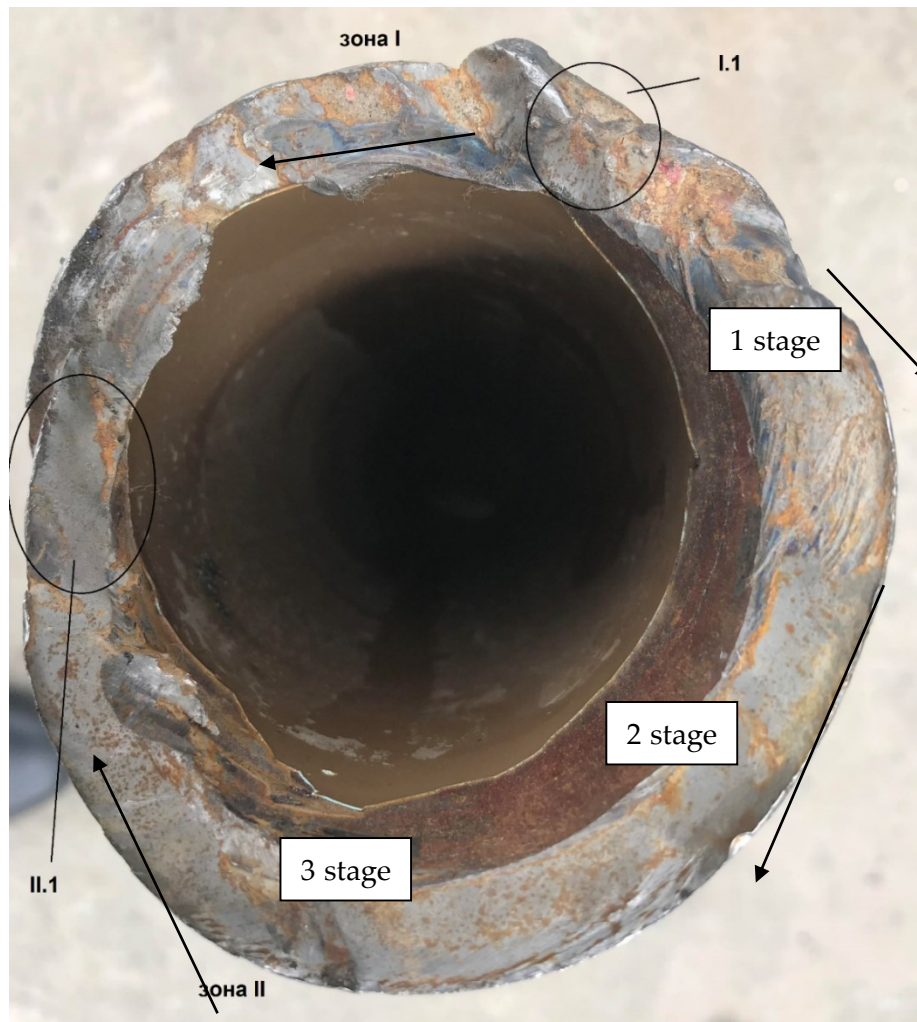
the presence of two zones that differ in their relief. The characteristic washings can be detected in zone I. They form a significant relief. In the central part of zone I there is a protruding section (I.1), obliquely oriented both to the inner and outer surfaces of the pipe. It is assumed that this is the site of crack initiation. There is a ridge separating the inner part of the fracture from the outside in the center of the cross section of the pipe wall at section I.1. Judging from the photo, the fracture surface adjacent to the inner surface of the pipe at section I.1 has a small inclination angle characteristic of the initial stage of crack initiation (1st stage). The inclination angle of the fracture surface changes after the ridge by about 30-50° to the outer surface. This indicates a change in the stress state in the pipe wall as the crack develops in section I.1. The conical shape of this section indicates a significant contribution of the hydro-erosion factor to the output of the drilling fluid through the formed through crack. Probably, a crack initiation process started on the inner surface of the pipe and began to develop towards its center. As the crack grows and opens, the wedging effect of the drilling mud resulted in a change in the stress state at the crack tip.

Figure 21: Broken pipe cross-section view

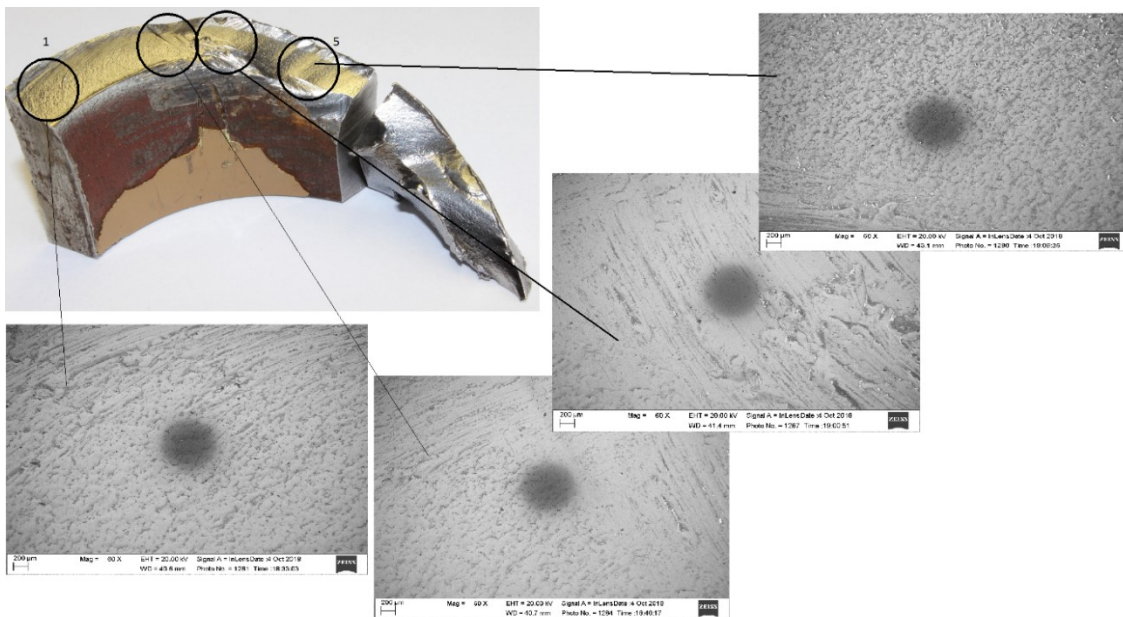
Fracture surface analysis, performed by electron metallography, showed that the fracture on the F1 fragment has a honeycomb pattern that is approximately uniform over the entire surface (Figure 22). This confirms the same loading conditions during the formation of cracks in this area. Cellular relief characterizes the viscous-brittle nature of the destruction of the metal that occurs during the embrittlement of the metal with a significant margin of viscosity during the accelerated development of cracks. Thus, on the fragment of fracture F1, the crack was in the stage of accelerated development, already after reaching the critical length.

Figure 22: Fracture relief on the F1 fragment (electron metallography)

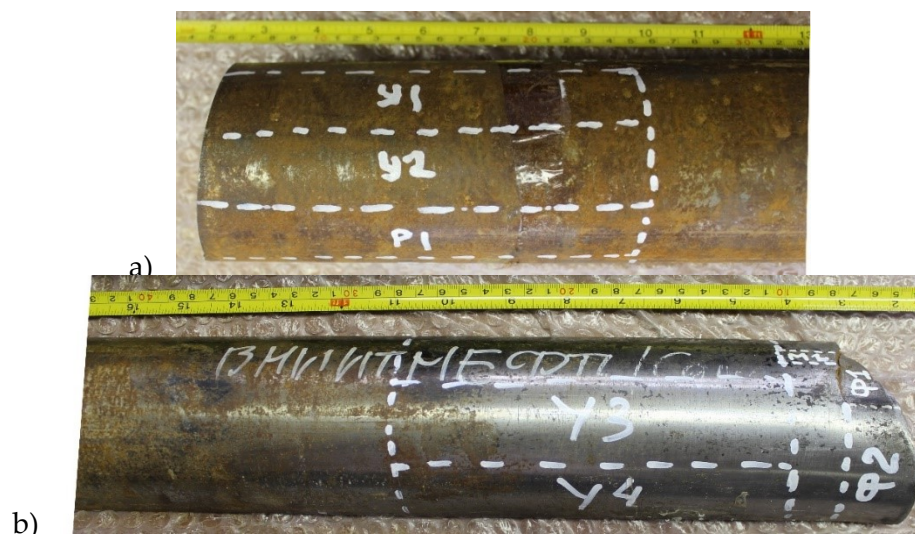
To estimate the drill pipe metal endurance a test cycle was performed for samples cut from pieces #1 (Y1, Y2) and #2 (Y3, Y4) (Figure 23).

Figure 23: Sample marking for endurance limit test. a) Fragment #1, b) fragment #2

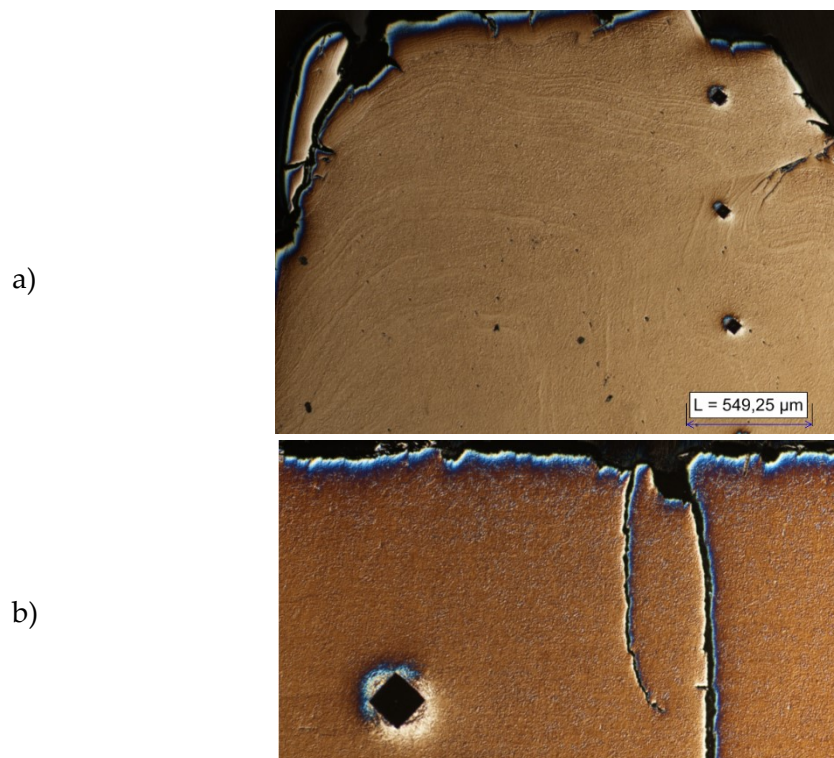
The presence of subplastic deformations that occurred on the inner surface of the pipe is confirmed by photographs made with the use of differential-interference contrast. Figure 24 shows photographs of the surface of the sample from the inner surface (a), where plastic deformation lines are visible, and from the outer surface (b), where they do not present.

Figure 24: Sample photographs made with the use of differential-interference contrast

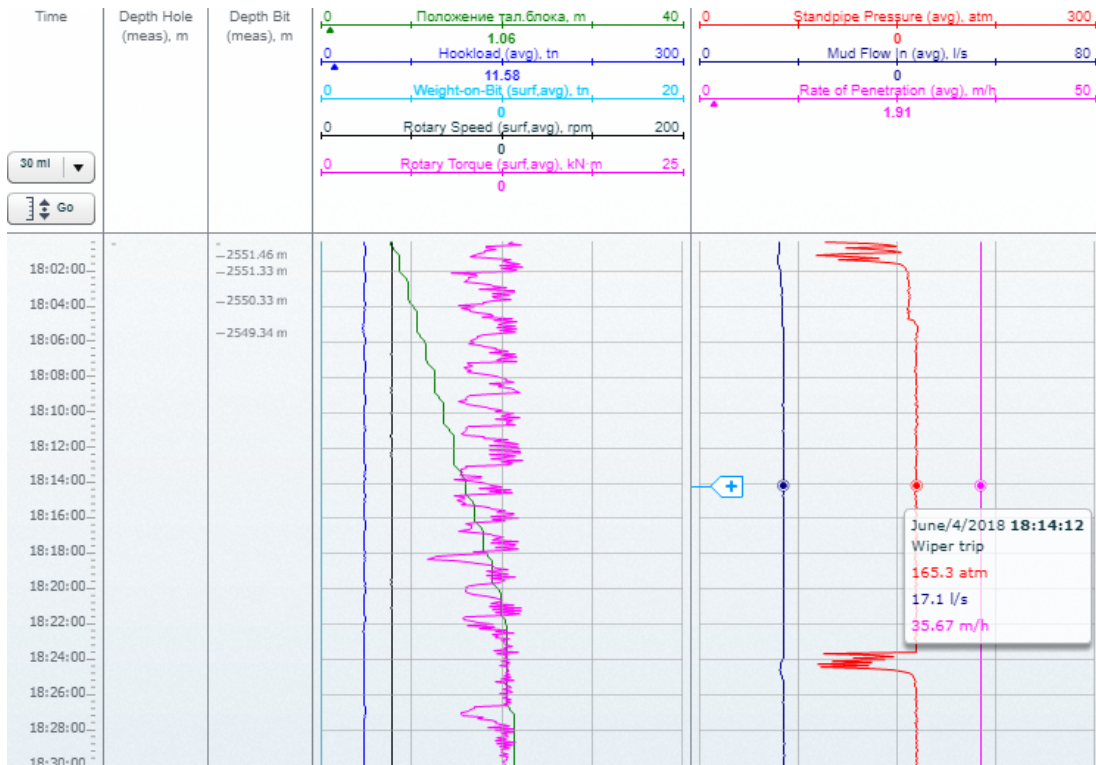
Figure 25: Mudlogging data screenshot. Wiper trip operation from 18:00 to 19:30 (04.06.18)

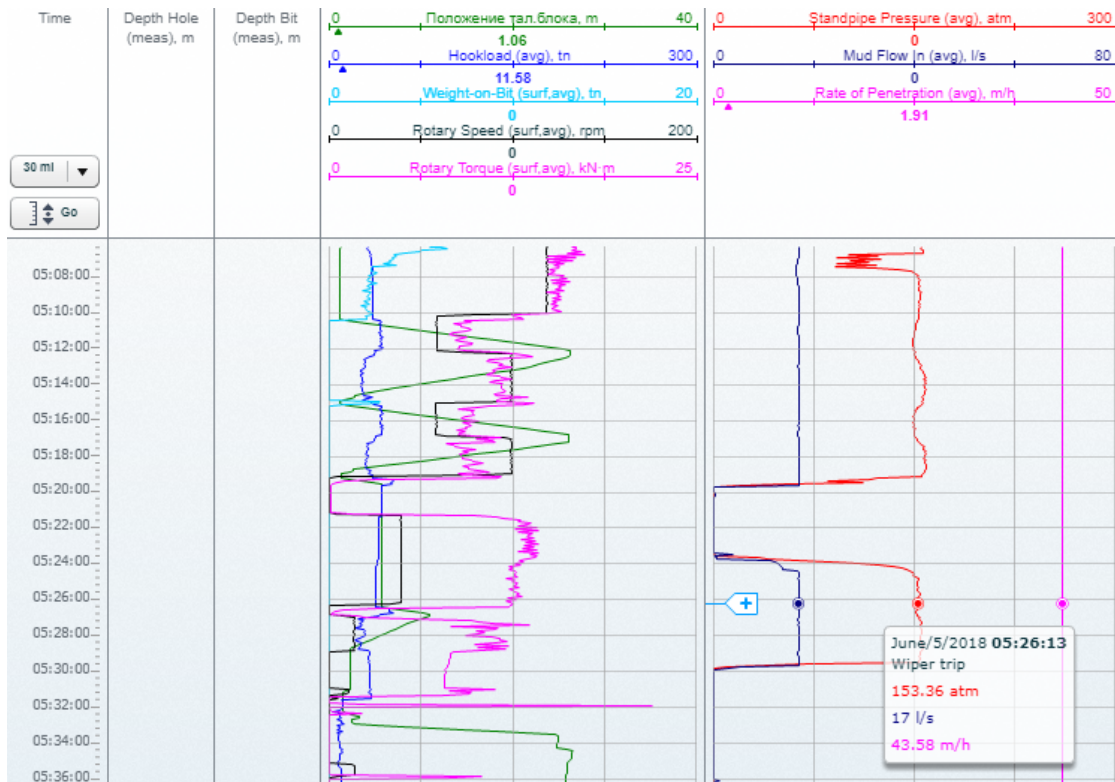
Figure 26: Mudlogging data screenshot. Wiper trip operation from 23:00 (04.06.18) to 09:18 (05.06.18)

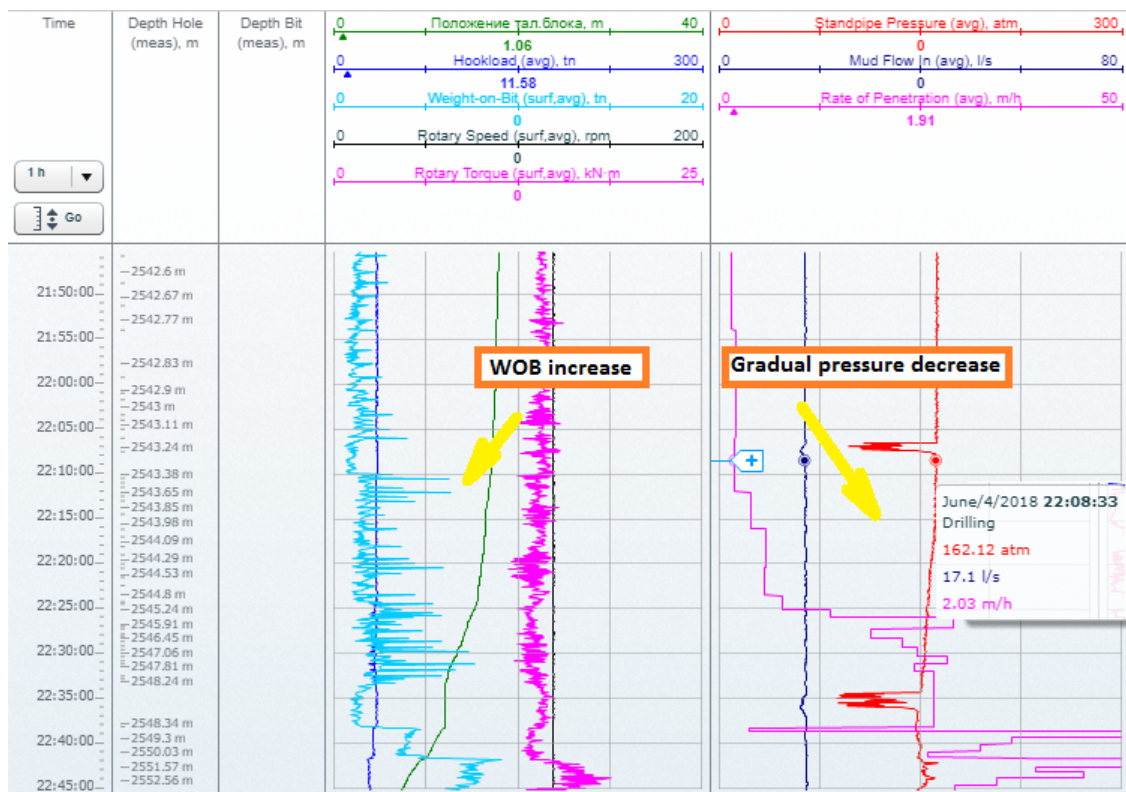
Probably, a washout occurred after an increase in WOB at 22:10 (06.04.18). SPP chart shows a noticeable gradual decrease in the readings (Figure 27).

Figure 27: Gradual decrease of SPP as a probable indicator of drill string washout

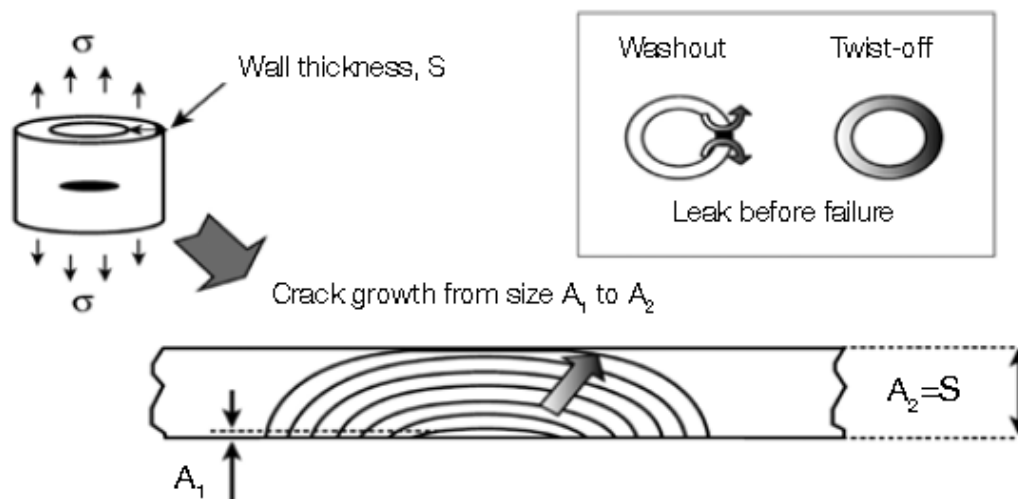
- In Stage 3 crack propagates the whole pipe wall thickness ($A_2 = S$, Figure 28), what leads to failure. The drilling mud starts to flow inside the crack under high pressure. It can wash out the pipe body within a few minutes resulting in a DS break down. Microcrack's life at stage 1 and 2 takes up to 80% of its life cycle before it can be identified by state-of-the-art defect detection methods, depending on the equipment sensitivity and metal type (Figure 29).

Figure 28: Microcrack development in the drill pipe body.

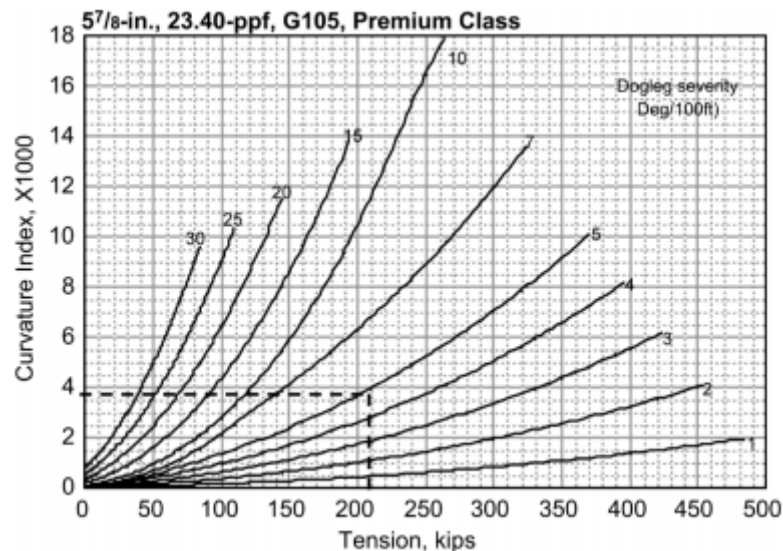
Curvature Index is an indicator of the relative fatigue life of a drill pipe that is working in rotating mode in a curved borehole. It takes into account hole curvature, pipe weight, grade, geometry and class, and axial forces in the pipe. The derivation of these CI-curves can be found in the Vol. 2 of DS-1 Standard (T. H. Hill). An example of curve is given in Figure 30 (Hill, et al. 2005).

Figure 30: CI-curve for 5 7/8-in, 23.40-ppf, G-105, premium-class drill pipe

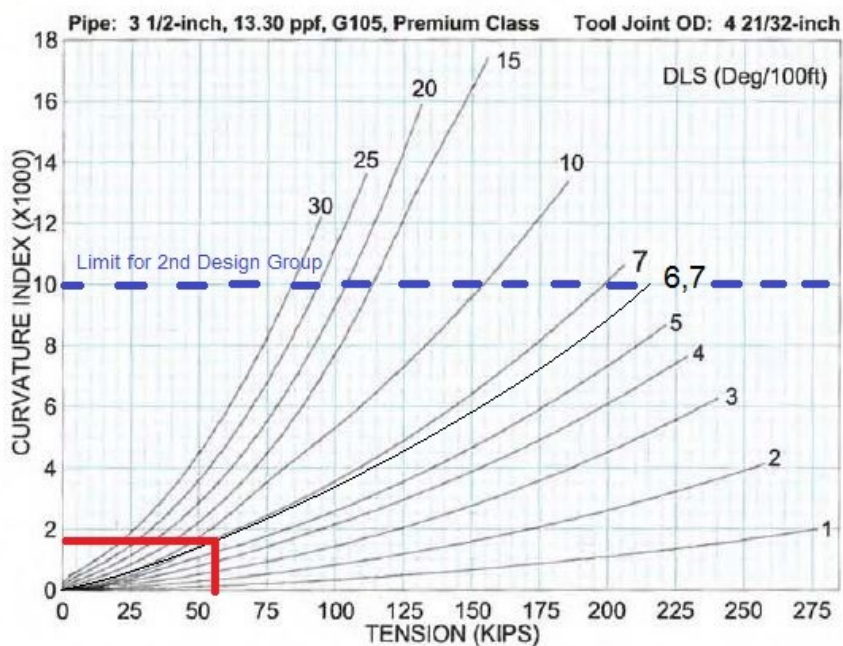
Thus, the overloading fatigue limits for 2nd design group are not exceeded.

Figure 31: Comparison of the maximum CI with an applied one

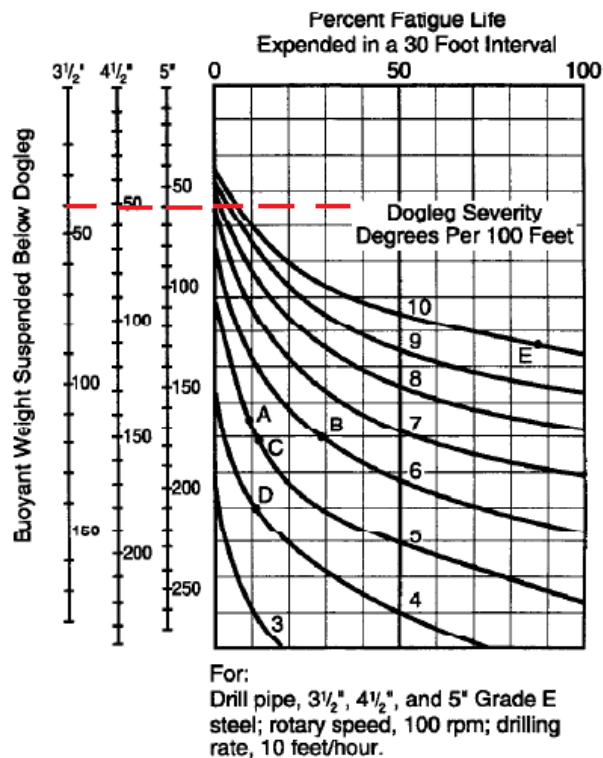
Figure 33 is for Grade E steel drill pipe only. Although fatigue experiments on small and polished specimens display great improvement with steel strength, experiments conducted on full-size joints show that fatigue characteristics either remain the same or improve very little. As a matter fact, higher strength steels displaying a greater notch sensitivity might even be inferior in fatigue performance (Lubinski and Hansford 1966).

Figure 33: Fatigue damage in gradual doglegs for noncorrosive environment
(Lubinski and Hansford 1966)

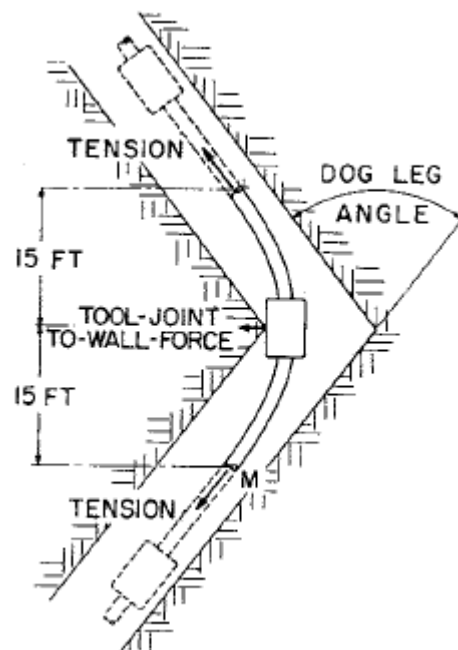
However, let's see one more fatigue estimation approach, which considers sharp changes in DLS along the wellbore. The schematic case of an abrupt dog-leg illustrated in Figure 34 **Ошибка! Источник ссылки не найден.** The borehole is geometrically straight (not necessarily vertical) both above and below the dog-leg. The angle by which the hole turns in the dog-leg will be referred to as "dog-leg angle". This greatest bending stress increases with the tension to which the pipe is subjected (Lubinski 1961).

Figure 34: Abrupt dogleg

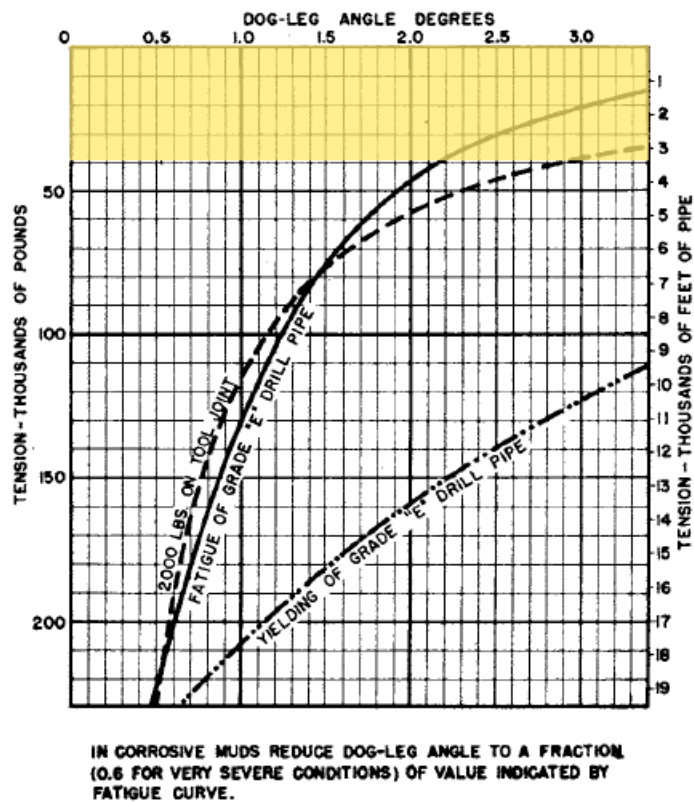
Figure 35: Abrupt dog-leg. Dog-leg angle vs tension for 3 ½ in., 13,3 lbf drill pipe

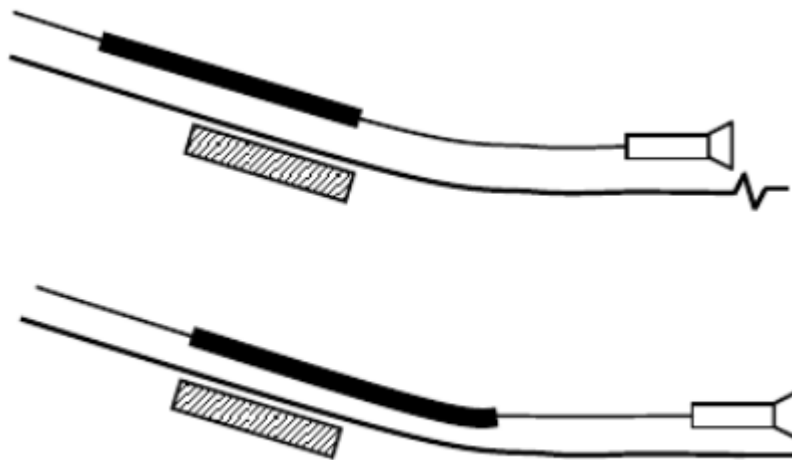
It may lead to some limitations in torque and drag analysis or hydraulics, but the game is worth the candle if the optimum design would be found (Mims M. 2003).

Figure 36: HWDP placing example in tangent section of drill string

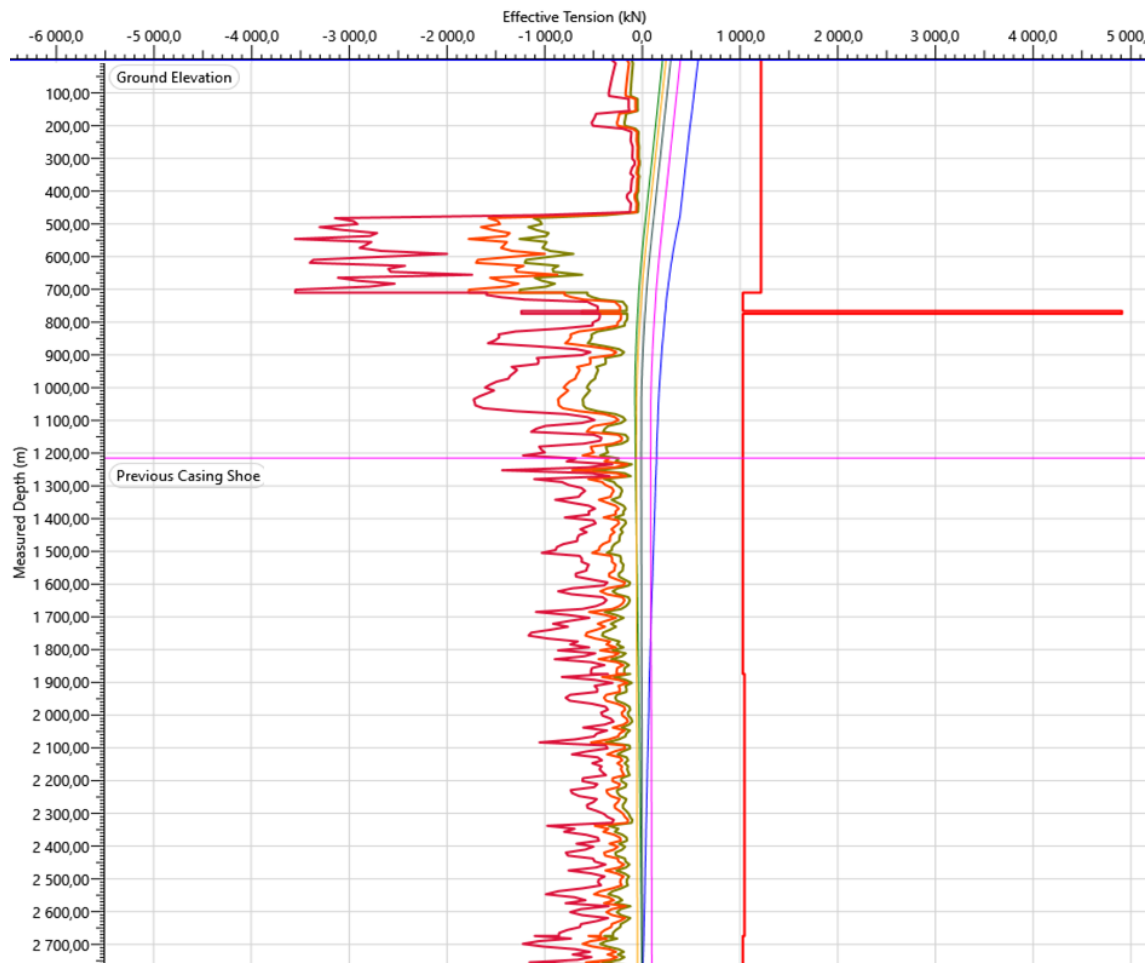
Figure 37: A Buckling analysis diagram for the new drill string design

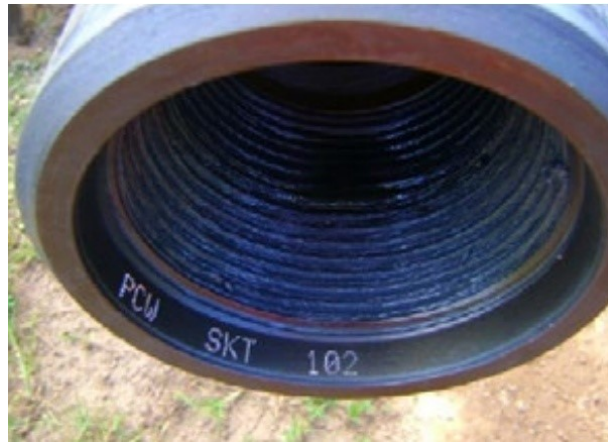
Figure 38: Marking space for drill pipe tool joint

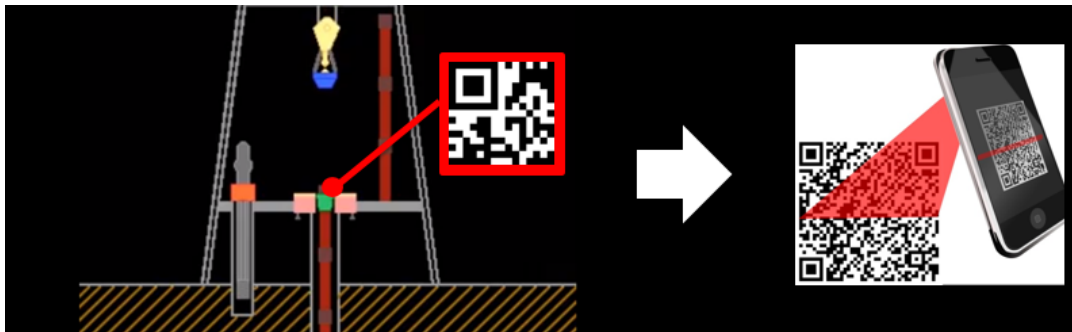
- while RIH operation drill pipe is set to the rotary bushing;
- rig hand before lubricating the thread clean out the marking zone and reads the QR-code by device (Figure 39);
- information about new drill pipe in drill string goes to the monitoring system. Pipe started to work;
- thread lubrication and makeup connection;
- pipe (or stand) runs in hole and the history data starts to record;
- while POOH operation the same reading of tag should be fulfilled to finish history data recording.

Figure 39: QR-code reading schematics
