Chair of Structural and Functional Ceramics

Master's Thesis

Wear of WC/Co Cemented Carbides during
Percussive Demolition

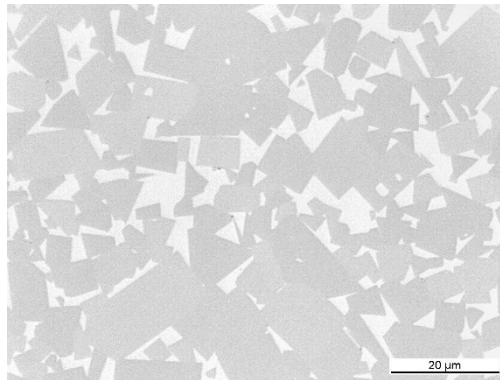
Figure 1: Microstructure of WC-9.5 wt% Co cemented carbide

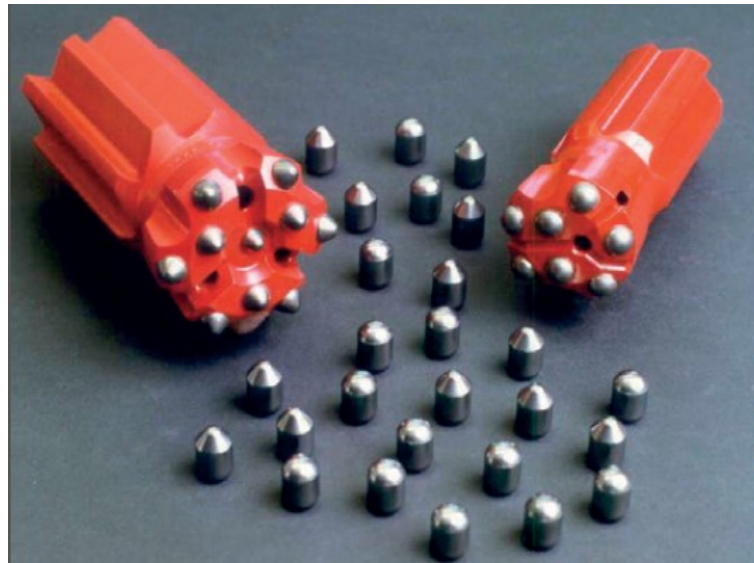
Figure 2: Drill bits for rotary percussion drilling [2]

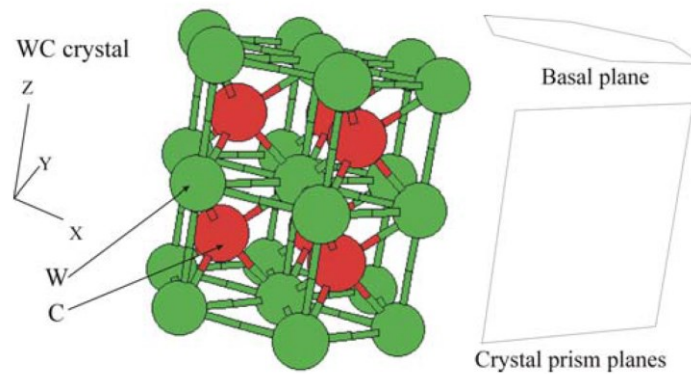
Figure 5: The hexagonal WC crystal structure [15].

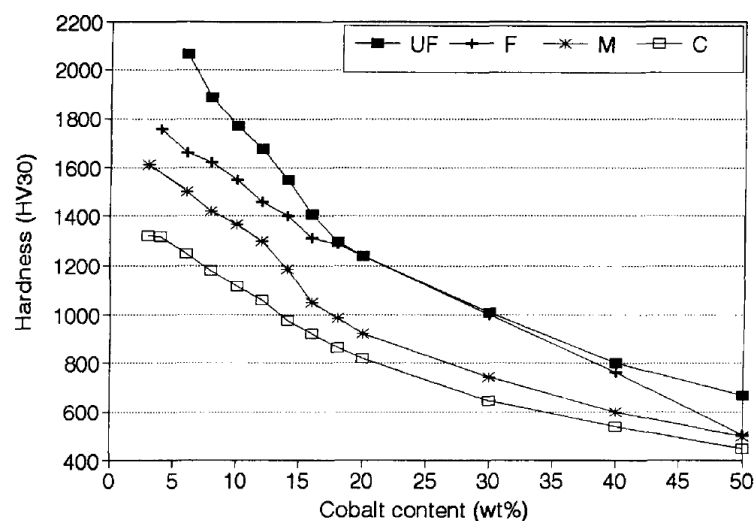
Figure 6: Plots of the hardness of different WC-Co grades vs the cobalt content, at approximately constant grain size. The grain size of the tungsten carbides is classified in UF (ultra-fine), F (fine), M (medium) and C (coarse) [16].

As previously mentioned, the tungsten carbide phase is the main reason for the hardness of WC/Co cemented carbides, with the main contributing factors being the volume fraction and the particle size of the WC phase [14]. With decreasing volume fraction of the carbide phase, thus an increasing cobalt binder content, the hardness decreases. Furthermore, if the particle size of the WC phase, also referred to as the carbide grain size, decreases, the hardness increases. These correlations are plotted in Figure 6.

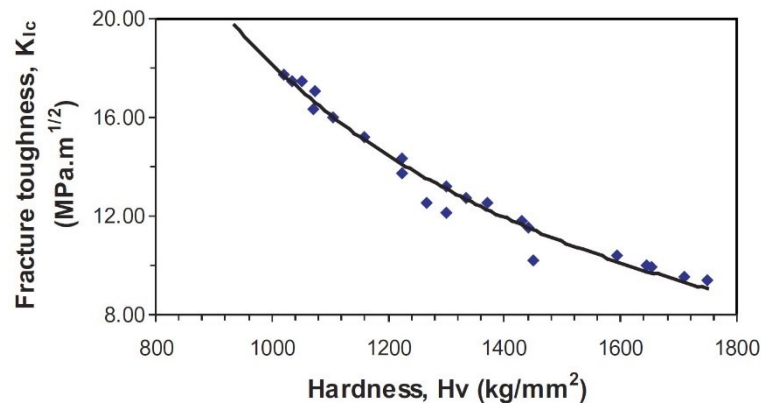
Figure 7: Correlation between fracture toughness and hardness for WC/Co cemented carbides [17].

Hence, the main influencing parameter on this mechanical property is the volumetric percentage of the binder phase, leading in general to an increasing fracture toughness of cemented carbides with higher binder amount. This is based on the ductile nature of the metallic binder, which allows it to absorb energy and plastically deform. Furthermore, the grain size of the carbide grains also reveals a correlation to the toughness, more precisely a coarser WC phase increases the fracture toughness. Consequently, it reveals the inverse relation with respect to hardness, which is also shown in Figure 7. [17]

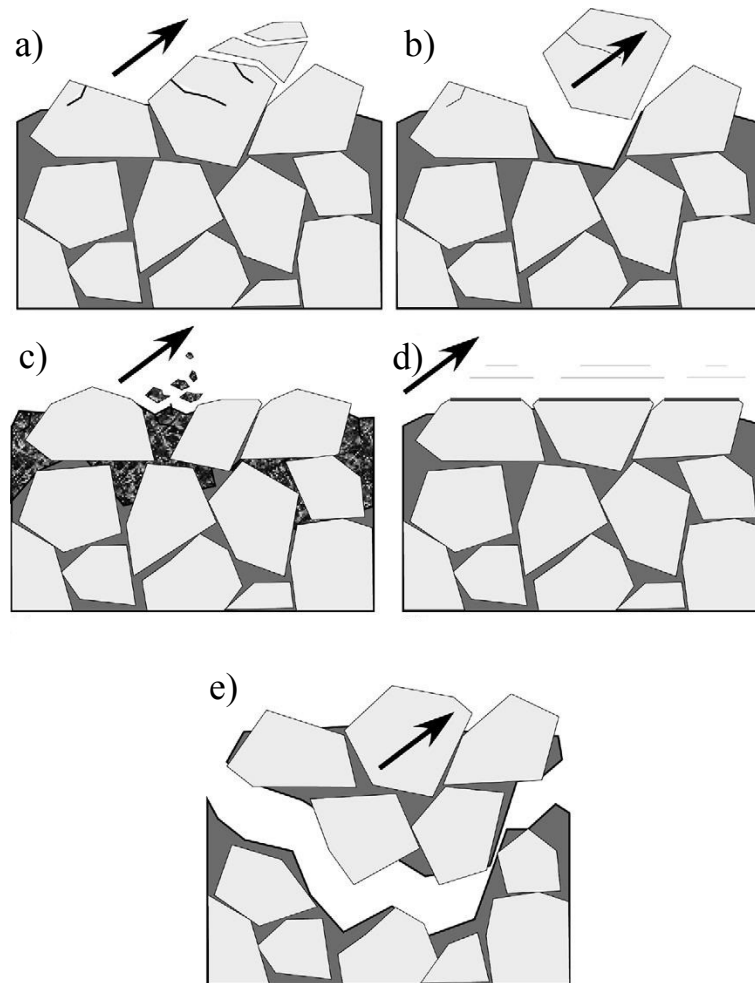
Figure 9: Schematic illustration of five important mechanisms of material removal of rock drill buttons. (a) Crushing of WC grains and release of fragments. (b) Detachment of whole or parts of WC grains (c) Crushing and removal of binder/rock mixture (d) Tribochemical wear of the carbides (e) Detachment of composite scale fragments [3].

The first mentioned removal mechanism is probably the most important, in contrast to the infrequent detachment of whole or parts of WC grains. Removal mechanism number 3 is more or less replacing the earlier assumptions, where the abrasive removal of the Co by its extrusion from the bulk to the surface, is described as a major degradation mechanism [9], [28]. The study by Beste and Jacobson [3] pointed out that this is very rare, however, rock intermixing with the surface of the cemented carbide seems to play an important role during application. Therefore, embrittlement of the binder takes place, followed by crushing fragments of this composite layer. Material removal mechanism number 4 is described by gradual corrosion or oxidation of the surface, where the newly formed layer is mechanically removed. Regarding the last removal mechanisms, it should be mentioned that the detachment of composite scale fragments is usually a rather uncommon event.

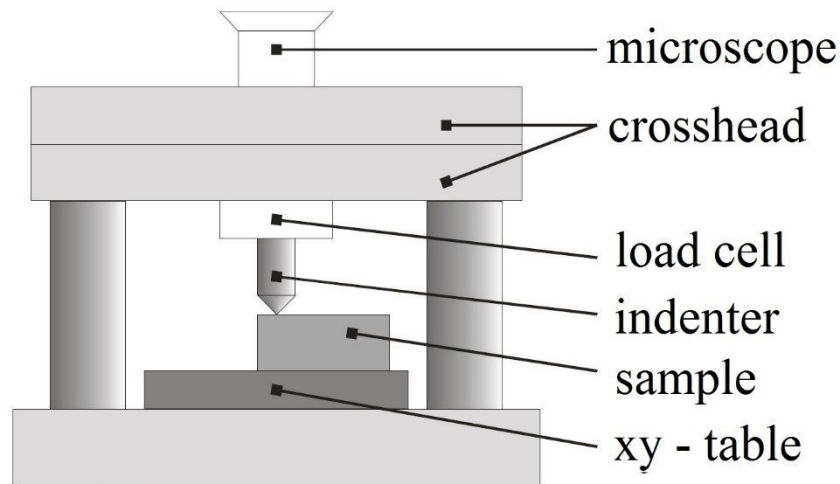
Figure 11: Edge toughness testing machine [37].

For many brittle materials, the edge chipping is one of the most common reasons for failure, and this is also the case for WC/Co cemented carbides. To examine this behavior of brittle edges under mechanical loading, Almond and McCormick [36] suggested a method in 1986, where a Rockwell-C indenter penetrated a point near the surface of the sample with increasing load until flaking occurred. In this way, the resistance of a brittle material against edge chipping, which correlates with the critical strain energy, can be determined, also referred to as edge toughness. [37] In 2010 the standard DIN CES/TE 843-9 was published, where the method of test for edge-chip resistance of ceramics is described. The setup of the edge toughness test is shown in Figure 11.

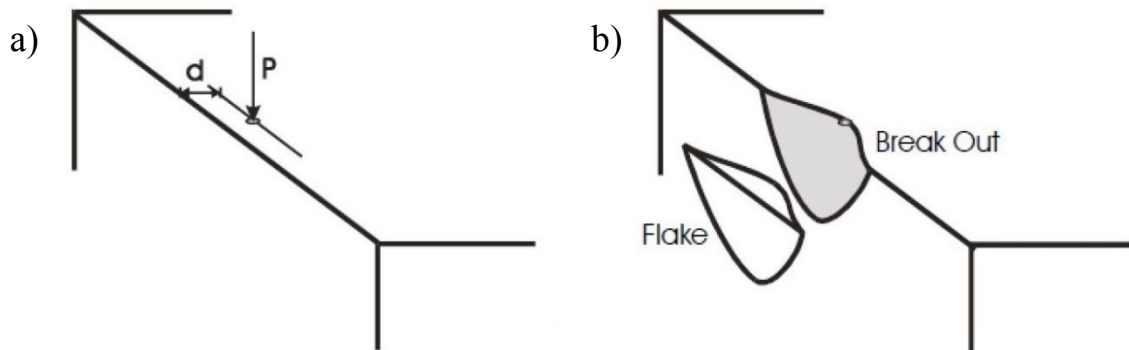
Figure 12: Schematic drawing where distance from the edge of the loading point is pictured a) before, and b) after the test [37].

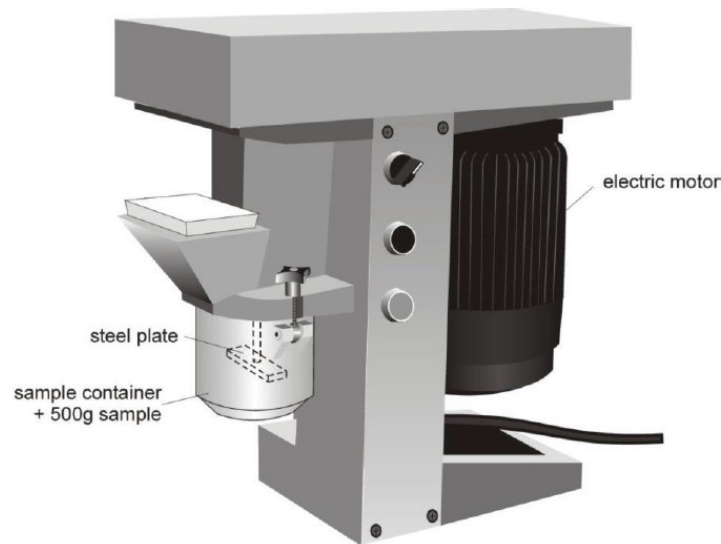
Figure 13: Testing aperture for the LCPC Abrasivity test [39].

The LCPC Abrasivity test was developed by the “Laboratoire Central des Ponts et Chaussées” in 1986, by which the LCPC Abrasivity Coefficient can be determined and used as a measurement of the abrasivity of the material. The test procedure and testing device is described in the French Standard P18-579, established 1990. Basically, there is a 750 W motor rotating a metal impeller (steel plate, 50 x 25 x 5 mm) in a cylindrical container filled with the granular sample ($500 \text{ g} \pm 2 \text{ g}$), the testing aperture is shown in Figure 13. Due to the mass loss of the impeller during each test, which usually takes 5 minutes, the abrasivity of the sample can be determined.

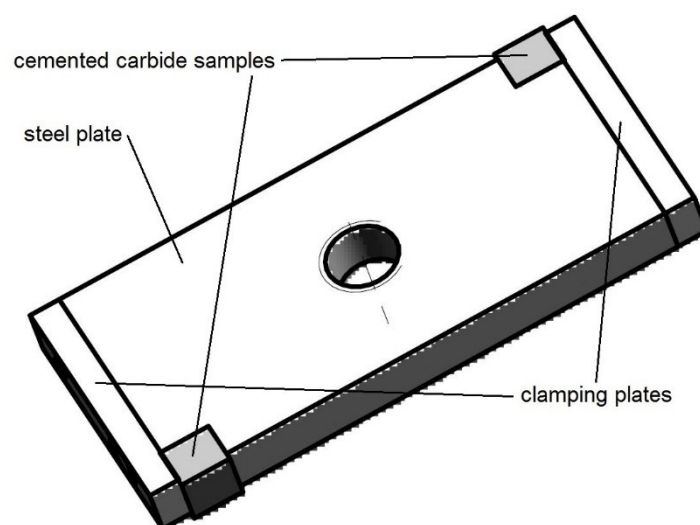
Figure 14: Modified impeller for testing cemented carbide samples by the LCPC Abrasivity test.

In a study of the wear of cemented tungsten carbide percussive drill-bit inserts the same concept with slightly different construction of the modified impeller was used [40].

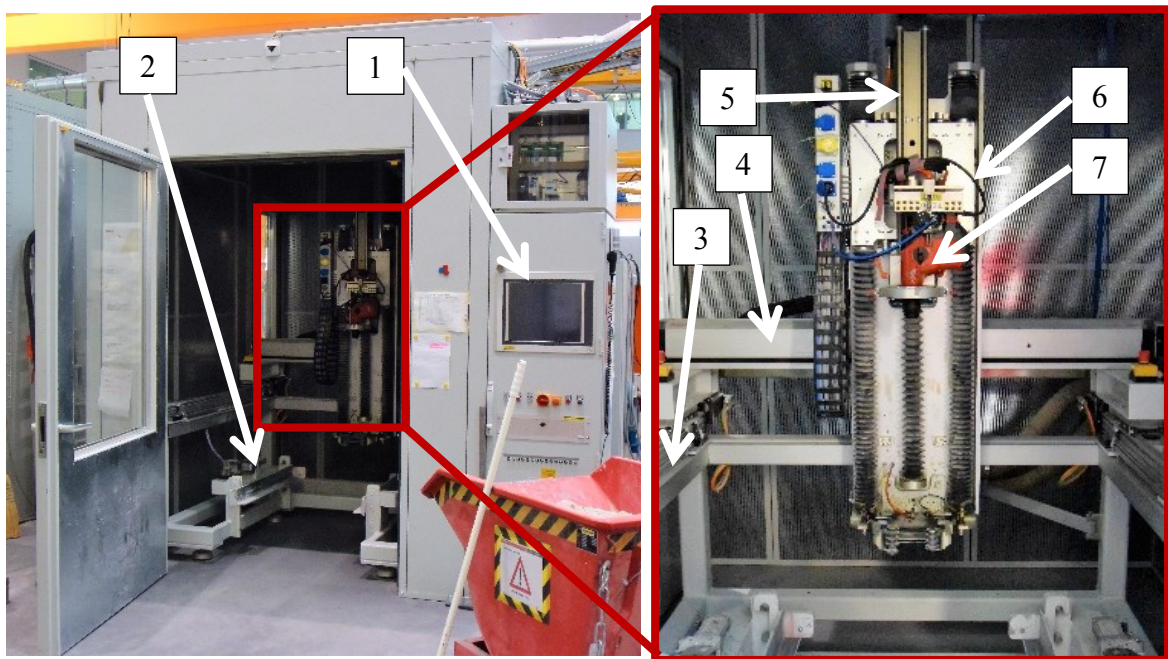
Figure 15: Fully automated 3-axis test bench situated at HILTI AG Headquarters in Schaan, FL. A combi-hammer tool is already installed, to start the test program a specific chisel and base material must be inserted in the next steps.

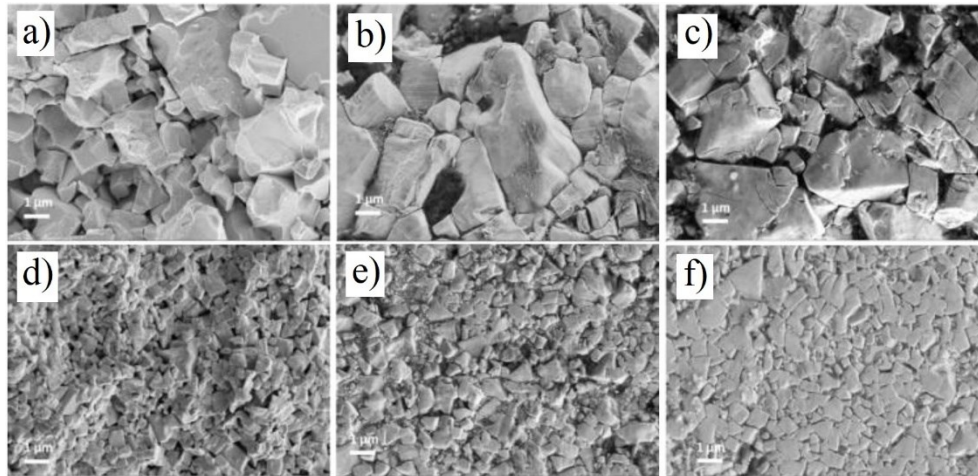
Figure 16: Wear intensity assessment reference pictures, the upper images represent a coarse grained cemented carbide, the lower a fine grained. a) fatigue/abrasion intensity "0", b) fatigue intensity "1", c) fatigue intensity "3", d) fatigue/abrasion intensity "0", e) abrasion intensity "1.5", f) abrasion intensity "3" [42].

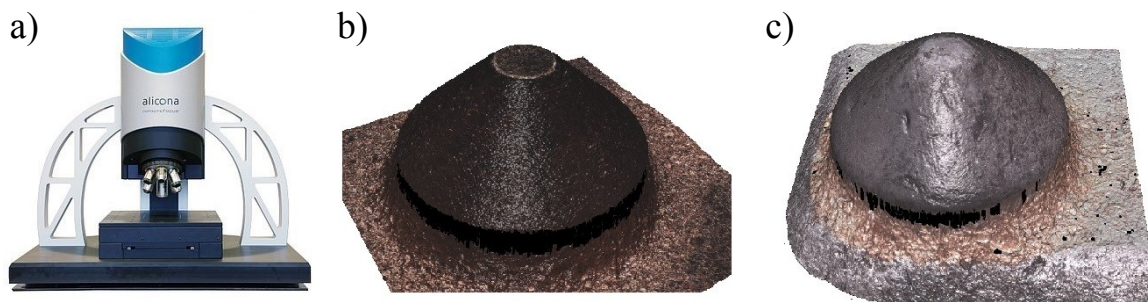
Figure 17: a) Alicona™ measurement equipment, Visualization of a b) unworn and c) worn WC/Co cemented carbide pin of a HILTI bushing tool.

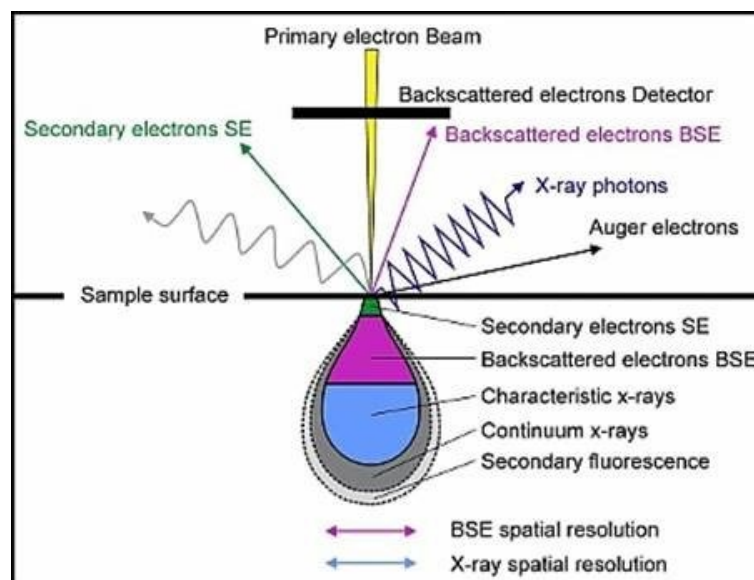
Figure 18: Interactions between the primary electron beam and the investigated sample surface [44].

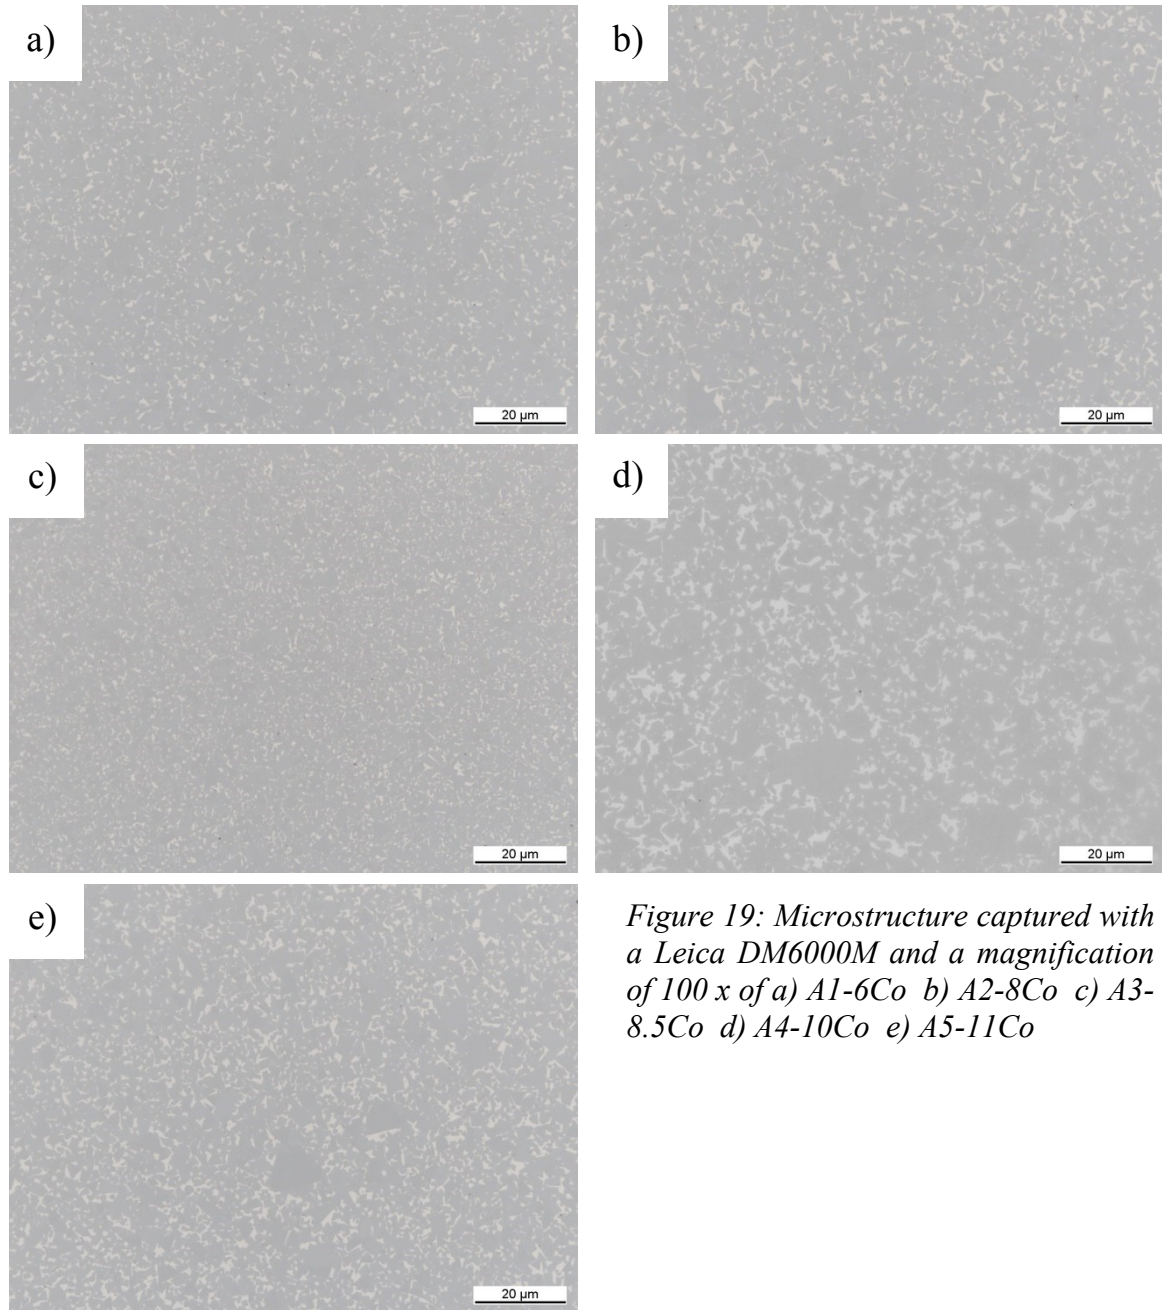
Figure 19: Microstructure captured with a Leica DM6000M and a magnification of 100 x of a) Al-6Co b) Al-8Co c) Al-8.5Co d) Al-10Co e) Al-11Co

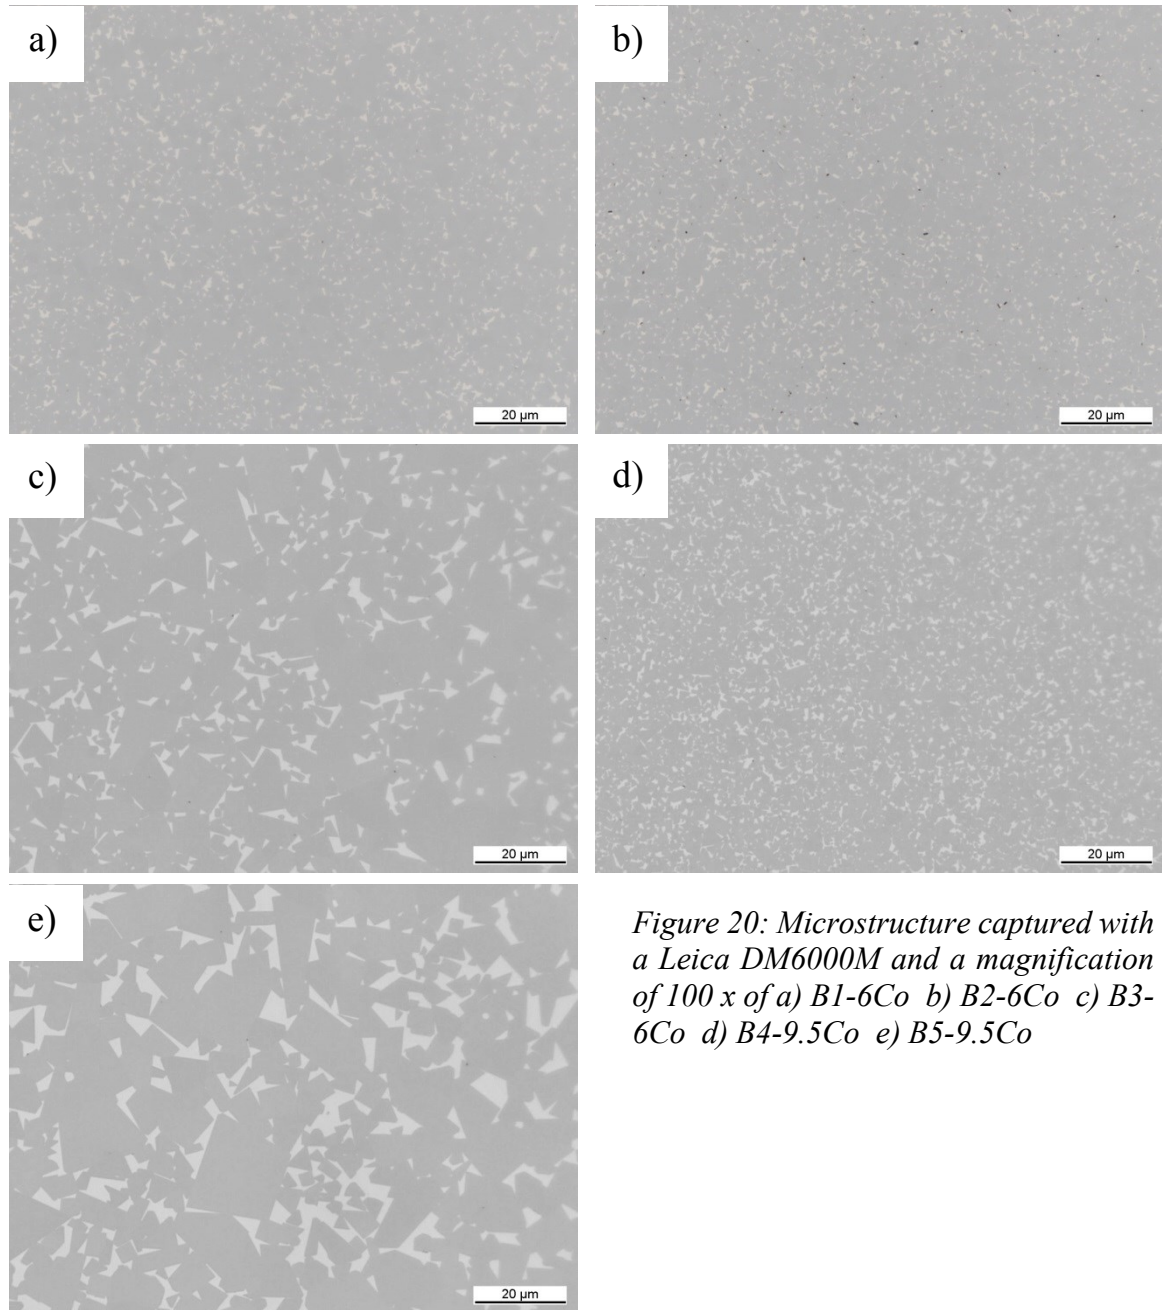
Figure 20: Microstructure captured with a Leica DM6000M and a magnification of 100 x of a) B1-6Co b) B2-6Co c) B3-6Co d) B4-9.5Co e) B5-9.5Co

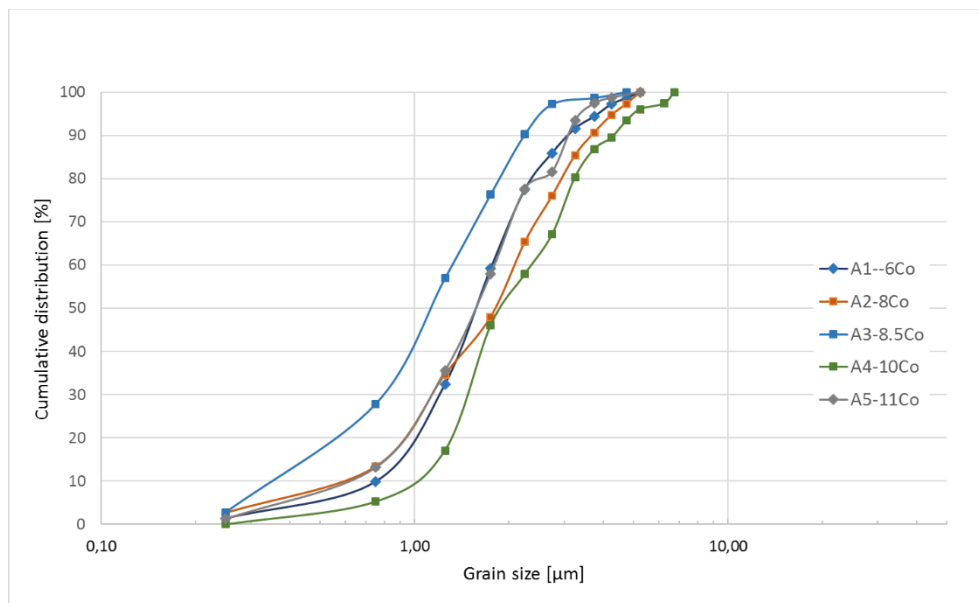
Figure 21: Grain size distribution for the A-grades cemented carbides.

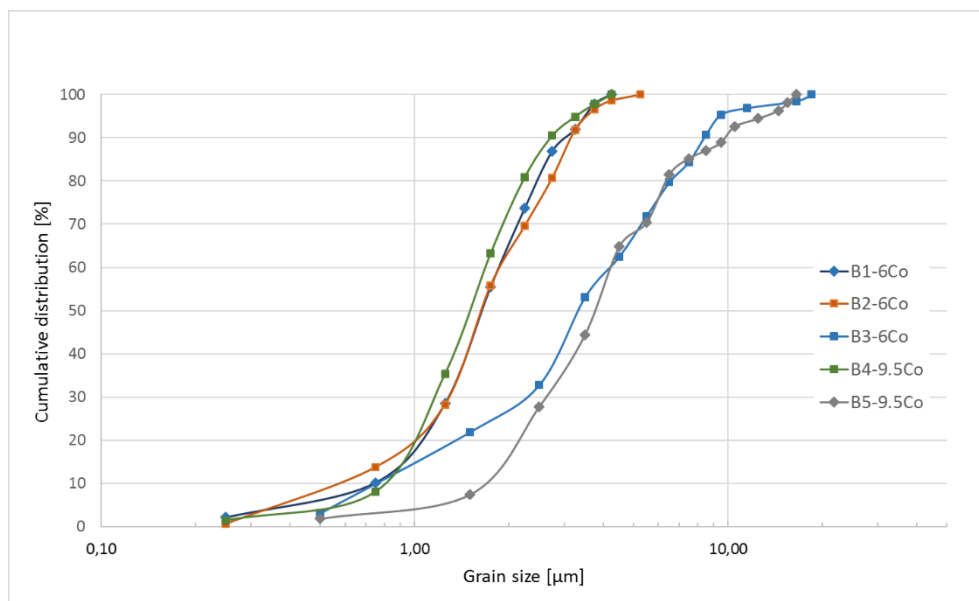
Figure 22: Grain size distribution for the B-grades cemented carbides.

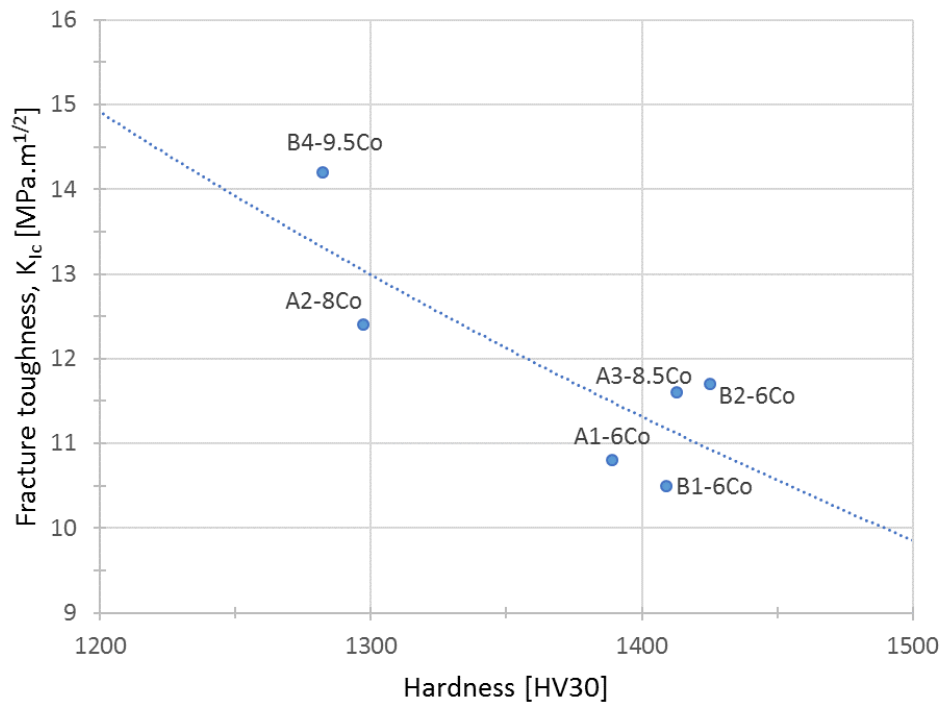
Figure 23: Determined Palmqvist fracture toughness over measured hardness values.

The inverse relation between the measured fracture toughness and hardness, described in 2.1.1 is shown in Figure 23.

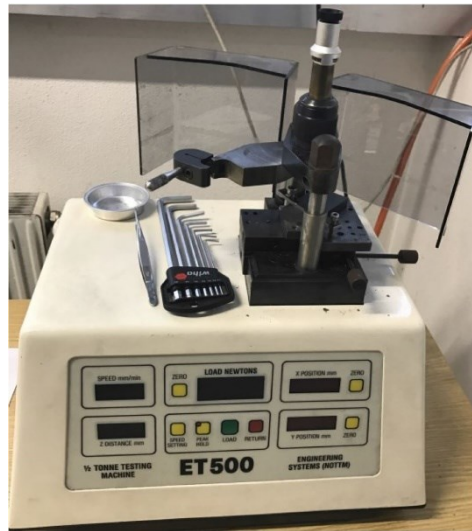
Figure 24: Edge toughness testing machine ET500

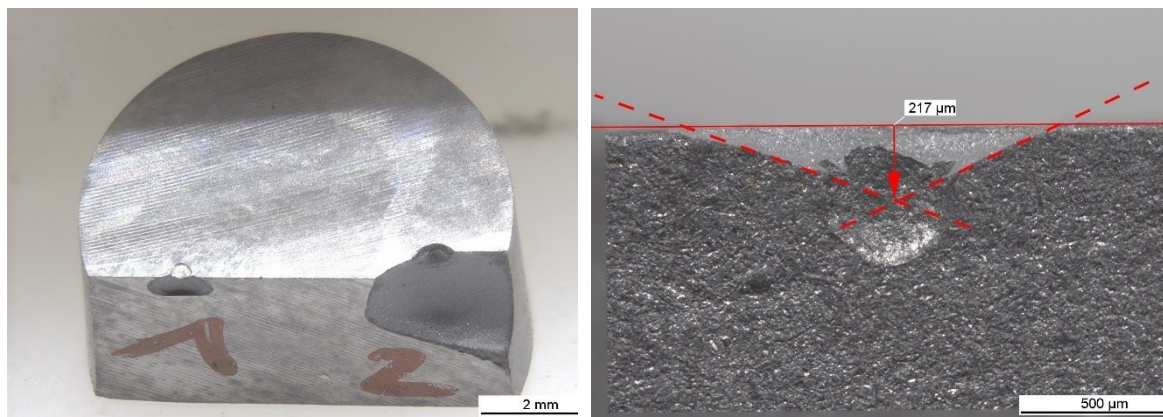
Figure 25: a) A valid result of an edge flake test on the left side of the sample, an invalid on the right. b) An example of the distance measurement of the loading point from the edge of the sample after a test.

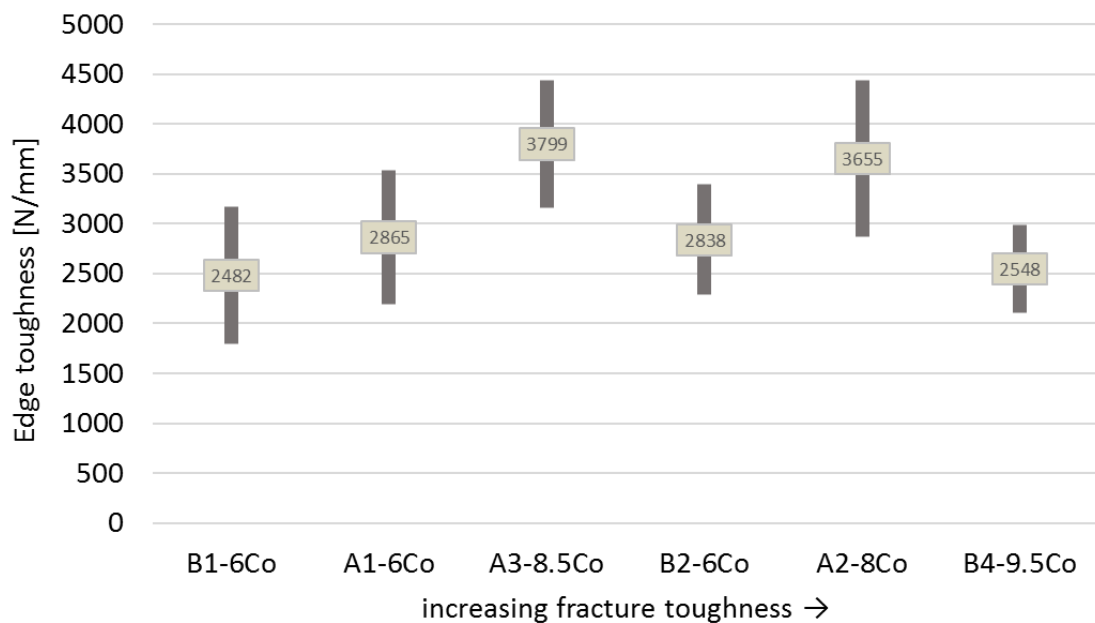
Figure 26: Correlation between the edge toughness and the determined Palmqvist fracture toughness (values see table 4) of the investigated cemented carbide grades.

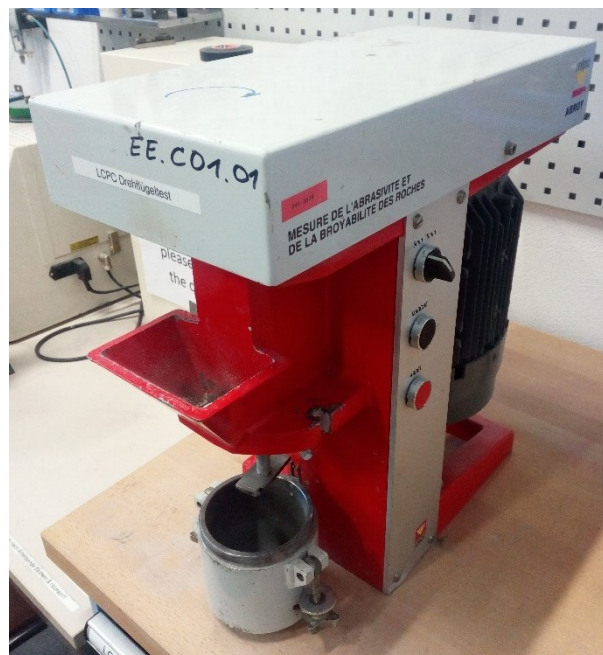
Figure 27: LCPC testing machine C.E.T.E de l'ouest, Abroy, Type 461B, No.: 39.

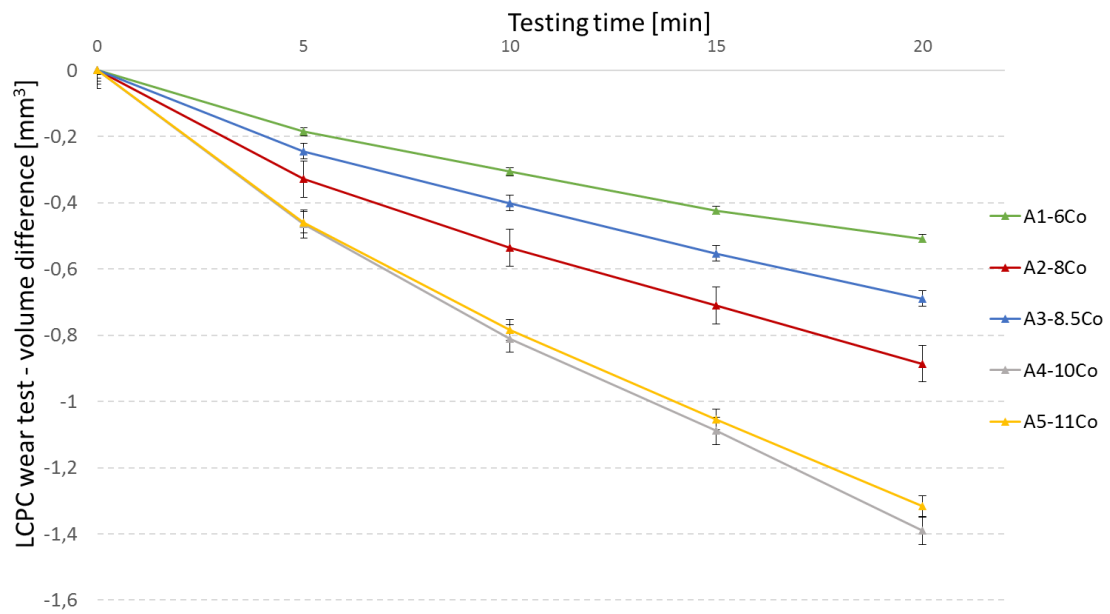
Figure 28: A-grades results of the LCPC wear test.

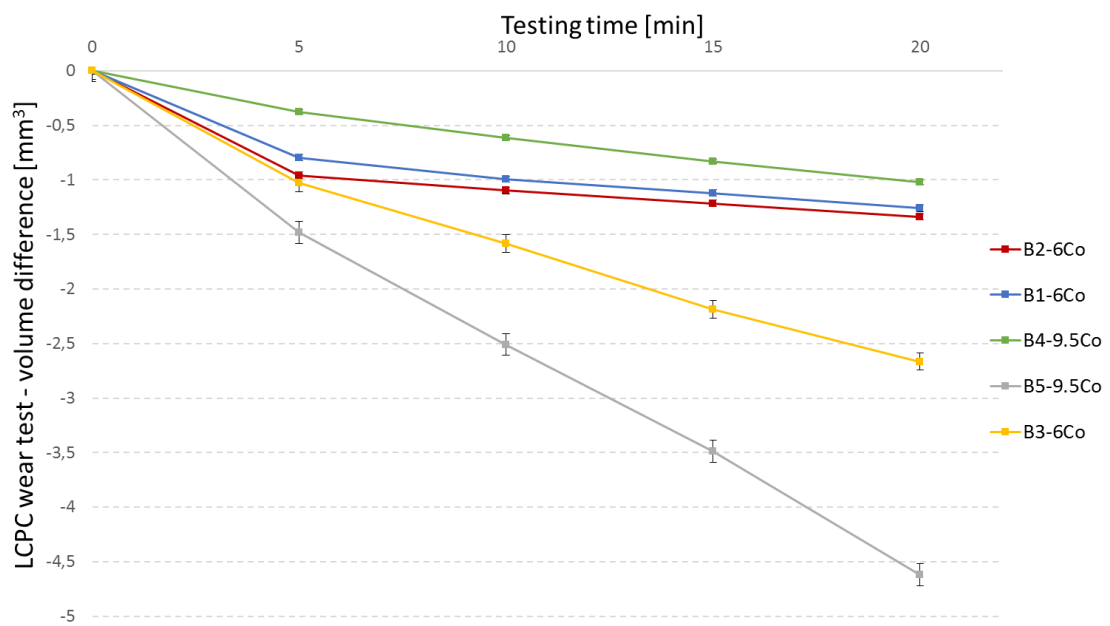
Figure 29: B-grades results of the LCPC wear test.

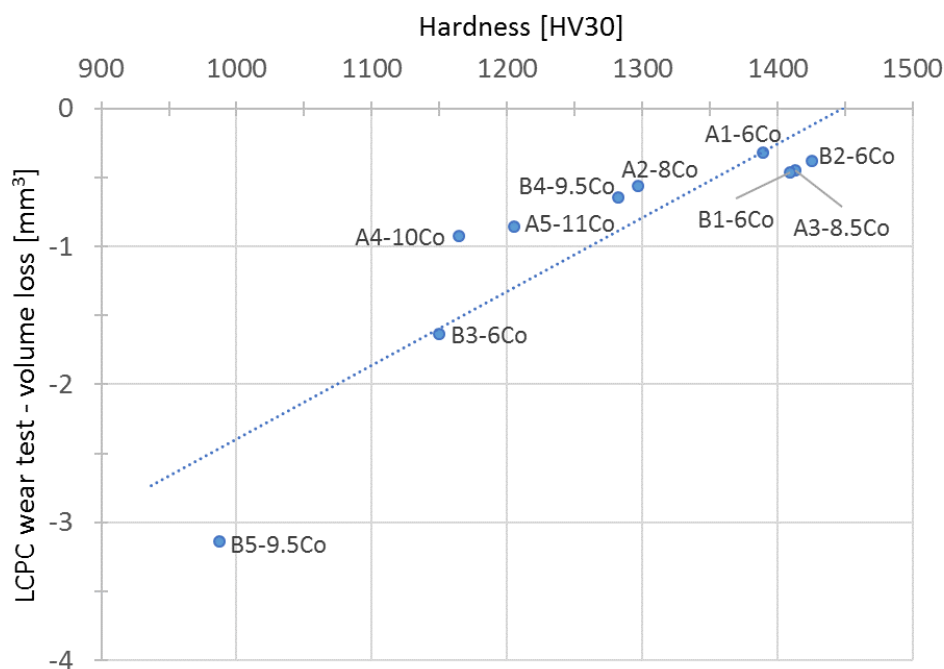
Figure 30: Correlation between the volume loss during the LCPC wear tests and the measured hardness. The volume difference measurement was started at the second test to avoid influences of the starting steel plate.

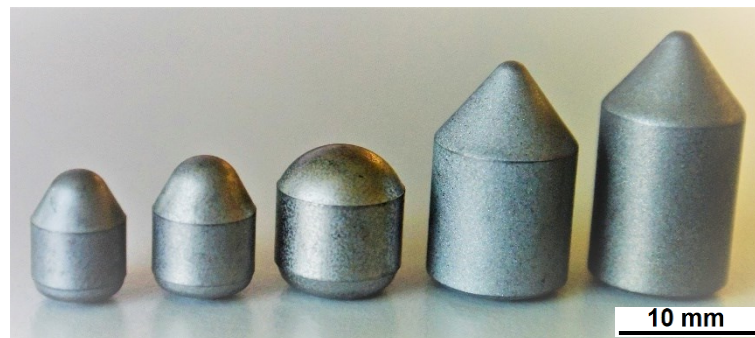
Figure 31: The different geometries of the pins for the application testing (from left to right): B2-6Co, B1-6Co, B4-9.5Co, B3-6Co and B5-9.5Co.

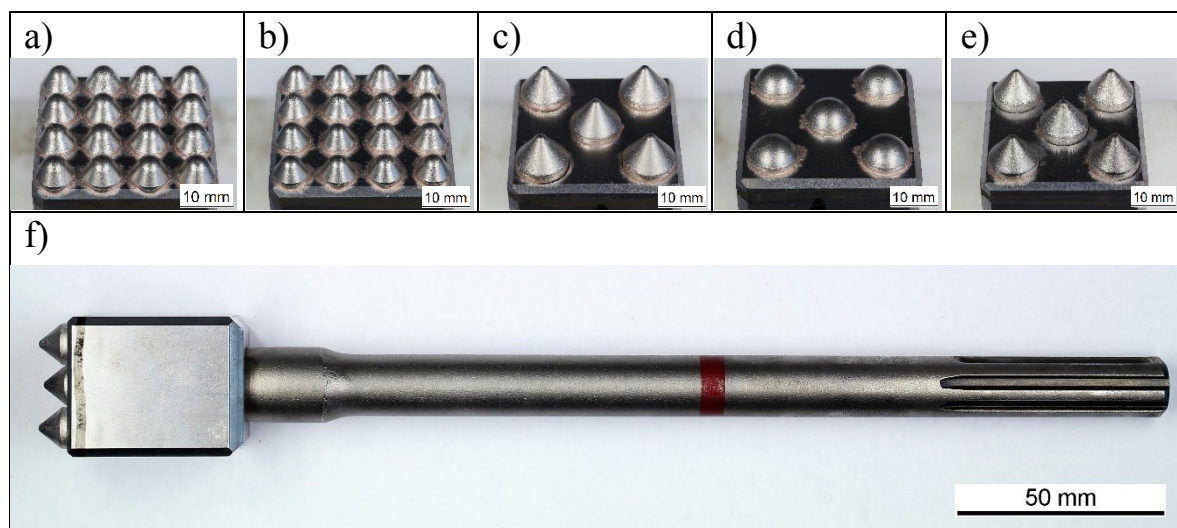
Figure 32: The modified bushing tool heads for the grade a) B1-6Co, b) B2-6Co, c) B3-6Co, d) B4-9.5Co and e) B5-9.5Co. f) shows the whole modified bushing tool for the grade B4-9.5Co.

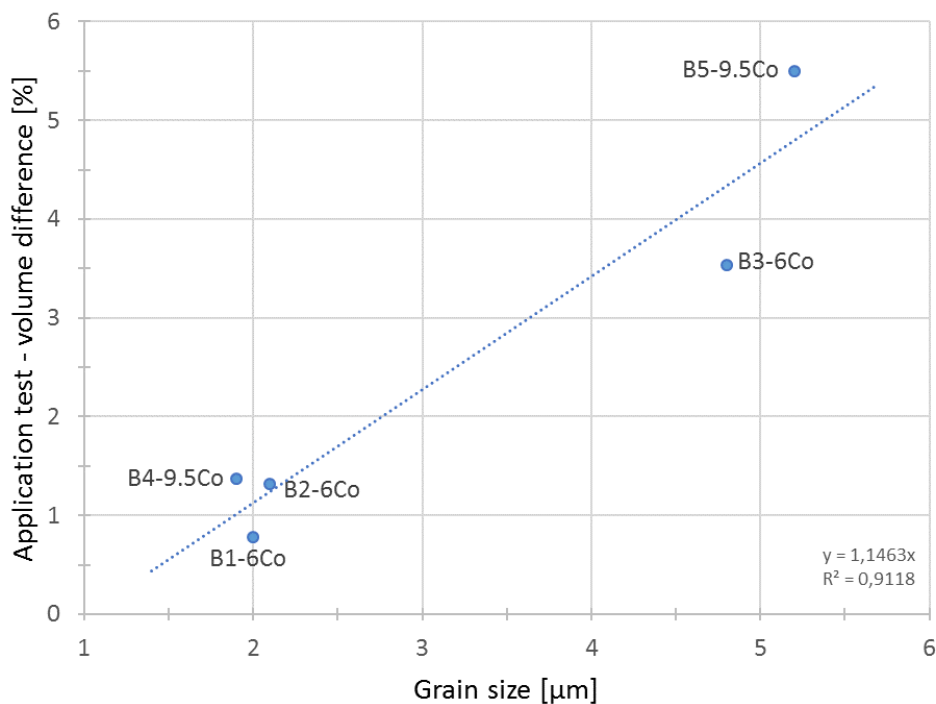
Figure 34 Correlation between the volume difference during the application testing and the grain size of the tested cemented carbide grades.

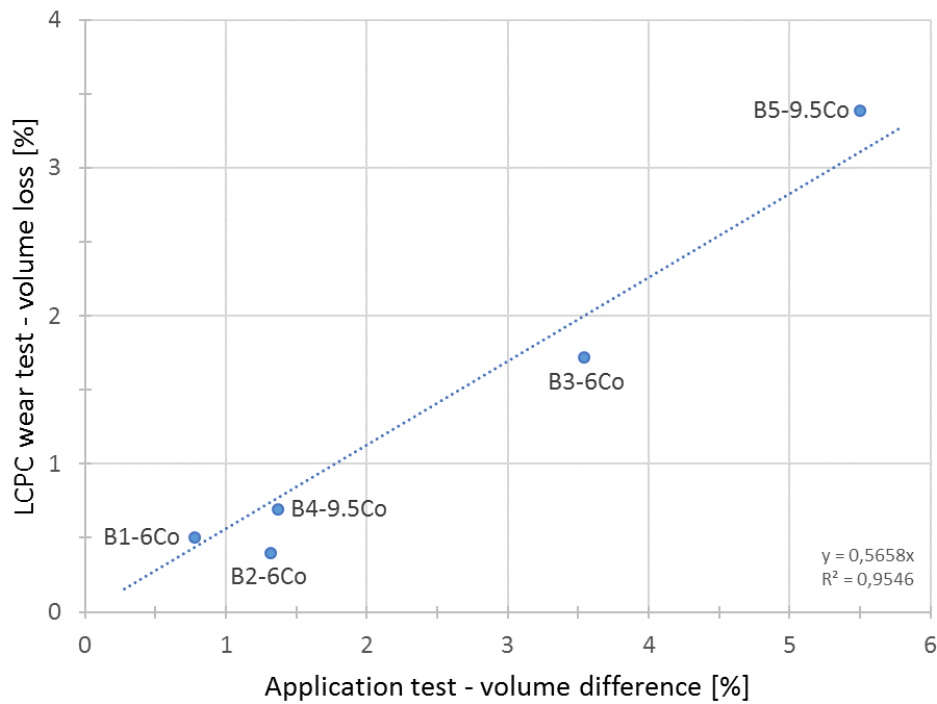
Figure 35: Correlation between the volume difference during the application testing and the LCPC wear test.

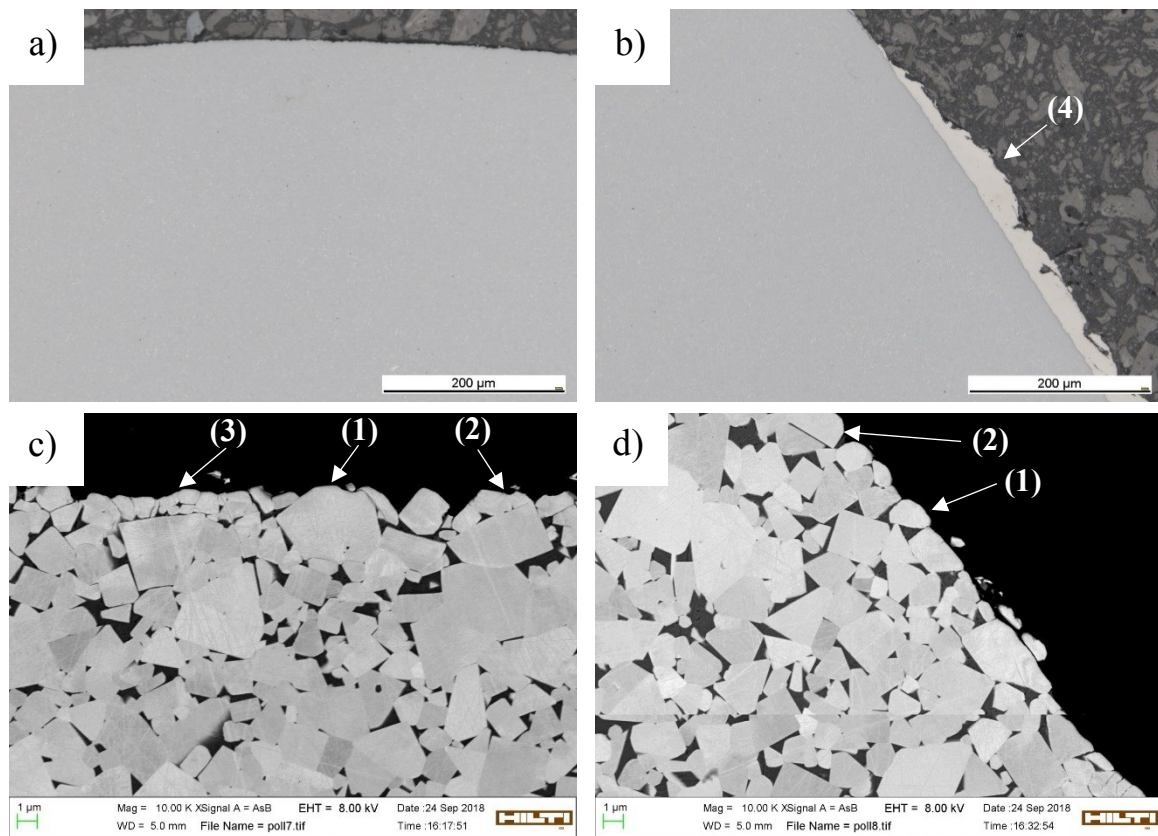
Figure 36: Microscopic analysis of grade B1-6Co after application testing. LOM images of the a) tip area and b) side area; SEM images of the c) tip area and d) side area.

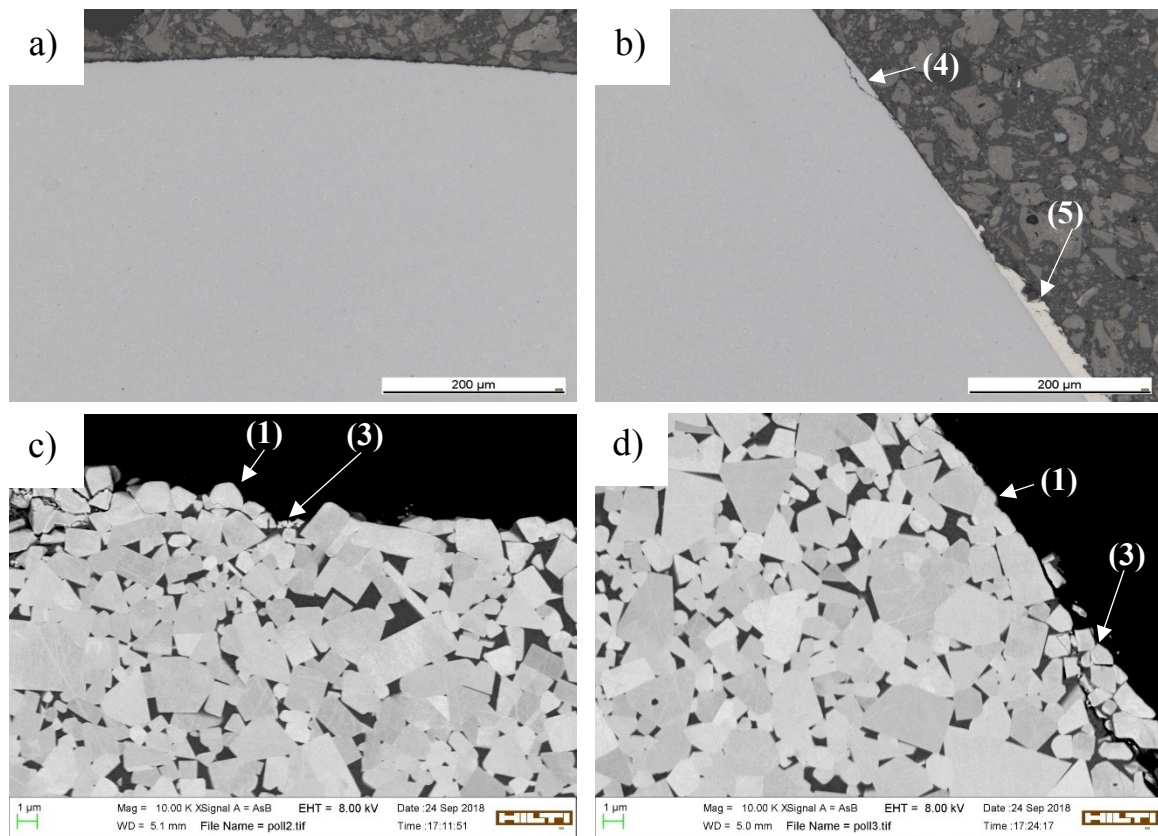
Figure 37: Microscopic analysis of grade B2-6Co after application testing. LOM images of the a) tip area and b) side area; SEM images of the c) tip area and d) side area.

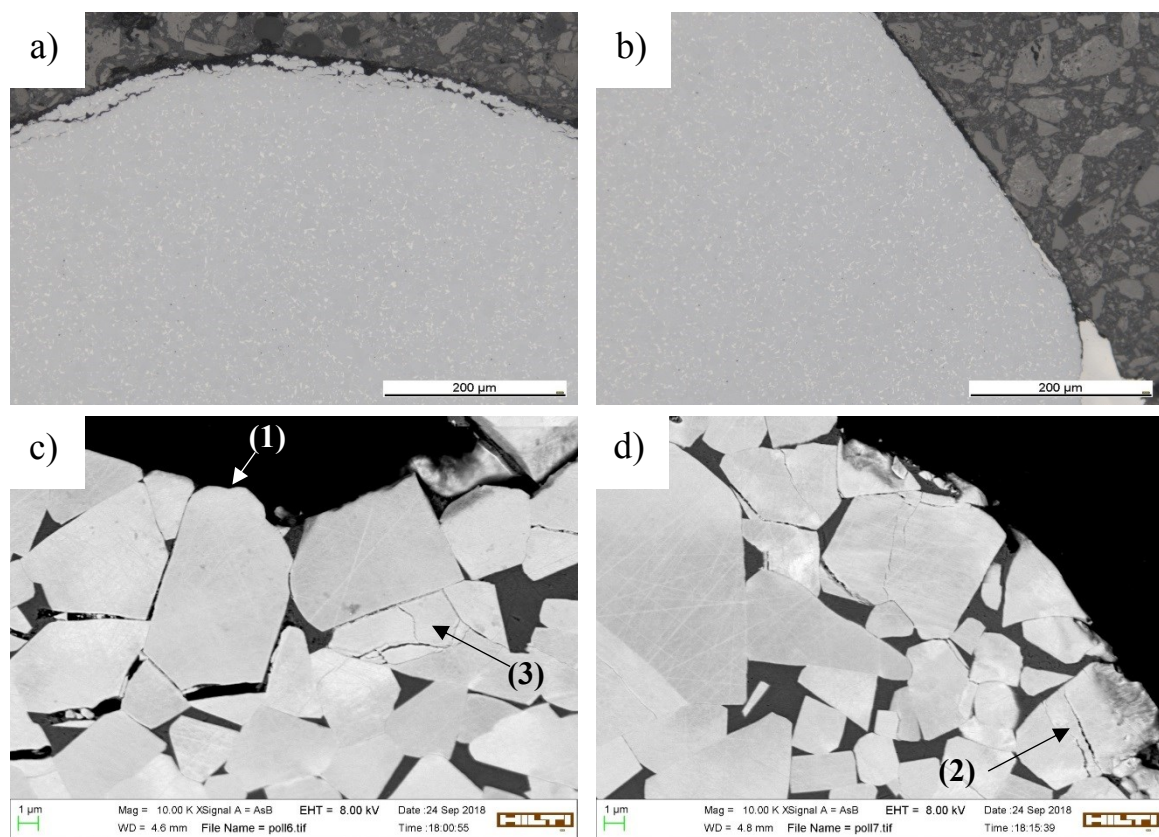
Figure 38: Microscopic analysis of grade B3-6Co after application testing. LOM images of the a) tip area and b) side area; SEM images of the c) tip area and d) side area.

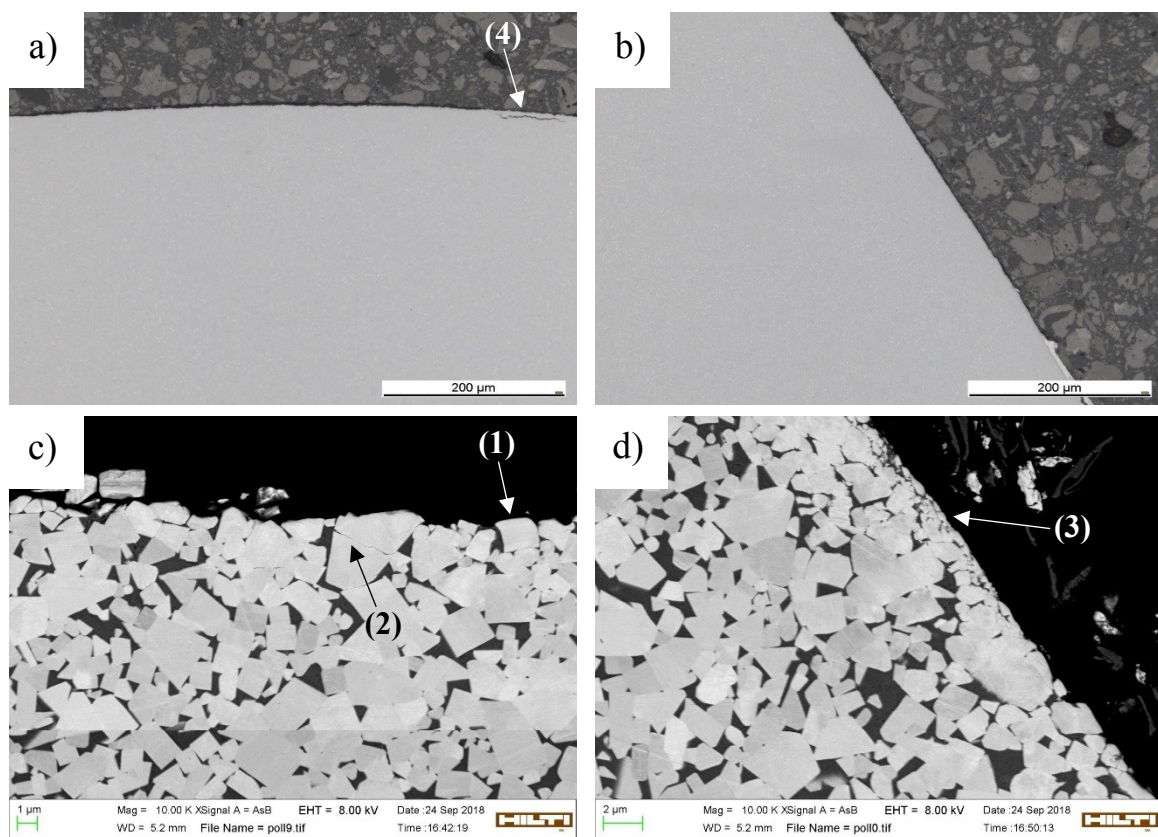
Figure 39: Microscopic analysis of grade B4-9.5Co after application testing. LOM images of the a) tip area and b) side area; SEM images of the c) tip area and d) side area.
