Chair of Structural and Functional Ceramics

Master's Thesis

Wear of WC/Co Cemented Carbides during
Percussive Demolition

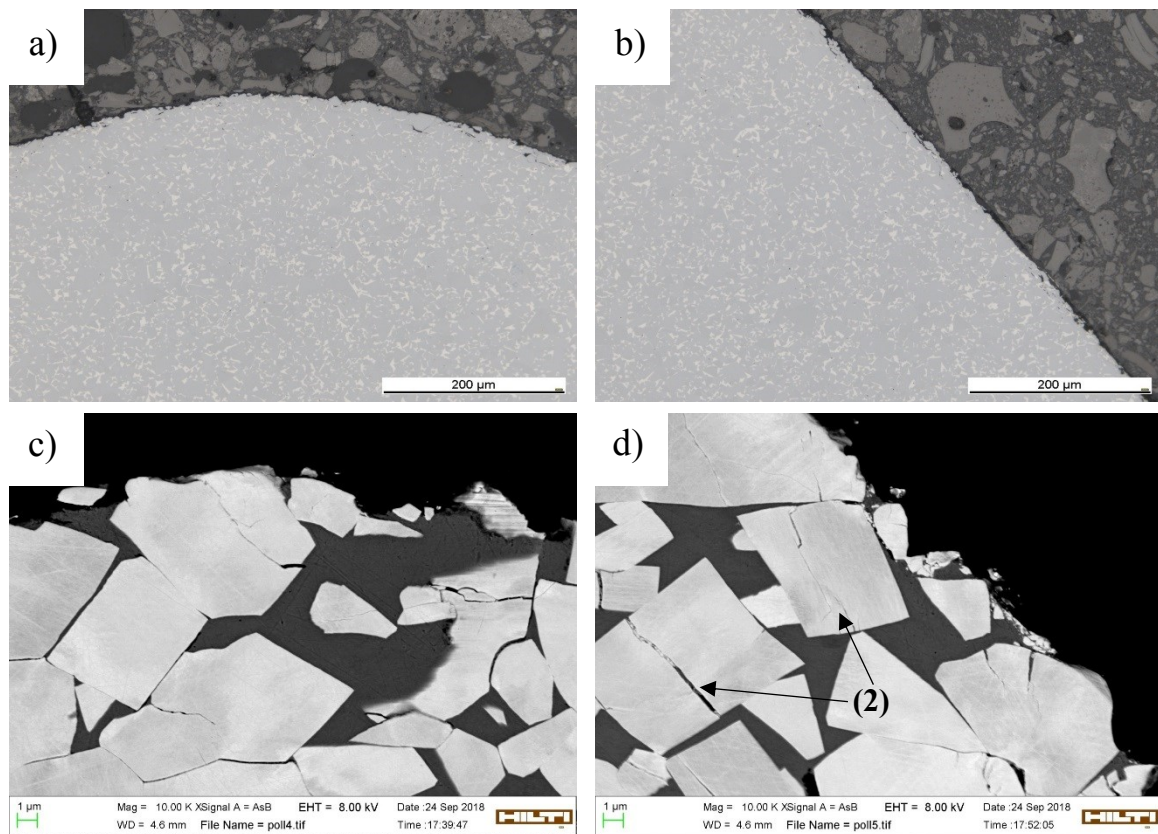
Figure 40: Microscopic analysis of grade B5-9.5Co after application testing. LOM images of the a) tip area and b) side area; SEM images of the c) tip area and d) side area.

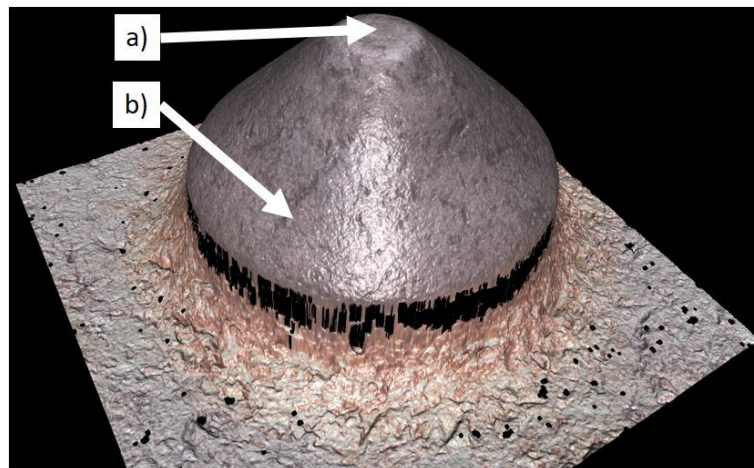
Figure 41: Areas of microscopic analysis: a) tip b) side

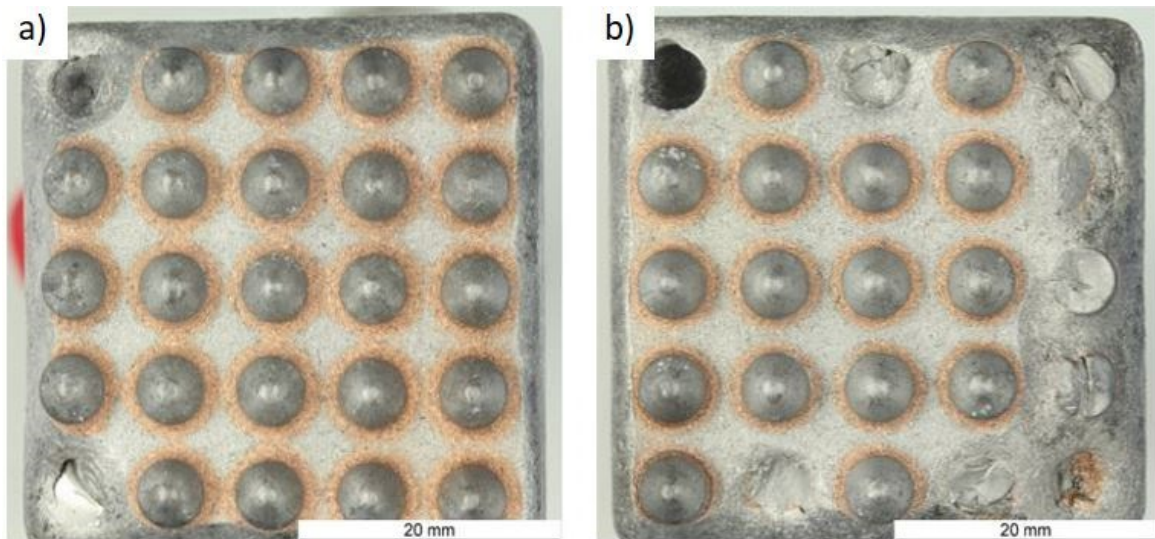
Figure 42: HILTI bushing tool tested in a test rig on concrete C50/60: a) ~3h b) ~13h

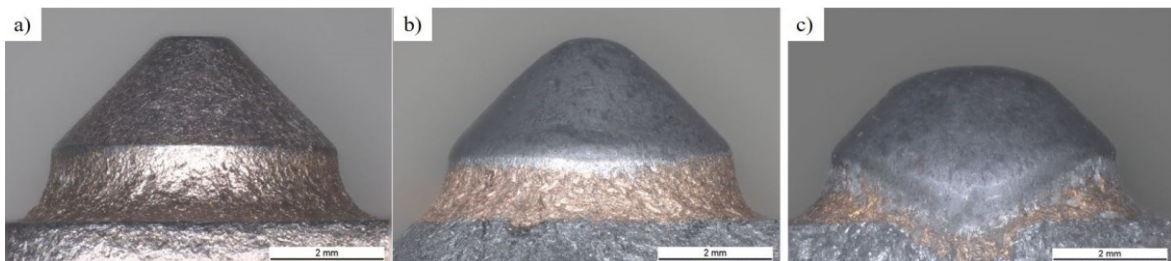
Figure 43: Cemented carbide pins of a HILTI bushing tool tested in a test rig on concrete C50/60: a) new b) runtime of ~3h c) runtime of ~13h

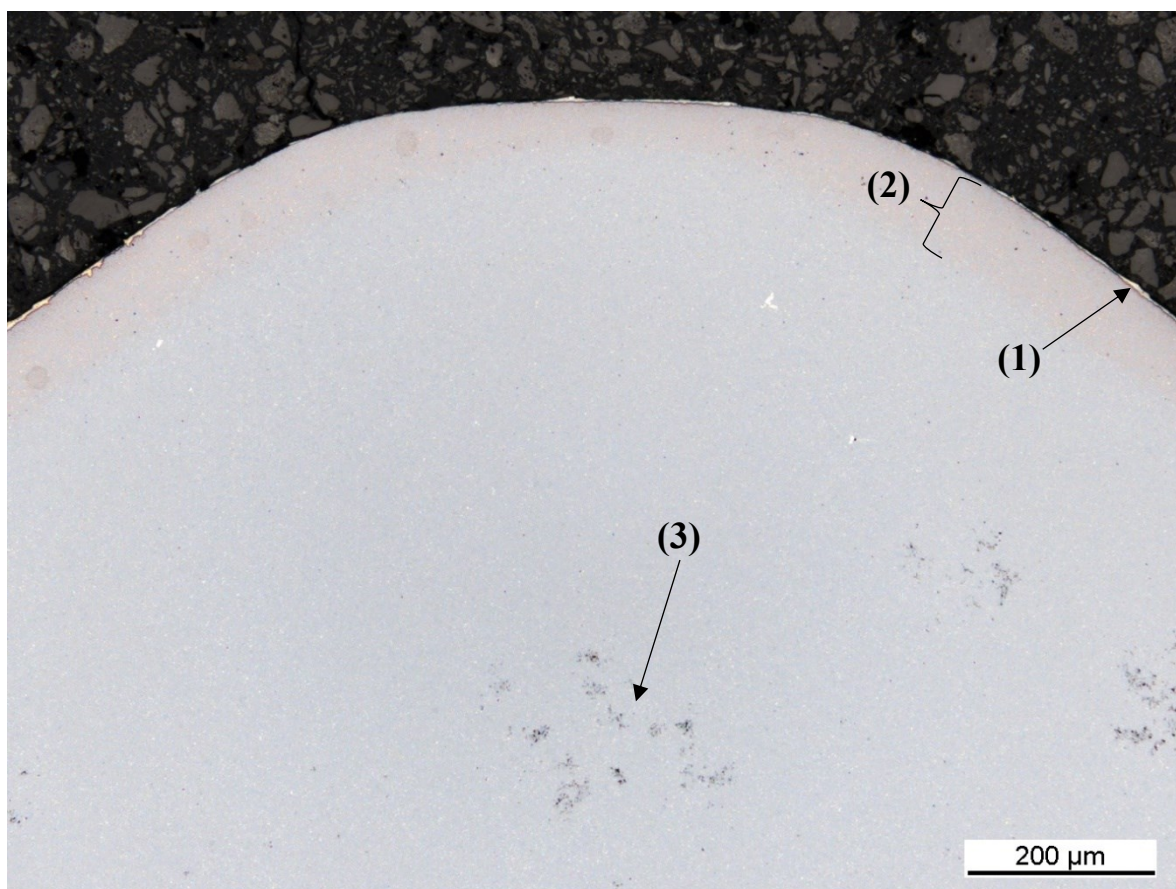
Figure 44: Cross-section of a new HILTI bushing tool

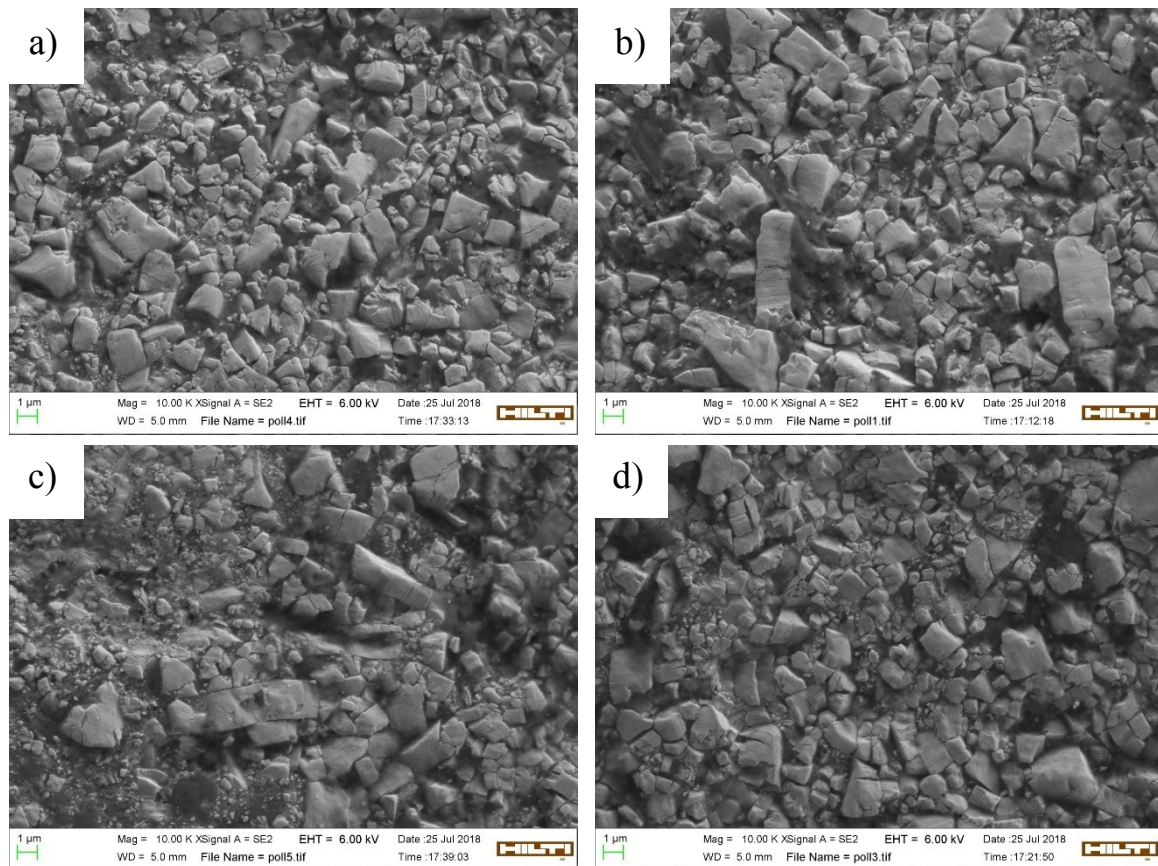
Figure 45: Surface images of worn cemented carbide pins of a HILTI bushing tool, showing the tip area after a runtime of a) ~3h, b) ~13h, and the side area after a runtime of c) ~3h, d) ~13h.

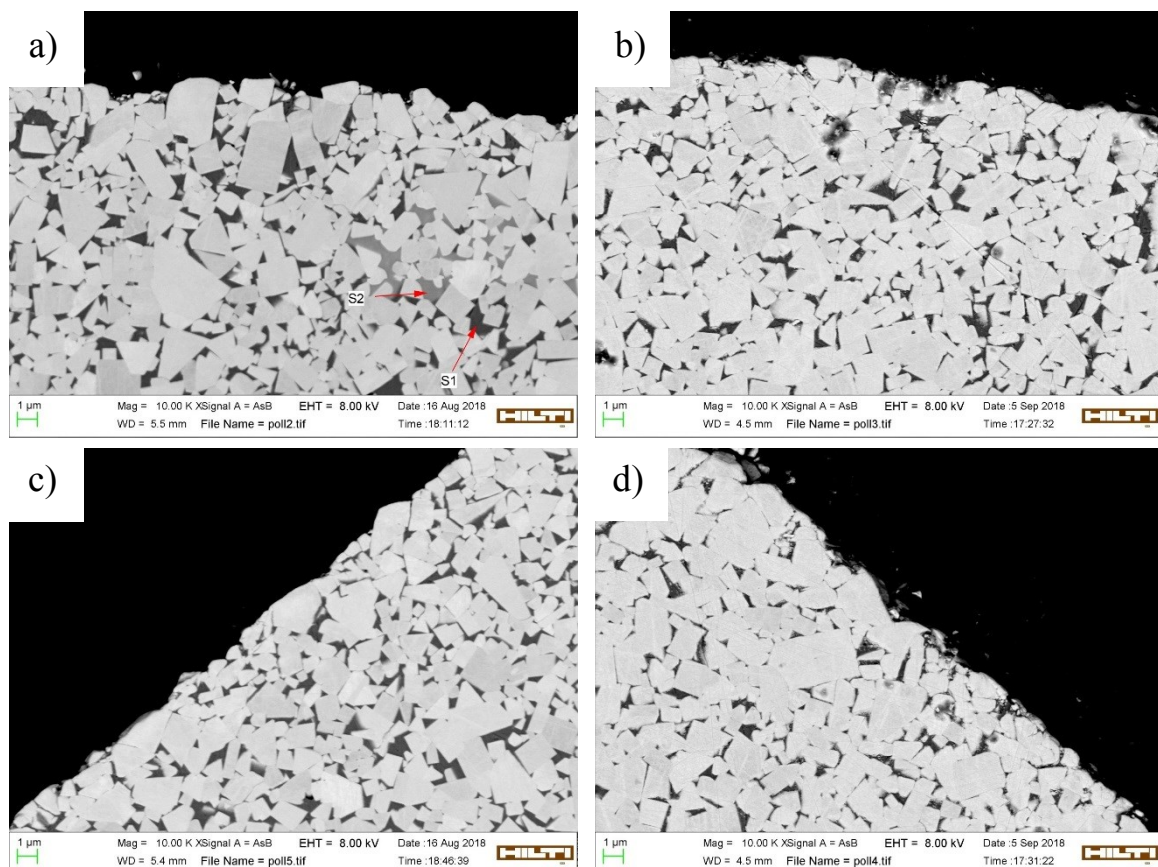
Figure 46: Cross-section images of worn cemented carbide pins of a HILTI bushing tool, showing the tip area after a runtime of a) ~3h, b) ~13h, and the side area after a runtime of c) ~3h, d) ~13h.

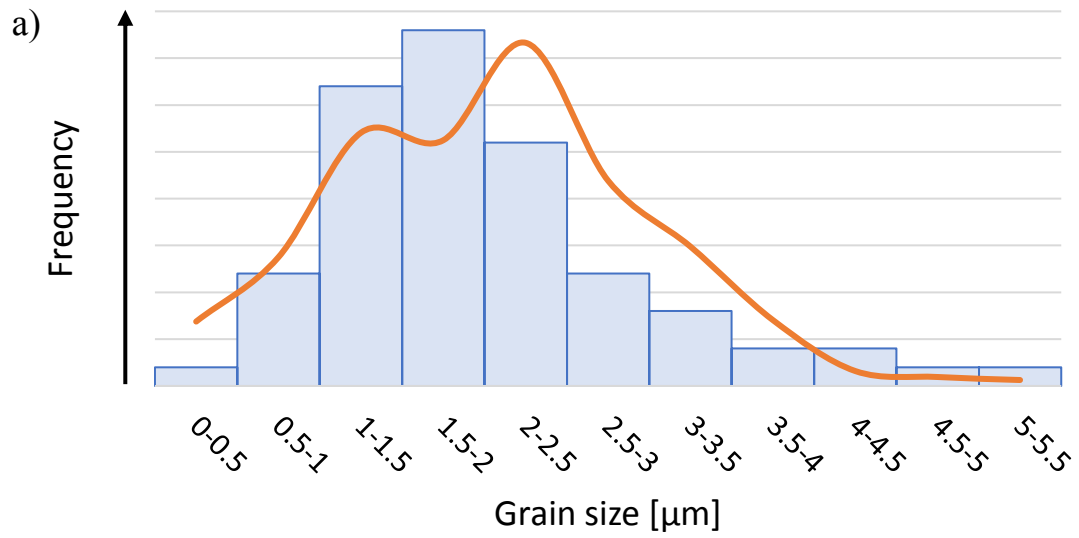
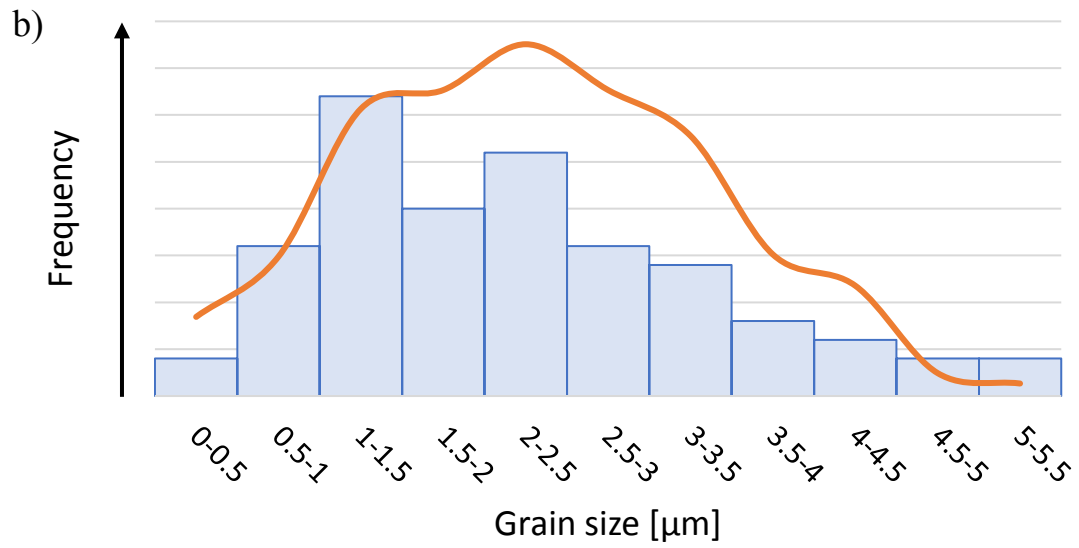
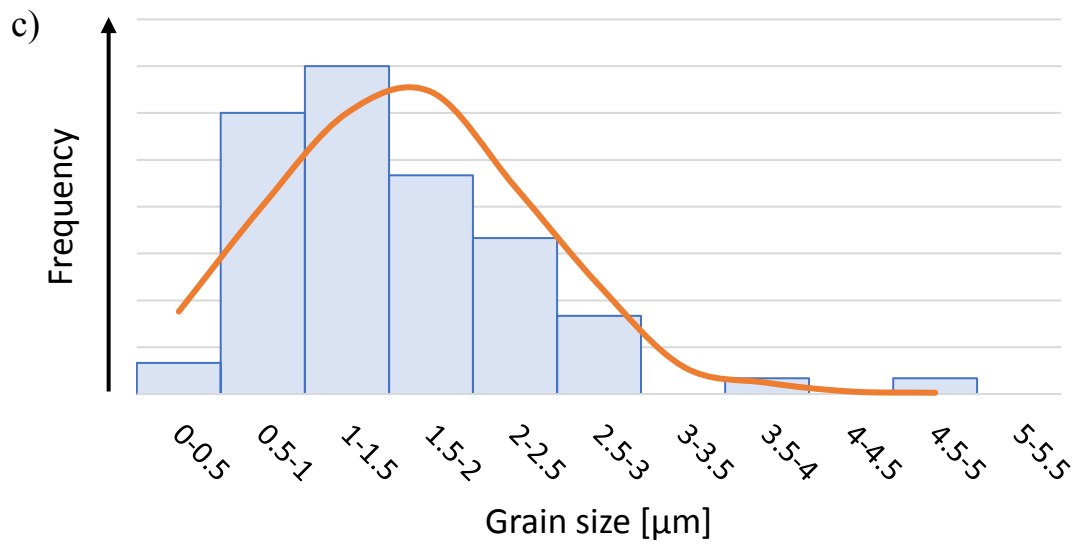
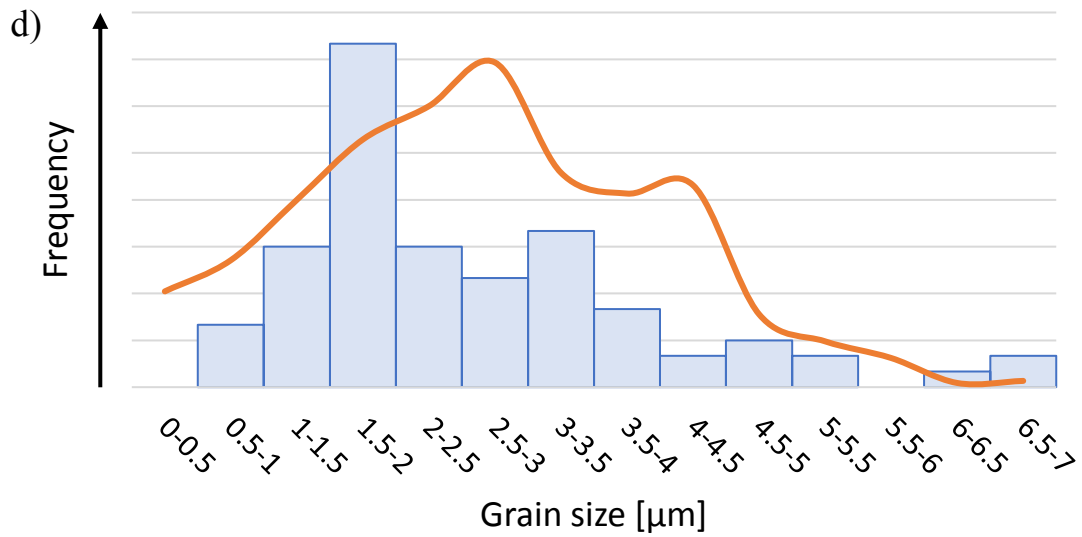
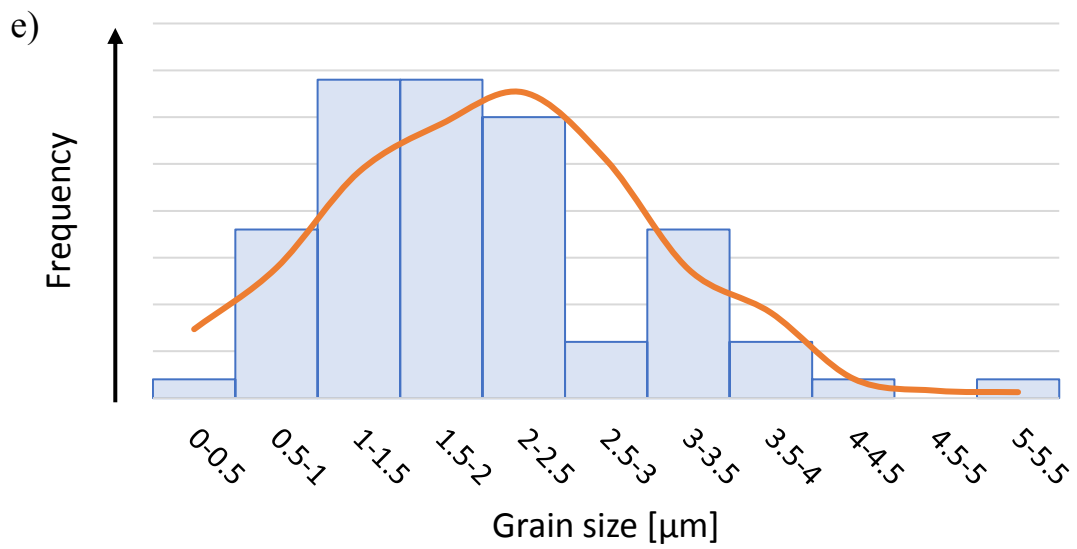
Figure 47: Grain size distribution determined by the lineal intercept procedure according to [45]. a) A1-6Co b) A2-8Co c) A3-8.5Co d) A4-10Co e) A5-11Co

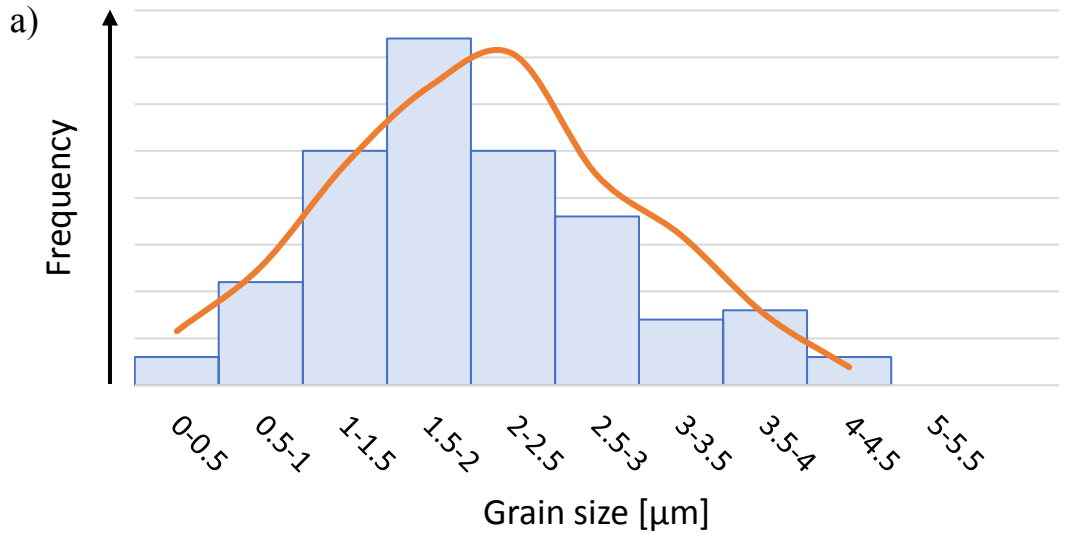
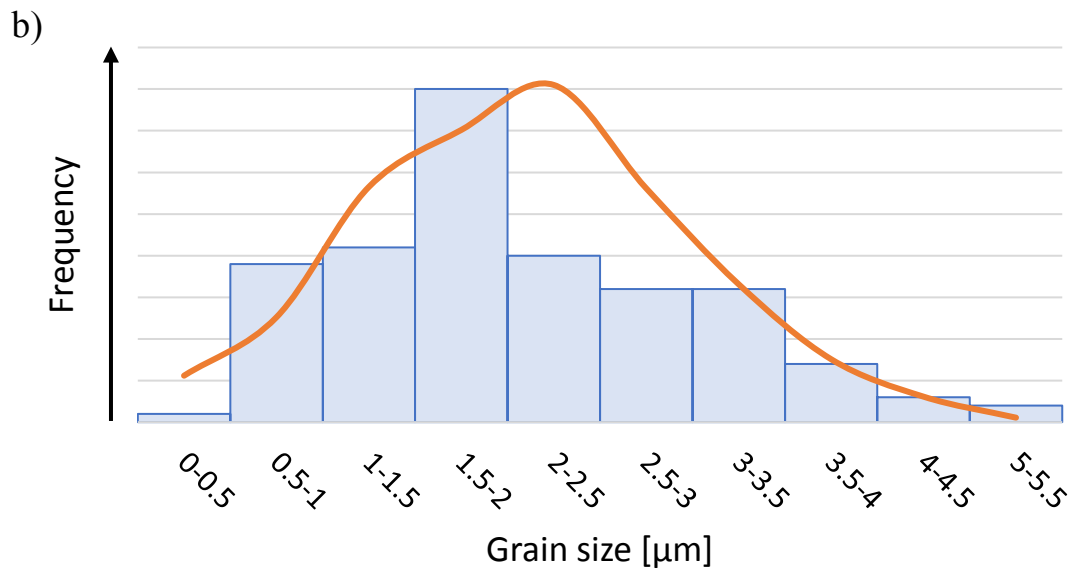
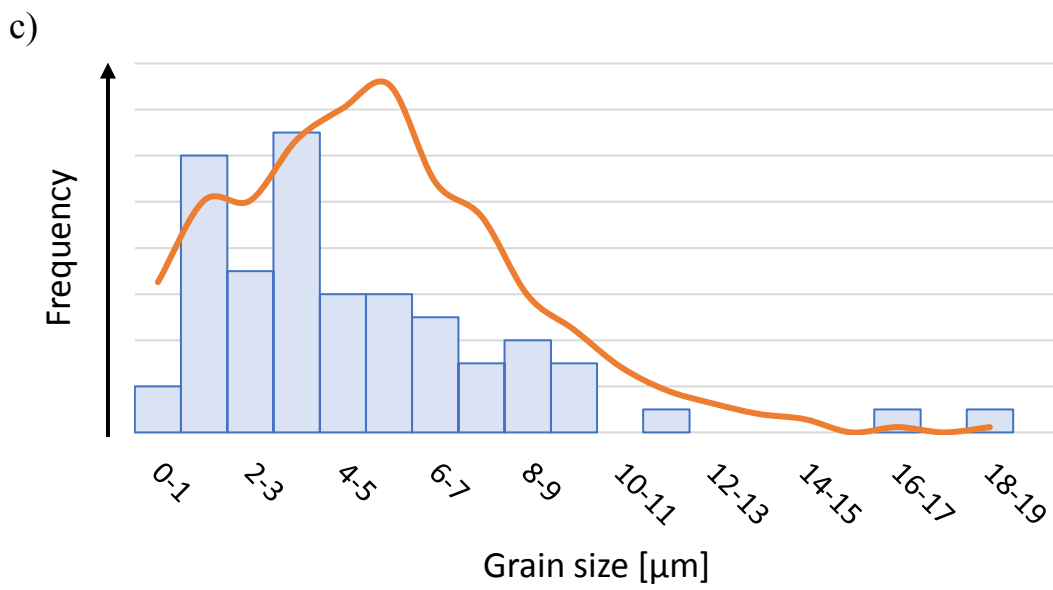
Figure 48: Grain size distribution determined by the lineal intercept procedure according to [45]. a) B1-6Co b) B2-6Co c) B3-6Co d) B4-9.5Co e) B5-9.5Co
